해양사고 특별조사보고서

- 자동차운반선 골든레이호 전도사고 -

사고일자 : 2019.09.08.

해양사고보고서

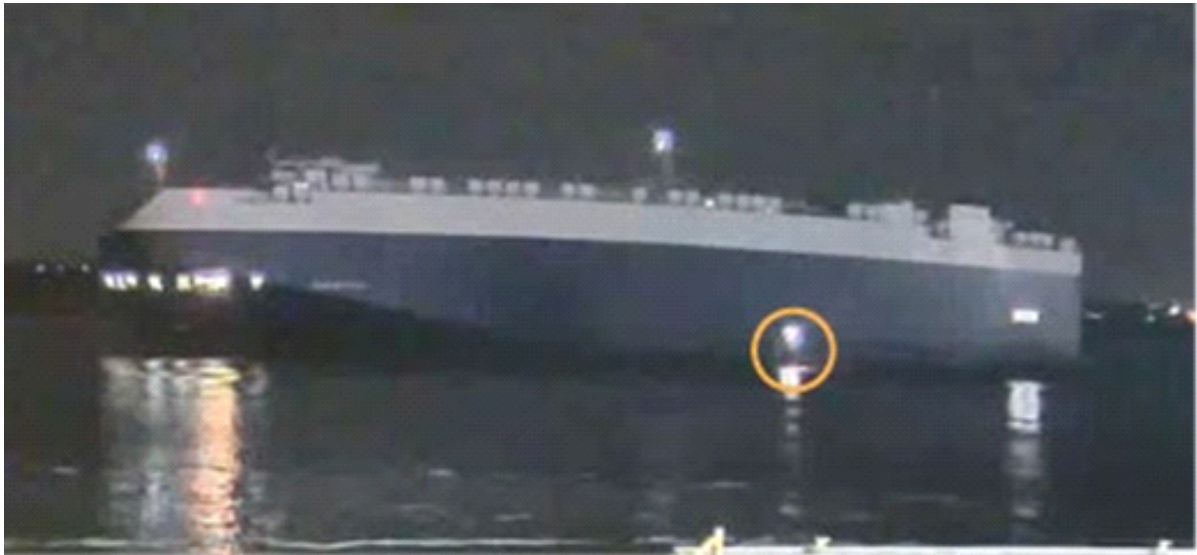
**[그림 3] 9월 7일 약 01시 30분경 플로리다주 잭슨빌을 출항하는 골든레이호.
선체 중앙부 불빛은 열려 있던 좌현측 도선사 출입문이다.
(파란 선체의 선수와 선미에 보이는 불빛은 계류설비 위치)**

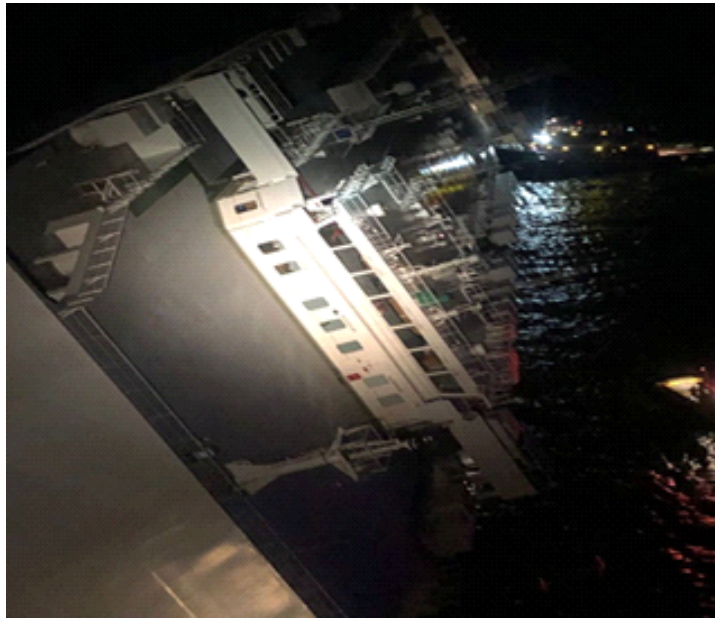
[그림 4] 사고 발생 후 2019년 9월 8일 선수에서 선미방향으로 바라본 60도 횡경사 상태의 골든레이호의 선교

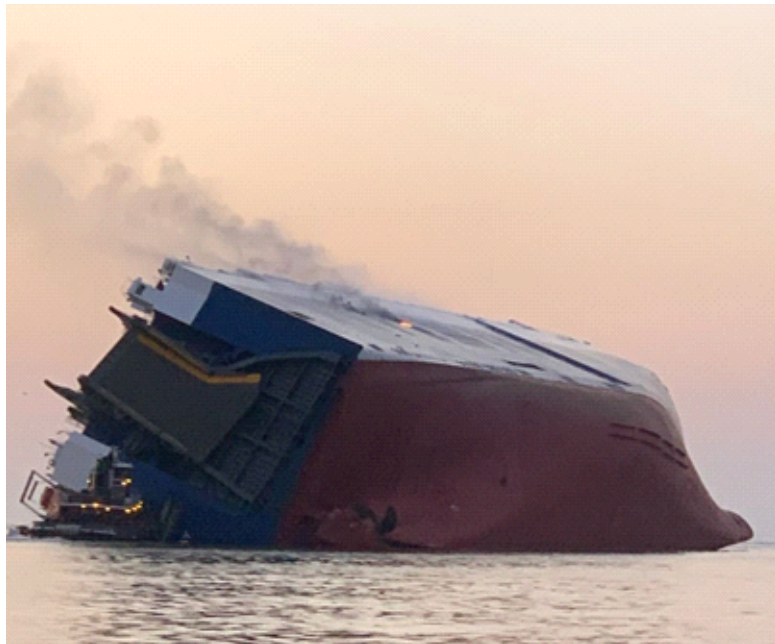
약 04시 30분경 구조대원들은 골든레이호 우현측 차량갑판에서 연기와 불꽃을 발견하였다(그림 5 참고). 해당 화물창에는 타이어와 플라스틱 차량부품을 포함한 가연성 물질이 있었다. 구조대원들은 짙고 검은 연기와 열로 인하여 실종된 기관사들을 수색하기 위한 선내 진입이 불가능했다. 화재는 약 24시간 동안 지속되다가 자연 진화되었다.

**[그림 5] 기울어진 후 좌초된 골든레이호 선미.
우현측 차량갑판에서 불꽃과 연기가 나오고 있다. 선박이 기울고 6시간 경과 후 촬영된 사진.**

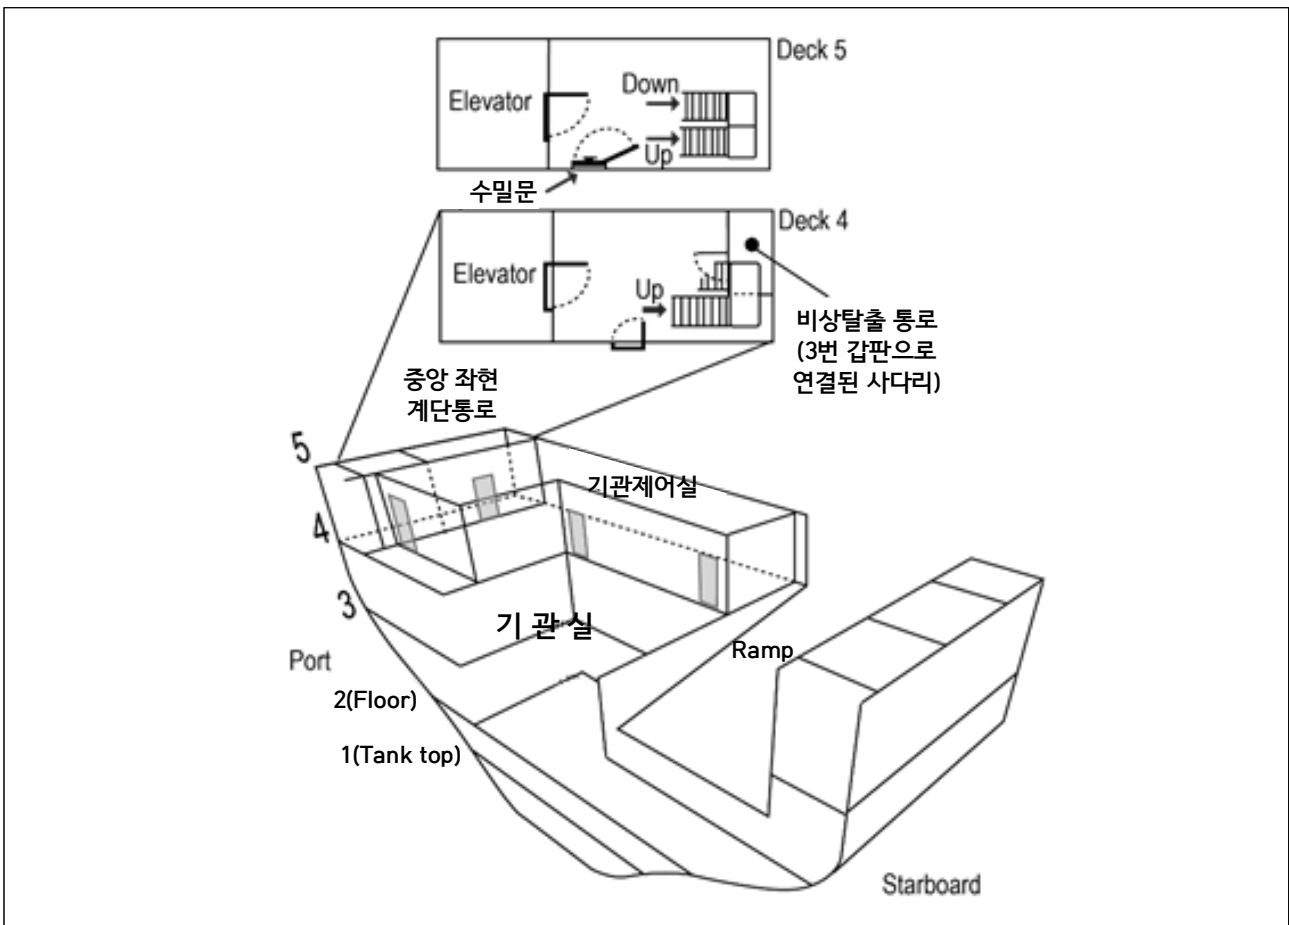
선박이 기울던 당시 기관사 1명과 실습 기관사 1명은 기관실 내부를 순찰하고 있었고 다른 두 명의 기관사는 4번 갑판에 있는 기관제어실에 있었다. 선박이 전도된 후 기관제어실에 있던 기관사 2명은 기관제어실과 기관실의 주계단통로인 중앙 좌현 계단통로를 통해 빠져 나가려고 시도하였으나 5번 갑판의 개방된 수밀문을 통해 해수가 계단통로로 유입되어 탈출이 불가능하였다. 기관제어실에는 기관실로 바로 진입할 수 있는 선미 방향의 문이 3개 더 있었다(그림 6 참고).

[그림 6] 기관실과 기관제어실 출구를 보여주는 간략도.
회색부분은 문을 가리킨다.

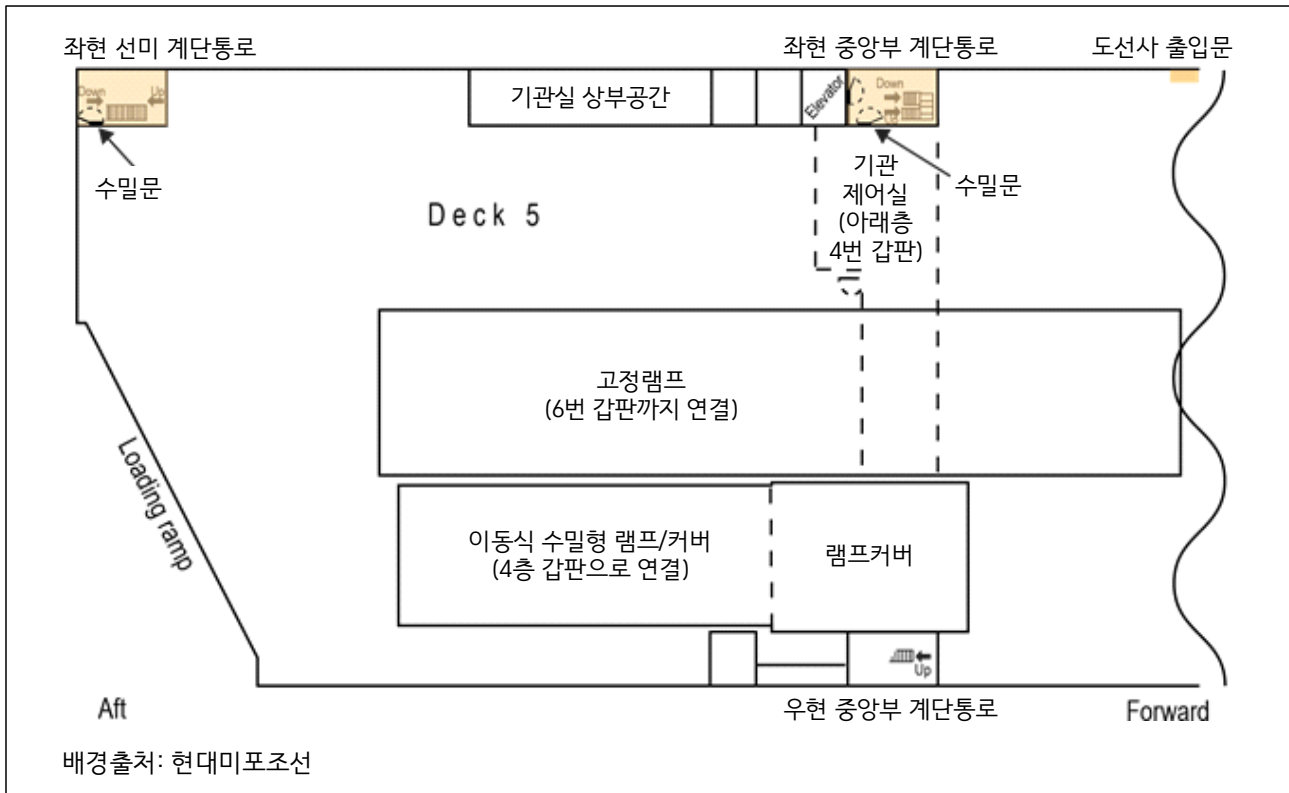
IMACS 데이터에 따르면 사고 당시 좌현측 도선사 출입문 뿐만 아니라 5번 갑판 선미 계단통로와 좌현 중앙부 계단통로로 연결되는 수밀문은 모두 개방되어 있었고, 선박이 콜로넬스 아일랜드 터미널을 출발하기 전인 9월 7일 23시 41분부터 계속 열려 있었다. 도선사 출입문에서 선미 방향으로 약 75피트(22.9미터) 떨어진 좌현 중앙부 계단통로는 4번 갑판의 기관실과 기관제어실로 접근할 수 있는 주요 출입구였다. 더 아래층 기관실로 연결되는 탈출 통로 계단으로 이동하면 4번 갑판에 있는 이 계단통로로 나가게 된다(그림 11 참고).

[그림 11] 5번 갑판 선미 부분 평면도
 색칠된 부분은 열려 있던 수밀문과 도선사 출입문이 있는 계단통로다.
 점선은 아래 4번 차량갑판의 공간을 가리킨다.

- ① 복원성 계산과정에서 발생할 수 있는 오류를 바로 잡을 수 있도록 선장과 회사 담당자가 담당사관의 복원성 계산결과를 검증하는 절차를 마련할 필요가 있다.
- ② 복원성 계산 담당사관이 복원성 계산능력을 충분히 갖출 수 있도록 복원성에 대한 교육 및 훈련을 강화할 필요가 있다.
- ③ 선원이 다른 선박에 승선하더라도 복원성 계산 컴퓨터를 쉽게 사용할 수 있도록 선대 전체에 유사한 형식의 복원성 계산 컴퓨터를 사용하는 것이 바람직하다.
- ④ 출항 전 수밀문 폐쇄여부 확인 절차(체크리스트)가 제대로 이행되도록 하여야 한다.

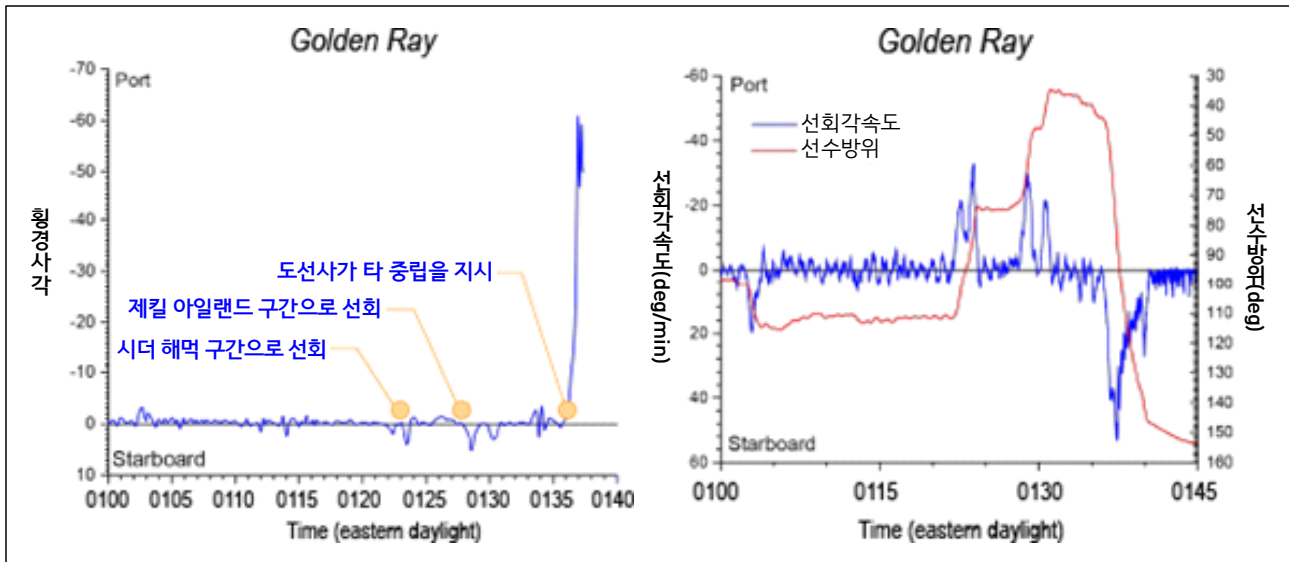
[그림 14] NTSB가 실시한 골든레이호의 성능 연구 그래프.
 좌측: 이전 두 차례 좌선회를 포함하여 통항하는 동안의 횡경사각.
 우측: 통항하는 동안 선수방위와 선회각속도.

본 연구에 따르면 선속 12~13노트에서 선박이 우선회하는 동안 무게중심 아래 거리에서 선체에 작용하는 유체동역학적 횡력으로 생성된 우력에 의해 선박의 횡경사각이 바뀌었다. 횡경사에 저항하는 유체정역학적 복원성(부력)은 일항사가 보고한 GM값인 2.45미터(8피트) 보다 훨씬 낮았으며, 오히려 GM값이 약 0.45미터(1.5피트)에 대한 복원성과 일치하였다. 또한, 연구에서 바람의 영향을 정확하게 계산할 수는 없었지만 경사모멘트가 일어난 다른 원인에 비해 바람으로 발생된 경사모멘트는 강도가 낮아 유의미하지 않았다. 연구 결과 선박의 실제 무게중심은 보고된 것보다 상당히 더 높아 횡요에 충분히 저항할 수 없었던 것으로 밝혀졌다.

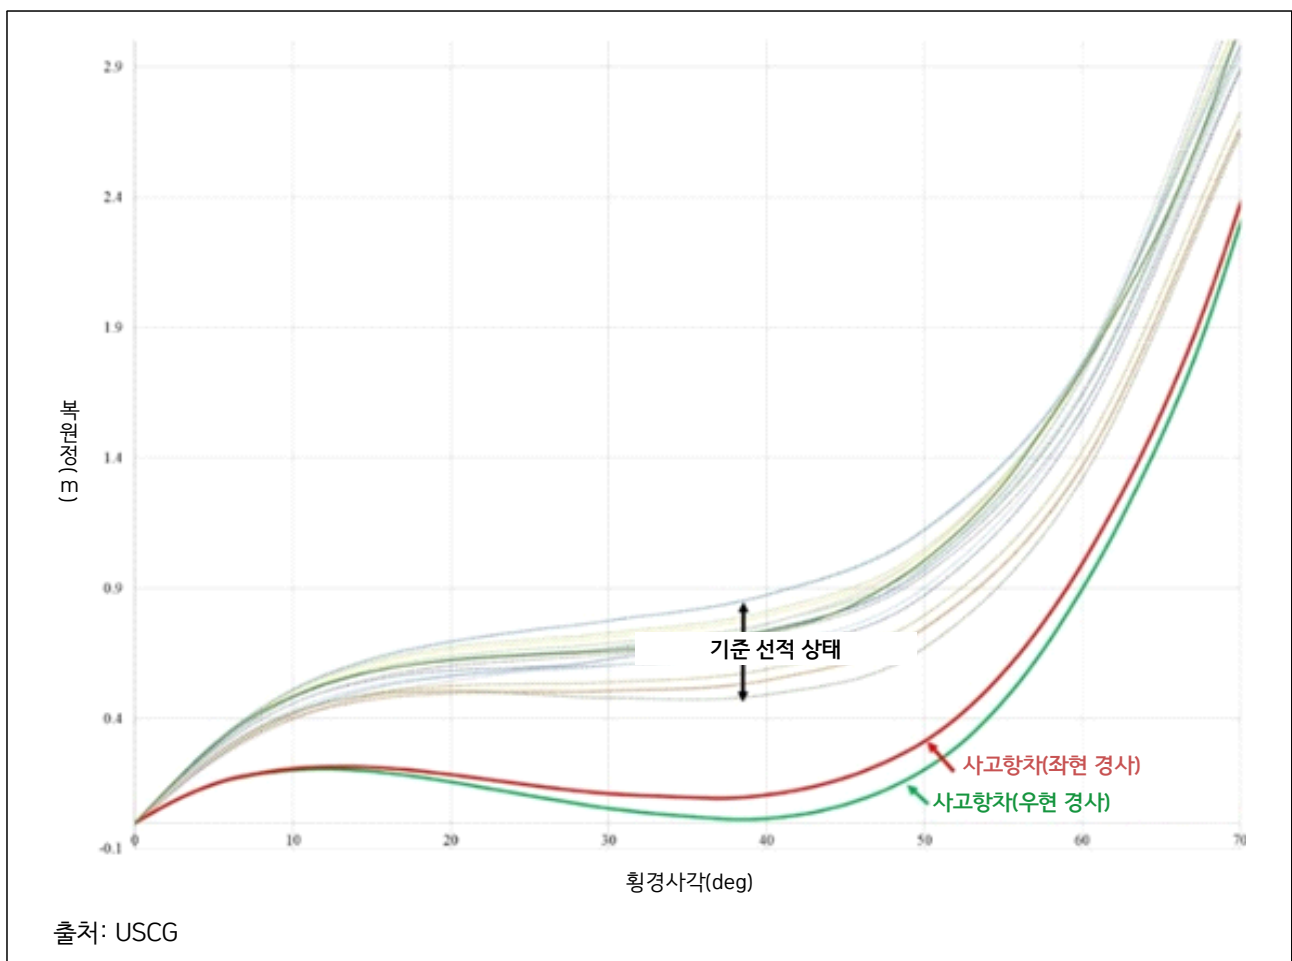
MSC는 비손상 복원성을 판단하기 위하여 골든레이호의 복원정곡선을 도출하여 그 결과를 IS 코드의 복원성 기준과 비교하였다. MSC가 도출한 복원정곡선은 “복원정 길이와 복원정곡선 아래 합산면적 모두 T&S 책자에서 기준으로 삼은 상황에서의 값보다 상당히 더 낮았다.” MSC는 IS 코드 기준을 이 복원정곡선에 적용하였을 때 골든레이호 선적 상태에서 횡경사각 30도와 40도 사이에서 복원정곡선의 아래 합산면적은 특히 좁았고, 따라서 골든레이호는 2008 IS 코드를 충족시키지 못했다고 분석했다(그림 16 참고). MSC는 복원정곡선 아래 합산면적이 좁았기 때문에 선박이 IS 코드의 극한 상태의 바람과 횡요 기준에서의 합산면적 비율 기준도 충족하지 못했다고 판단하였다. 그 결과, MSC는 골든레이호는 화물이 적재된 상태에서 극도로 낮은 복원력을 가지고 있었으며 그로 인해 음(-)의 정적(adverse static) 또는 동적 경사효과를 더 견디지 못하였고 우선회하는 동안 선박에 작용된 원심력으로 인해 전도되었을 것이라는 결론을 내렸다.

[그림 16] 골든레이호의 T&S 책자 속 유사한 선적 상태에 대한 기준 복원정곡선과 MSC가 골든레이호 분석으로 도출한 사고항차 당시 복원정곡선의 비교

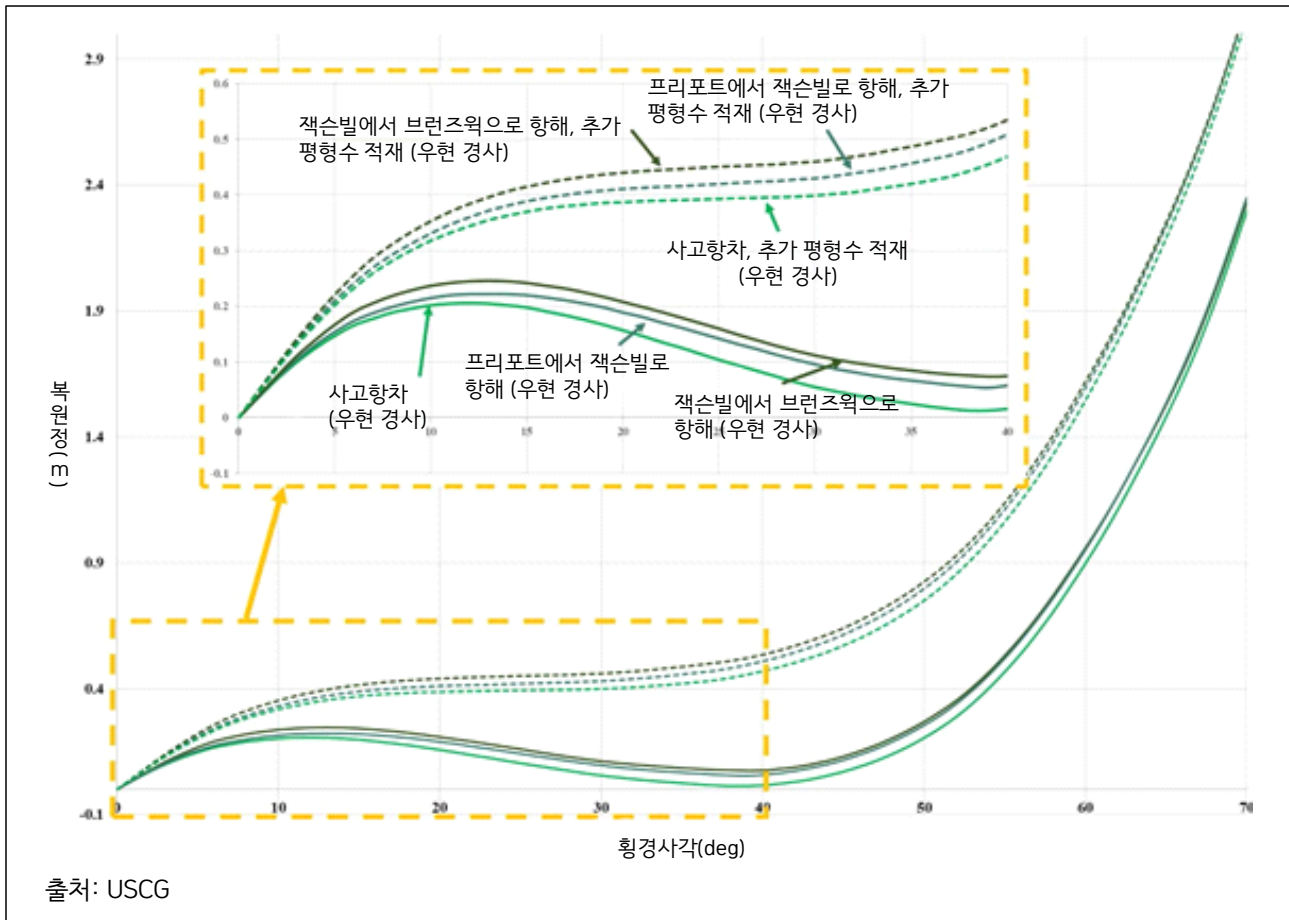
또한, MSC 보고서에서는 만일 골든레이호가 1,492톤의 평형수(프리포트에서 출항 후 1,500톤의 평형수를 주입하였고 잭슨빌에 입항하기 전 항만의 흡수요건을 충족하기 위해 배출하였다)를 추가로 적재했다면 선박은 이전 두 항차와 사고항차 모두에서 IS 코드를 준수했을 것이라고 설명하였다(그림 17 참고). 또한, MSC는 추가 평형수를 적재하였을 때를 가정하여 계산한 골든레이호의 이론상 초기 GM값은 사고항차의 경우 2.25미터(7.4피트), 프리포트 출항 항차에는 2.4미터(7.9피트), 그리고 잭슨빌 출항 항차에는 2.47미터(8.1피트)였을 것으로 기술하였다(비교를 위해 MSC는 당시 선적 상태에 대한 초기 GM값은 사고항차의 경우 1.76미터(5.8피트), 프리포트 출항 항차는 1.84미터(6피트), 그리고 잭슨빌 출항 항차는 1.91미터(6.3피트)로 산출하였음).

[그림 17] 1,492MT의 추가 평형수가 적재된 경우 MSC의 골든레이호 분석에서 산출된 사고항차와 이전 2항차의 이론상 복원정곡선(녹색 점선).

MSC의 분석에서 산출된 각 항차별 실제 선적 상태에 대한 복원정곡선(녹색 실선)과 비교하였다.

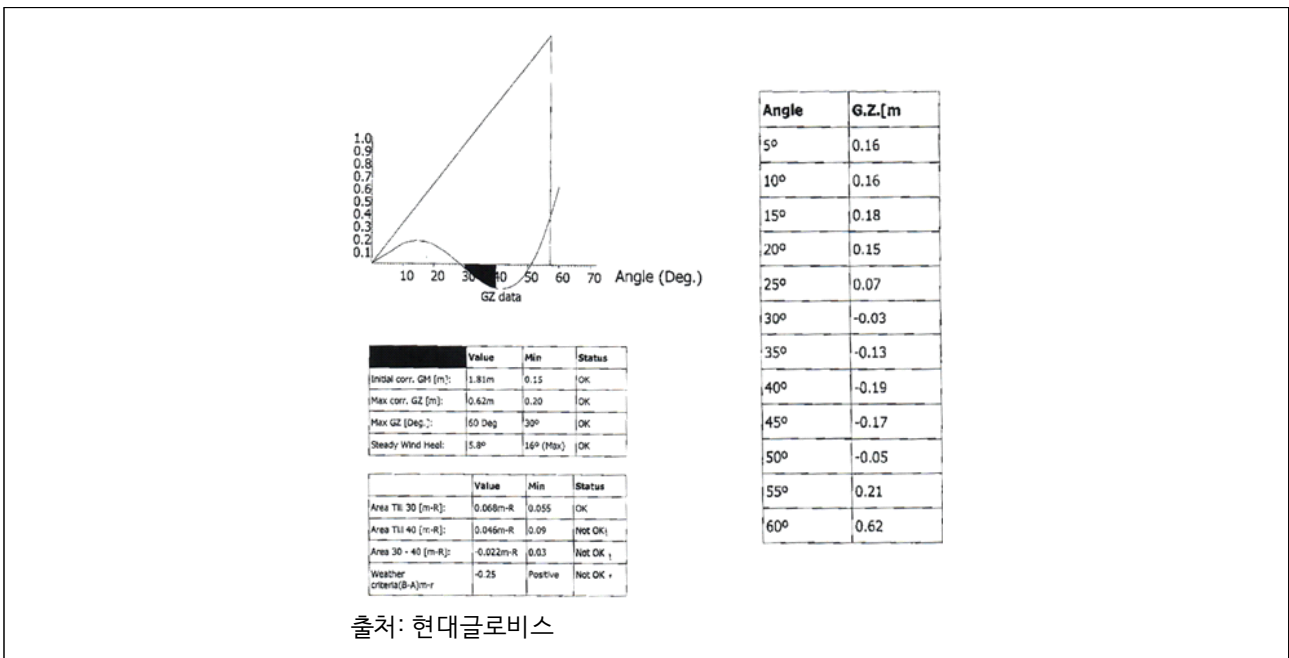
현대글로벌비스(Hyundai Glovis). 이 용선자는 골든레이호와 동급 선박인 실버레이호에 설치된 복원성 계산 컴퓨터를 사용하여 골든레이호의 복원성을 분석하였다(현대글로벌비스, 2020년). 용선자는 본 시뮬레이션에서 자체 수집한 선박 데이터와 상태자료를 활용하였으며 USCG나 NTSB는 참관하지 않았다. 해당 시뮬레이션에서 골든레이호의 GM값은 1.8미터(5.9피트)로 계산되었으며 사고 당시 골든레이호의 복원정곡선은 극도로 낮았고 3건의 복원성 요건에 대해 복원성 계산 컴퓨터에서는 “불량(Not OK)”으로 나타났다(그림 18 참고). 또한, 횡경사각이 약 25도가 되자 복원정곡선은 음(-)의 복원성을 보였다.

[그림 18] 사고 당시 골든레이호 선박 데이터에 기초하여 실버레이호의 복원성 계산 컴퓨터로 계산한 복원정곡선. 3개의 복원성 요건 모두 “불량(Not OK)” 상태를 보였으며 복원정(GZ)은 횡경사각이 25도를 넘어서자 음(-)의 값을 가졌다.

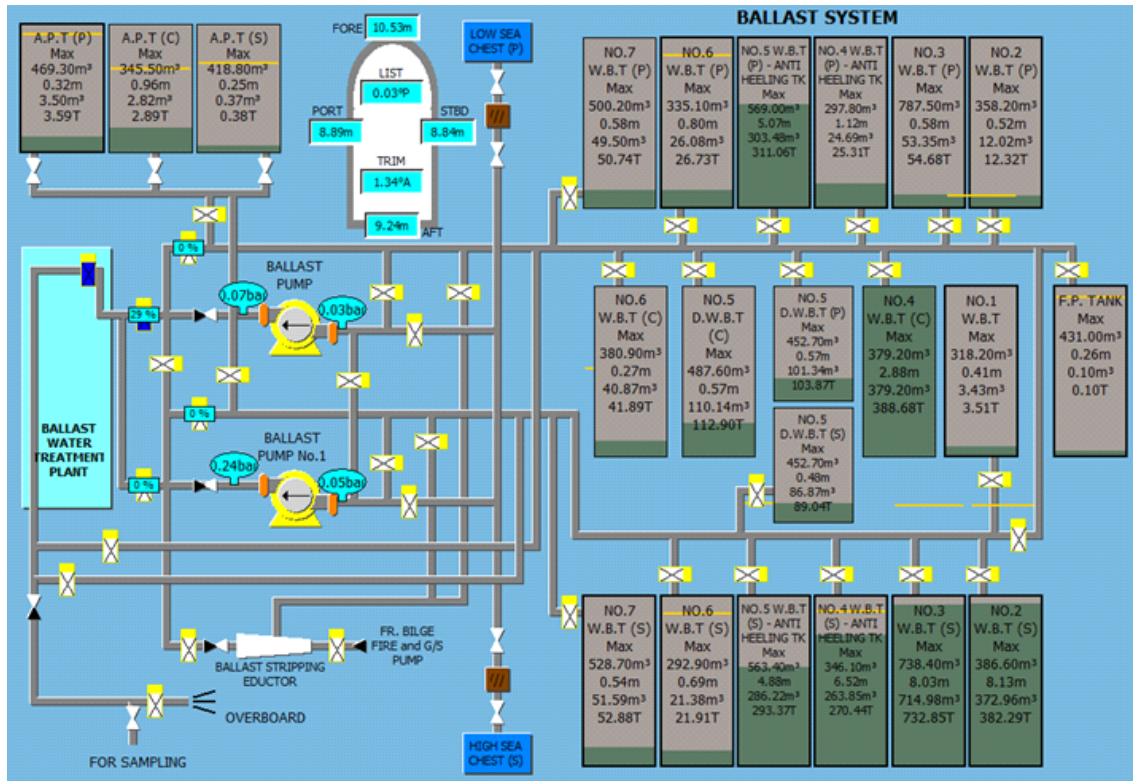
일항사는 선박이 플로리다주 잭슨빌에 입항하기 전 배출한 평형수 1,492톤을 정확하게 처리하지 않았을 가능성이 있다. 게다가, MSC는 이전 2항차 동안 선박이 적절한 양의 평형수를 적재하지 않았다는 사실을 확인하였다. 따라서 NTSB는 일항사가 평형수탱크 수치를 선내 복원성 계산 컴퓨터에 잘못 입력하여 복원성을 잘못 판단하게 된 것으로 결론을 내렸다. 다음 장에서는 어떤 이유에서 한 가지 오류나 실수가 사고로 이어지게 만드는 단일 장애점(a single-point failure)이 이번 사고에서 발생할 수 있었는지, 회사가 복원성 계산 컴퓨터 사용 능력을 향상시키기 위해 무엇을 하고 있는지, 그리고 선박이 복원성이 부족한 상태에서 출항하는 것을 막기 위해 무엇을 더 할 수 있는지에 대해 검토한다.

[그림 D-1] 골든레이호가 콜로넬스 아일랜드 터미널을 출항하기 전 IMACS의 평형수시스템 데이터

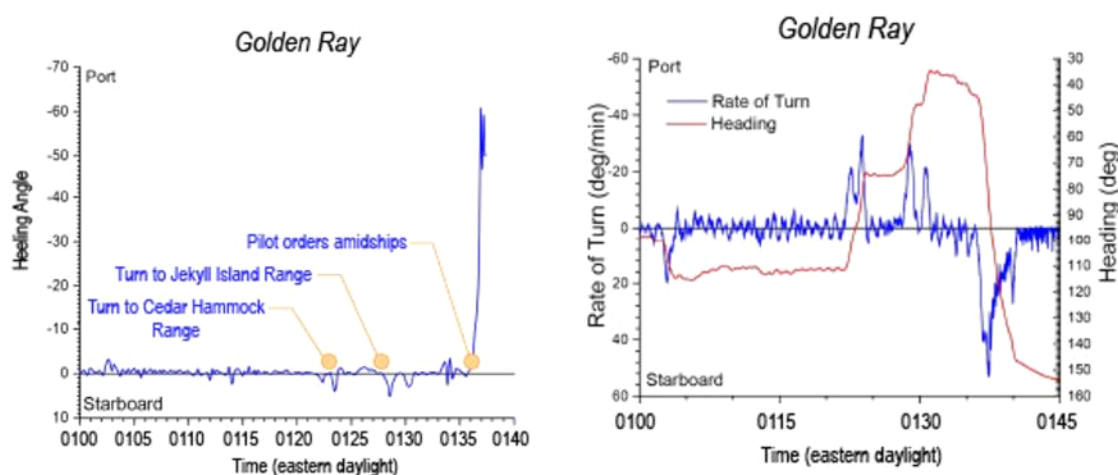
After the accident, the NTSB used data from the *Golden Ray*'s VDR and IMACS to determine the forces acting on and their effect on the vessel at the time of the accident. The study showed that from an initial heel of about 8° at 0136:00, the vessel heeled past 50° in about 50 seconds (by 0136:50) and reached over 60° in less than a minute, while its starboard rate of turn increased from about 2° per minute to over 40° per minute (see figure 14).

Figure 14. Graphs from the *Golden Ray* performance study by the NTSB. Left: heeling angle through the transit, including previous two left turns. Right: heading and rate of turn through the transit.
