[MSI Report 2022-002]

Marine Safety Investigation Report on Containership Sawasdee Bangkok – Fatality of a crew member –

Date of Accident: 31 December 2017

**Korea Maritime Safety Tribunal
Marine Safety Investigation Team**

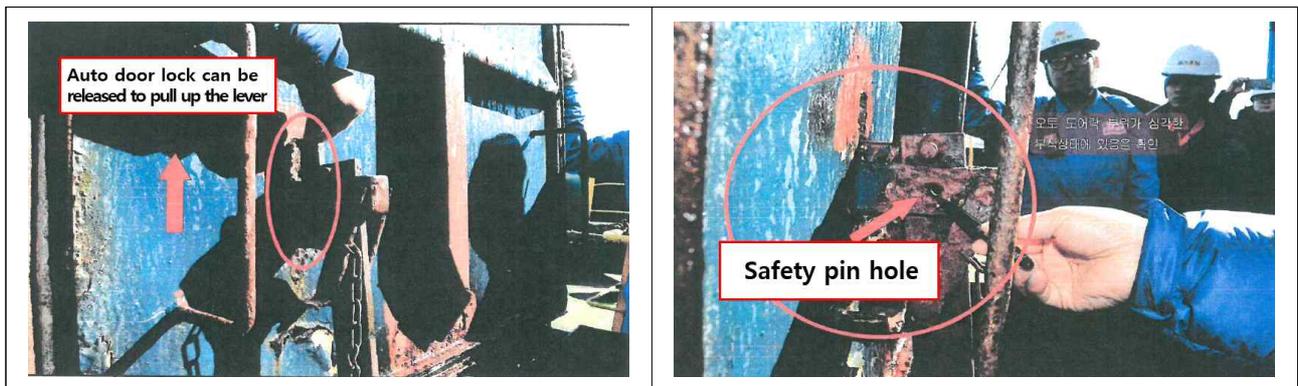
- 2.6.1 The hatch coaming of the bosun store stands about 80 centimeters above the forecastle deck. The square small hatch measures about 140 x 140 cm, and this steel cover weighs about 100 kilograms⁴).
- 2.6.2 The bosun store small hatch is equipped with two devices to prevent it from closing by itself: an automatic door lock and a safety pin. Both are installed inside the small hatch.
- 2.6.3 When the small hatch for the bosun store is open, the automatic door lock, located inside the small hatch, comes down by itself and holds the small hatch open, even if a person does not grasp it by hand. Once the small hatch is secured to open, if the safety pin is inserted into a hole below the holding mechanism, the door lock cannot be released.

<Figure 5> Inside of the bosun store small hatch on the forecastle deck

- 2.6.4 To close the small hatch, meanwhile, the locking devices are released simply by removing the safety pin from the hole and lifting the automatic door lock. The small hatch automatically closes from its own weight. If the safety pin is still in the hole, the automatic door lock cannot be released, making it impossible to close the small hatch.

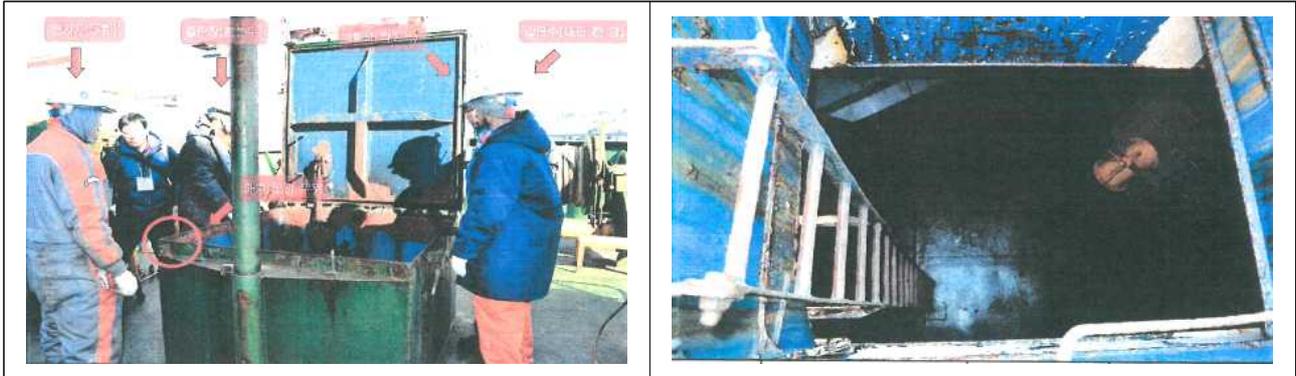
2.6.5 In addition to these locking devices, a spring on the outer hinge of the small hatch controls the closing speed of the small hatch so that it does not shut too fast on account of its weight.

<Figure 6> The opened bosun store small hatch and its access ladder

4.3.4 He added that the small hatch's spring was very old and completely lost its capability to slow down the closing action of the small hatch.

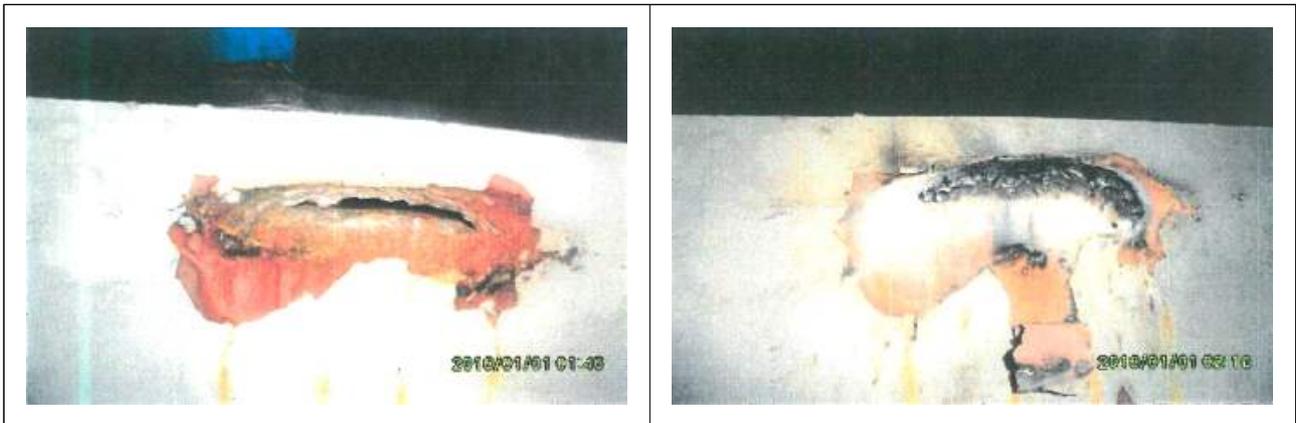
3.2.3 After reaching the forecastle deck, the 2/O confirmed that the containers were fine. However, he noticed that the port anchor was not tightly secured and housed, causing its anchor crown to bang against the hull. Thus, he discovered a crack in the hull⁷⁾ and the leakage of seawater into the bosun store through this crack.

7) The C/O stated that he had slightly lowered the anchor to prepare for emergency anchoring when departing from Ho Chi Minh Port on 30 December 2017. After departure, however, the anchor was not properly housed. When the hull was rolling, so was the anchor, and its crown hit the hull. He stated that the crack could have been made at that moment.

3.2.6 At 16:10, the C/O opened the bosun store small hatch to look closely at the cracked area. The bosun went inside and identified a crack 7 centimeters long.

<Figure 9> Cracked area (before & after repair)

3.2.8 At 16:30, the master checked the conditions of wind, waves, and hull roll. Despite relatively high wind and waves, he determined that it would be possible to repair the hull, and he ordered the C/O to take temporary measures to plug up the cracked area with wedges and cloths.

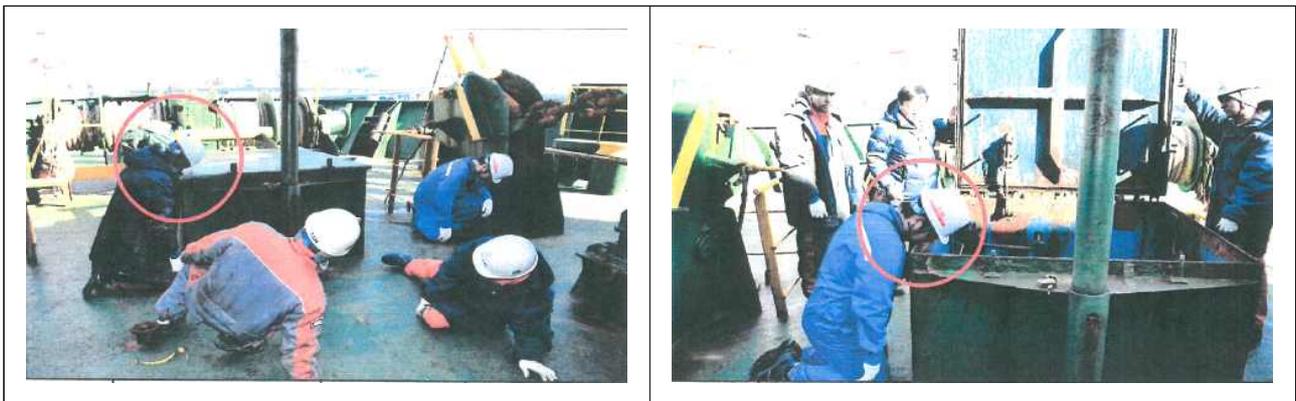
- 3.2.11 Huge waves struck the bow area of the ship twice at this time. After the second hit, the ship experienced a huge slamming. As the waves washed the crew over the bulwark, they lost their balance and fell down. And, the small hatch they had been holding slipped out of their hands.

- 3.2.12 At that moment, the C/O heard someone screaming, “Argh!” He discovered that the small hatch had closed and the head of the OS was trapped between the small hatch and the hatch coaming. The C/O opened the small hatch immediately, laid the OS down, and checked his injury. The OS had a long and diagonal cut (cleaver wound) on his face down to his nose.

<Figure 10> Reenactment of the accident

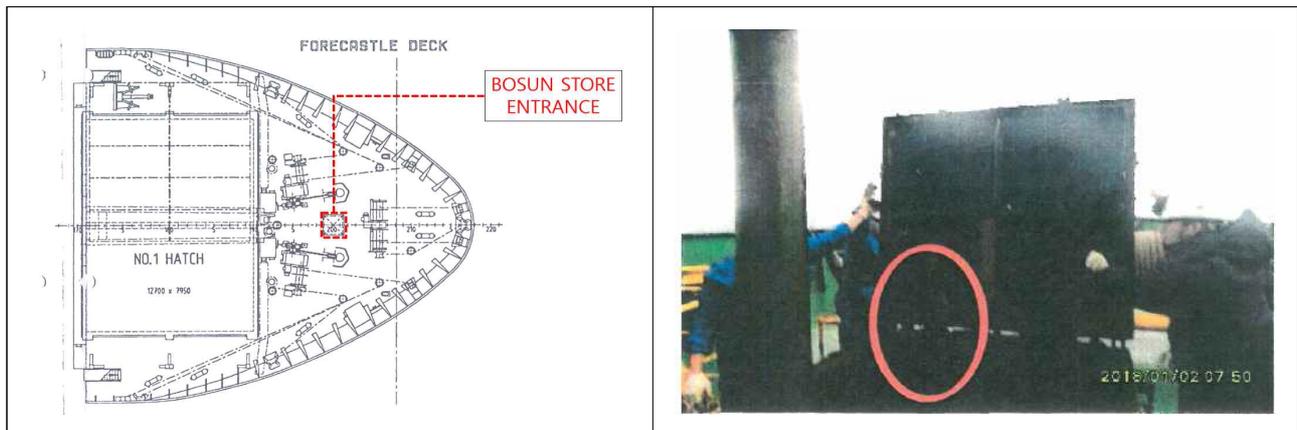
4.3.1 The bosun store small hatch of Sawasdee Bangkok is a lifting type which requires persons to lift the small hatch to open and go down via the access ladder.

<Figure 12> Location and entrance of the bosun store on the forecastle deck

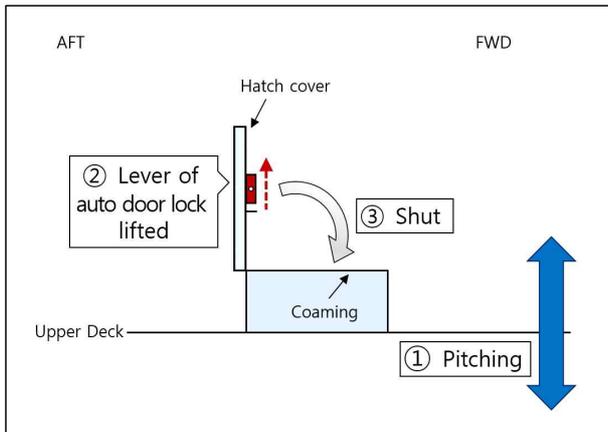
4.3.2 The small hatch is installed with dual locking devices: once persons open the small hatch by lifting it, an automatic door lock keeps the entrance open mechanically; and then, if they manually insert a safety pin, the automatic door lock cannot be released. However, it is assumed that the Sawasdee Bangkok crew used only the former without knowing the fact that the latter was missing when the accident occurred.

4.3.3 The C/O stated that the automatic door lock was rusted from long-term corrosion at the time of the accident. That is why the lock functioned only loosely, not tightly.

4.3.5 All things considered, including the structure of the automatic door lock and the statements given by the crew, it is determined that the small hatch was held open only by a slack automatic door lock, while the safety pin had not been inserted. Thus, the hull slammed by the waves and the impact of the waves over the bulwark could have released the automatic door lock. In addition, the worn spring did not function properly and failed to slow down the closing speed of the small hatch.

<Figure 13> Closing procedures of the bosun store small hatch

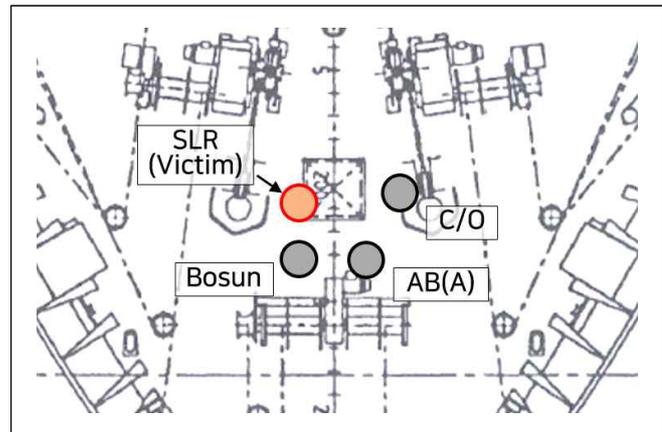
<Figure 14> Positions of the crew during the accident

- 4.5.5 Given the fact that the crewmembers were told to hold the left and right side of the small hatch, it seems that the C/O was somewhat aware that the automatic door lock was slack, and thus, the small hatch might shut on its own. Still, he did not take additional actions, such as putting in the safety pin or lashing the small hatch with a rope.

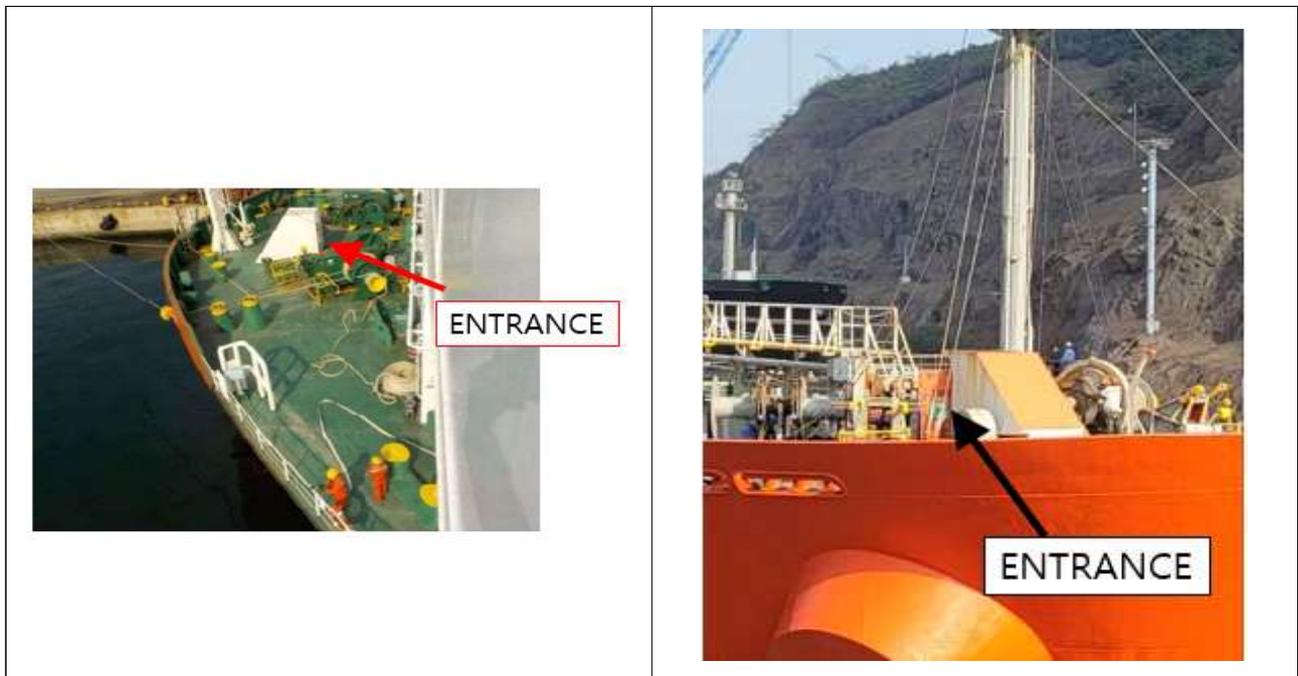
6.3.1 It is difficult for one crewmember alone to lift and open the small hatch of the bosun store, like the one on Sawasdee Bangkok, instead of entering the bosun store through the door on the upper deck, as the small hatch is heavy. Also, when the automatic door lock gets old, it may become a hazard.

<Figure 15> Example of the hinged door

6.3.2 Therefore, if possible, it is necessary to consider changing the small hatch of the bosun store from the current lifting type to the hinged door, which swings in and out when a person pulls it, in order to lower such risk and facilitate safer work environment.
