[MSI Report 2021-006]

# **Marine Safety Investigation Report**

**– Fire Accident onboard the Cable-laying ship Responder –**

Date of Accident : September 11, 2020

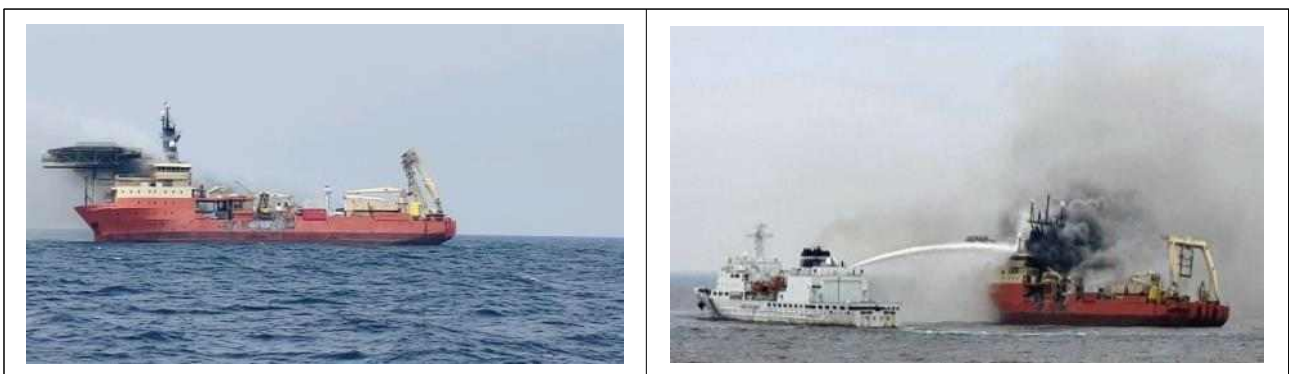
**<Figure13> Fire and fire extinguishing work of Responder**

- 2.14.4 Afterwards, the vessel sank<sup>18)</sup> due to a sudden inclination at the bow of the vessel while the coast guard and fire department suppressed the fire, and clean up operation was carried out to remove a thin oil band and oil slick created at sinking waters.

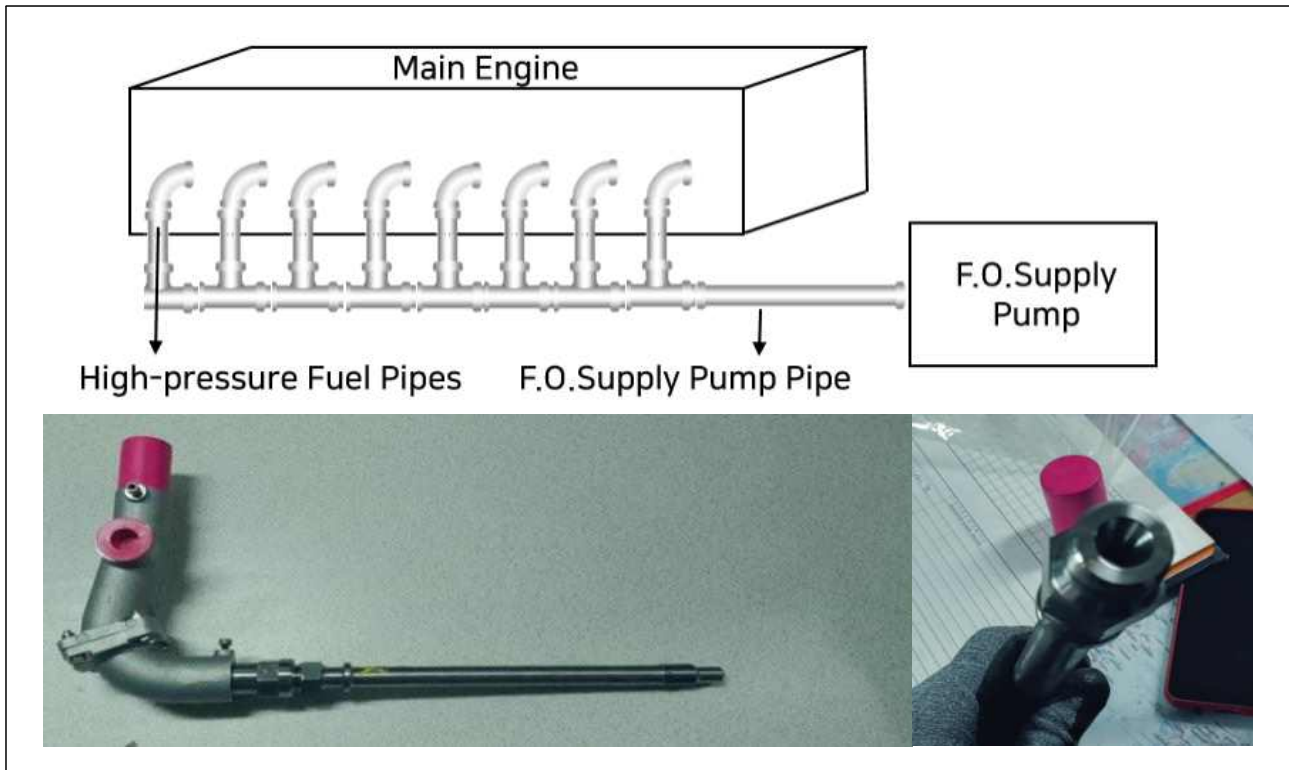
<Figure 16> The piping arrangement of main engine(reconstructed according to the statement of crew) and high pressure pipe (sample of Miraero)

- 3.2.11 The Second Engineer B went down to the site to check the condition of the Main Engines, and he found that large amounts of oil were leaking from the high-pressure fuel pipes<sup>23)</sup> of the 4th and 6th cylinders of No.2 Main Engine, and he also observed<sup>24)</sup> the oil leak on the outside of the No.8 crank case of the No.2 Main Engine. Lots of oil was flowing on the surface of several high-pressure fuel pipes of the cylinders of the No.1 Main Engine, some of which were gathered in the bilge well of the Main Engine.

24) According to the engineer's statement ,the amount and the speed of oil leaking at the time were about 'the 200ml milk carton could be fully filled in about 15 seconds .'

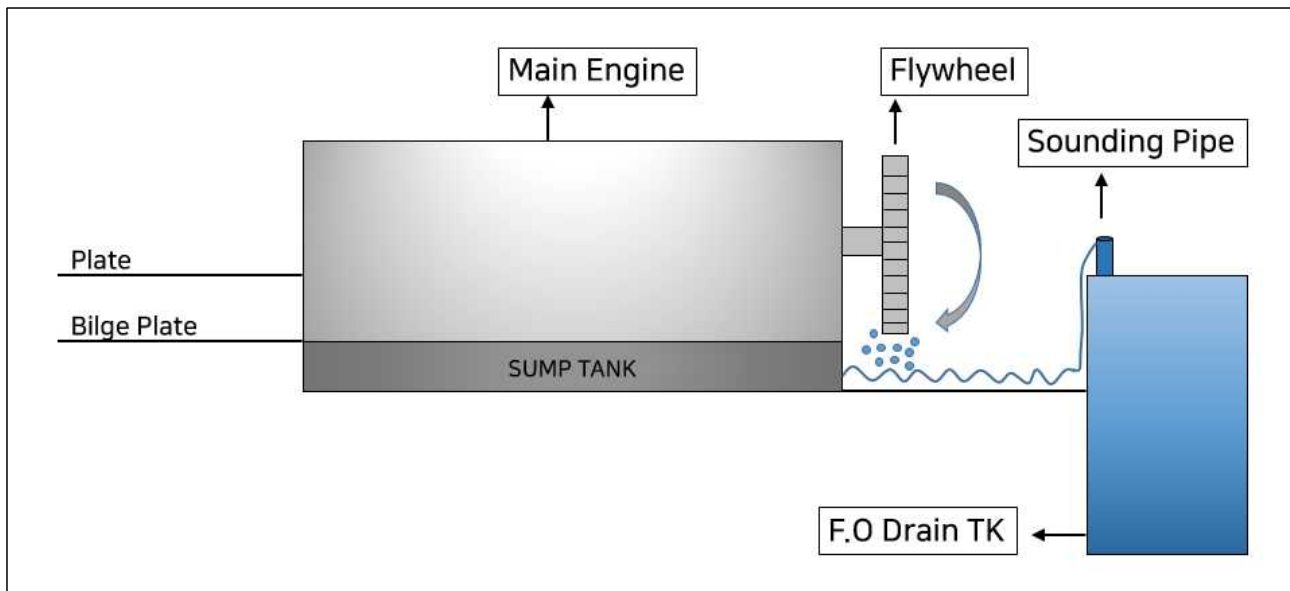
**<Figure 17> Arrangement of main engine and F.O drain tank (reconstructed according to the statement of engine room crew)**

- 3.2.14 At around 02:50 on the same day, the Chief Engineer and the First Engineer received a brief report from the Second Engineer B in ECR and went down to the Main Engines to check their condition. They observed the oil mist originating from the splash of the oil which was generated by the spinning flywheel.<sup>25)</sup>

- 3.2.15 The Chief Engineer and the First Engineer thought that considering there was a severe oil leak, the pipe might have been broken or holed, not just a small crack, so they decided to stop the main engines to prevent the leakage.

- 3.2.16 But due to the scattering of oil caused by the spinning flywheel, the source of oil leakage was not easily identifiable. So the Chief Engineer and the First Engineer decided to stop the No.1 Main Engine on the assumption that oil leakage might occur from the pipeline connected from the F.O boost pump<sup>26)</sup> to the Main Engine. Then, they reported the situation to the bridge and stopped the No.1 Main Engine.

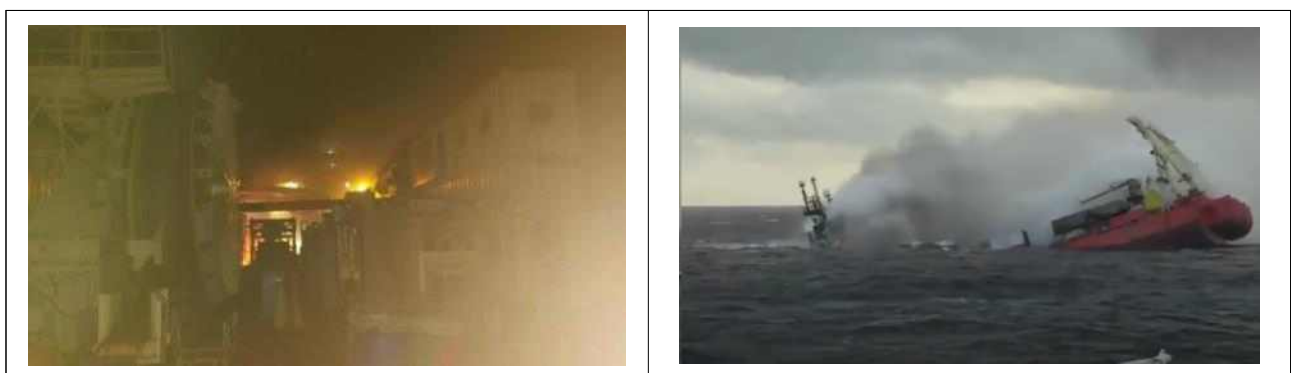
<Figure 18> The picture of fire and sinking of Responder

3.4.6 On the next day, at around 16:55 on September 12, 2020, the bow of Responder began to sink and at around 17:42 of the same day, Responder completely sank<sup>30)</sup> into the sea 42 miles south of the Yokjin Island, Tongyeong-si, Gyeongsangnam-do (Latitude 33°54'20"N, Longitude 128°14'34"E)

30) Responder sank in a position about 050 degrees, approximately 19 miles away from the location of initial fire

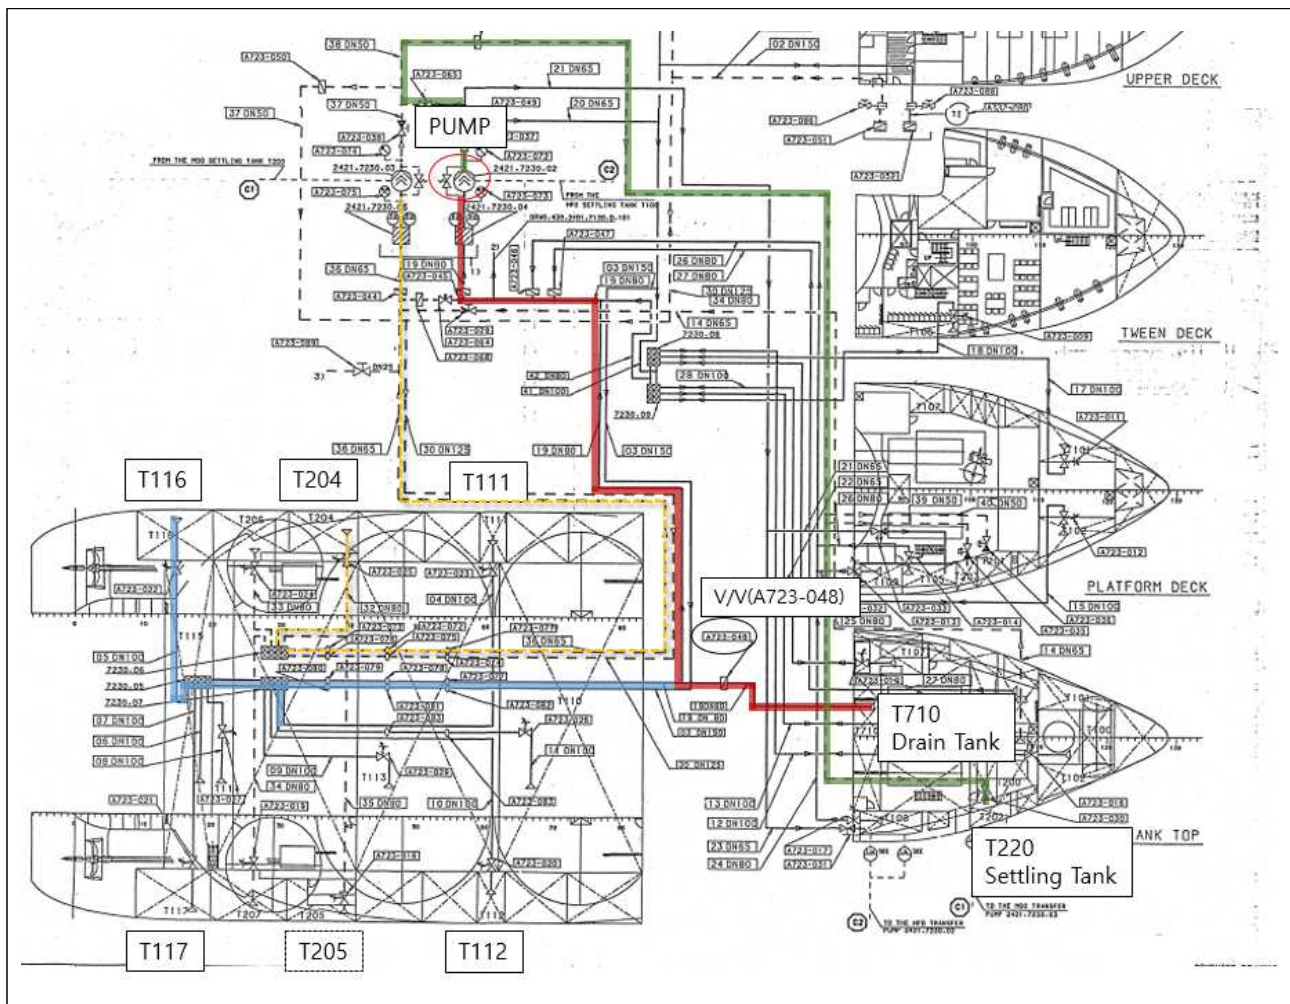
<Figure 19> The pipeline of main engine room (MDO / HFO Transfer Sys. floor plan)

4.1.1.11 Considering this fact and the pipe connection arrangement, there was a high possibility that oil flowed into the drain tank via the transfer valve (A723-048) of the T116 tank which was opened by the Second Engineer A for the change over of the fuel tank. In other words, it is presumed that the transfer valve that the Second Engineer A shut off according to his statement, was not properly closed for some reasons such as mechanical malfunction or human operation error in valve operation.

\* **Blue** : Transfer line of No.116 tank, **Yellow** : Transfer line of No.204 tank,  
**Red** : Connection line to drain tank, **Green** : Connection line to settling tank

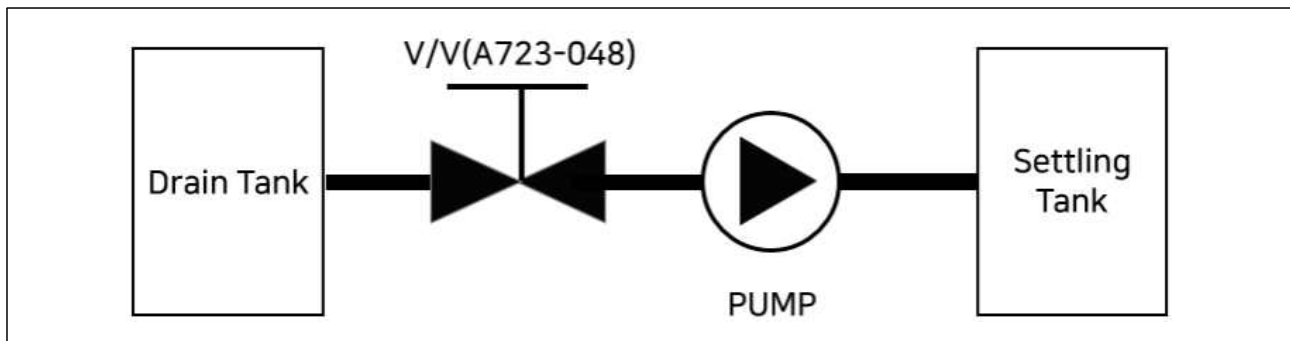
<Figure 20> Transfer diagram from F.O drain tank to settling tank

4.1.1.12 As such, the most probable scenario for the cause of the 35 minutes of inflow of 8.6 tonnes of oil in the F.O drain tank, was that the transfer valve (A723-048) connected to the F.O drain tank and T116 was open, and fuel oil in T116 flowed into the F.O drain tank via the pipe of the valve (A723-048)

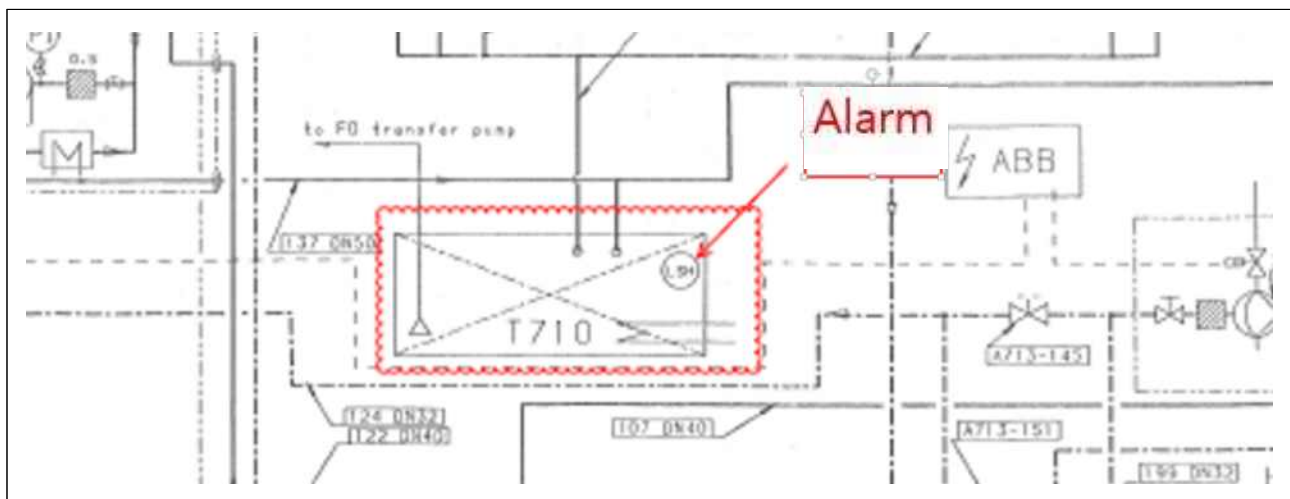
<Figure 21> The alarm sensor of the F.O drain tank (M127, F.O Service System, floor plan)

2.10.10 The F.O drain tank was designed to go off an alarm if the oil level in the tank exceeds a certain point, but the alarm installed in the F.O drain tank of Responder had been out of control, so the crew members of Engine Department were subject to manually sounding of the oil level periodically.

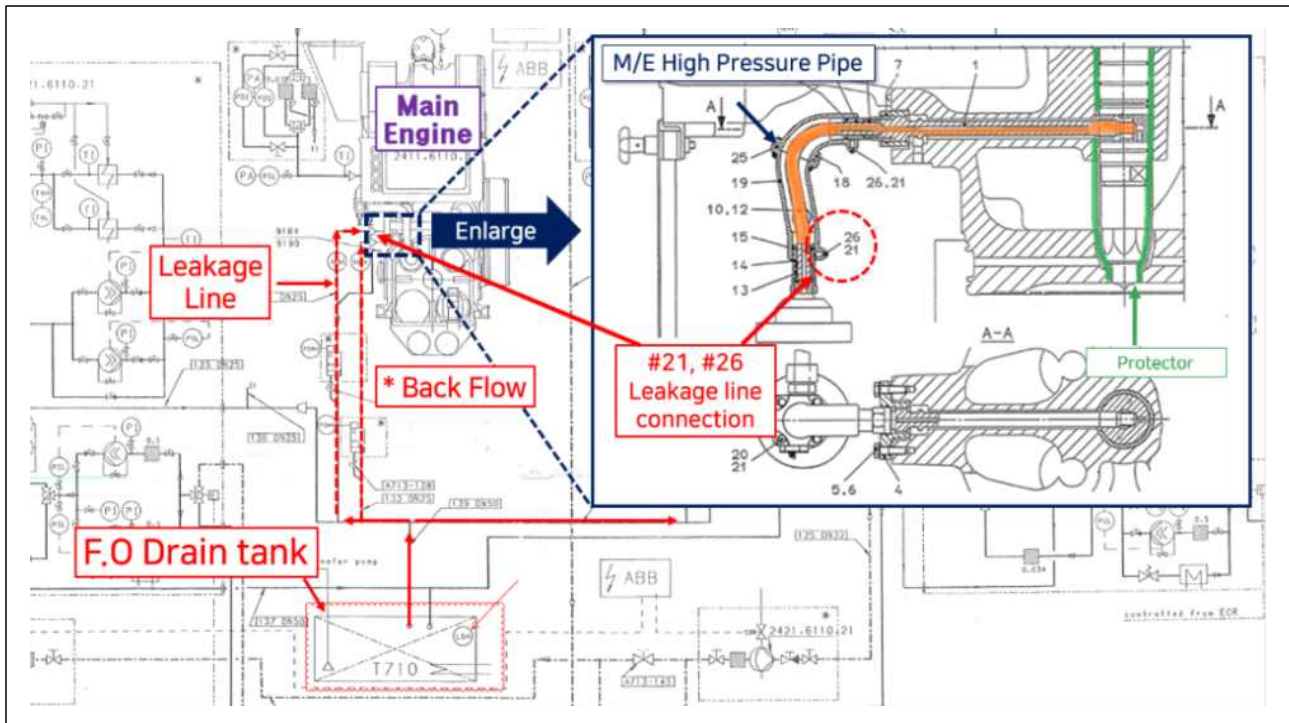
<Figure 22> Piping diagram of transfer pipe (leakage line) of leaked fuel oil in main engine(M127, F.O Service System floor plan)

- 4.1.2.10 According to the statement of an engine room crew, the nuts (#21 and #26 of the Figure 22) which connected the fuel supply high pressure pipe and leakage line were loosened <sup>34)</sup> to check visually the oil leakage of the fuel supply high pressure pipe. That means if there was no oil leakage caused by the damage of the fuel supply high pressure pipe, when the fuel oil flowed backward from the F.O drain tank, the oil could leak out of the fuel supply high pressure pipe through connecting nuts of leakage line. Then, the F.O leakage alarm would go off, if there were oil leakage near the fuel supply high pressure pipe.

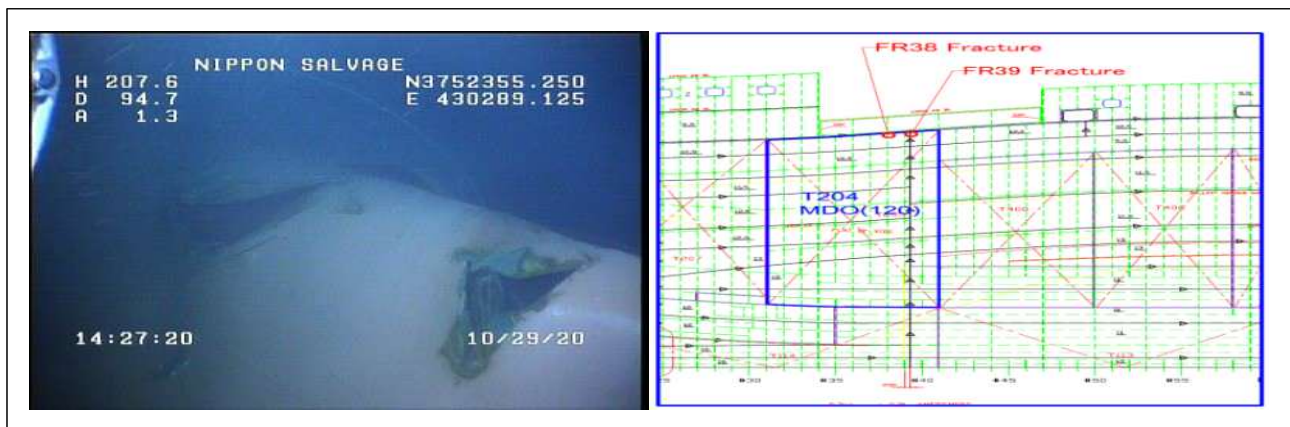
<Figure24> Picture and floor plan of No.204 tank(breakage point) where the explosion occurred

4.6.3 As such, Responder began to sink toward the bow during its fire suppression operation, and as the fire from the Engine Room spread in the adjacent area of the cable tank, and the cables with high thermal conductivity were ignited which led the fire to spread further. As the fire in the cable tanks spread to the fuel oil tanks, the remaining oil and steam in the fuel oil tank<sup>43)</sup> exploded, which created a hole on the shell plate. As large amounts of seawater flowed into the vessel, the sinking of the hull accelerated and the vessel eventually sank.

43) The No.204 fuel oil tank where the explosion occurred was surrounded by a cable tank at the time and had the largest amount of remaining fuel oil.
