[MSI Report 2022-001]

Marine Safety Investigation Report

– Sinking of VLOC, Stellar Daisy –

Korea Maritime Safety Tribunal
Marine Safety Investigation Team

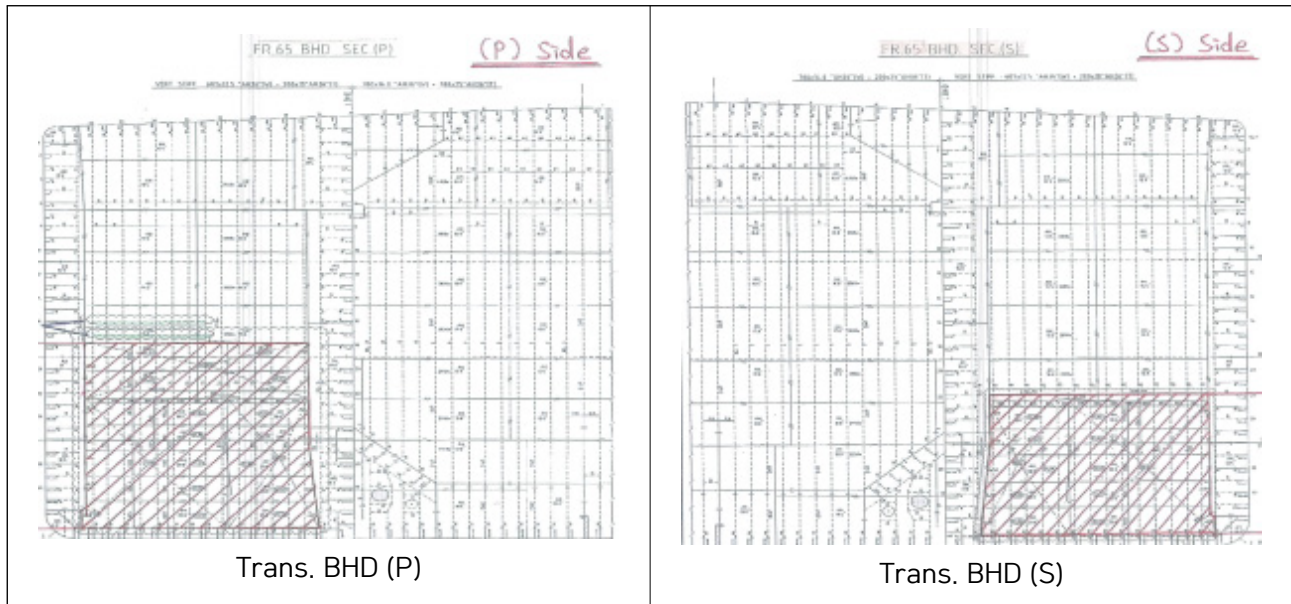
[Figure 13] Repairs of FR. 65 BHD

- A transverse bulkhead between WBT Nos. 3 and 4 (S): a 12.1 m x 9.4 m face plate of the transverse bulkhead, and 14 vertical stiffeners and 14 brackets for that area were renewed.

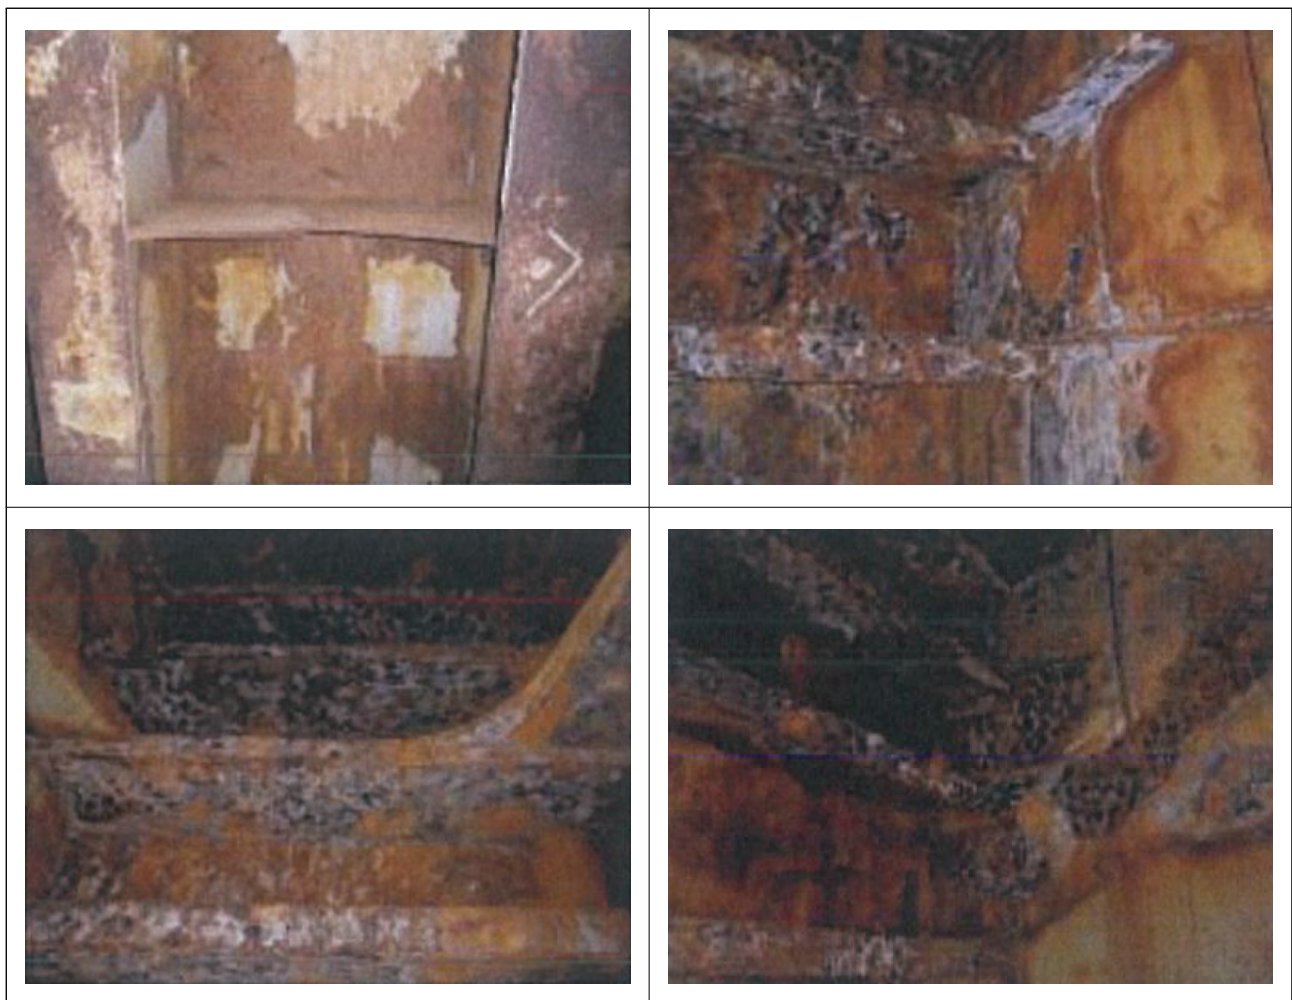
[Figure 14] WBT No. 3 (P) (4Q2013 Hull Inspection Report)

- 2.10.4 After the initial inspection report, the buckling of the overall upper deck was observed continuously. However, no record existed to suggest it had developed further after a certain period of time.
- 2.10.5 The poor coating condition of the ballast tanks or void tanks was consistently reported in internal inspections. Notably, the coating condition of WBT No. 3 (P) was reported as "Poor" in every inspection report (see [Figure 14]), while that of VT Nos. 1 and 5 (P/S) had been mostly rated as "Poor" from 2010 to 2Q2015. VT Nos. 1-5 (C) under the cargo holds had also been constantly reported as being in a "Poor" coating condition since 4Q2013 (see [Figure 15]).

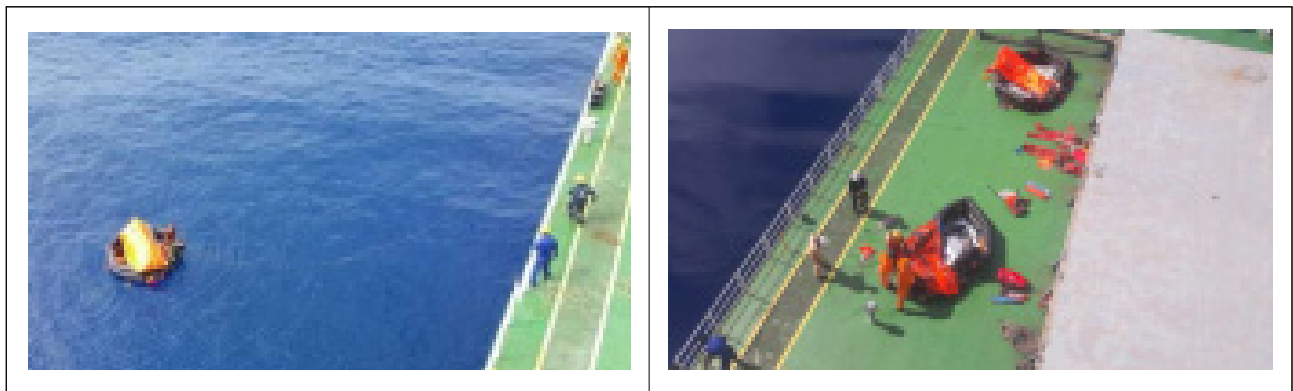
[Figure 28] Liferafts sighted during the search and rescue operations

3.6.4 At around 12:50 (UTC), M/V Elpida sighted two liferafts and rescued AB A and the No. 1 oiler from one of them.³⁴⁾ M/V CKNG also found another liferaft and two lift boats, all of which were damaged. However, no survivors were in them.

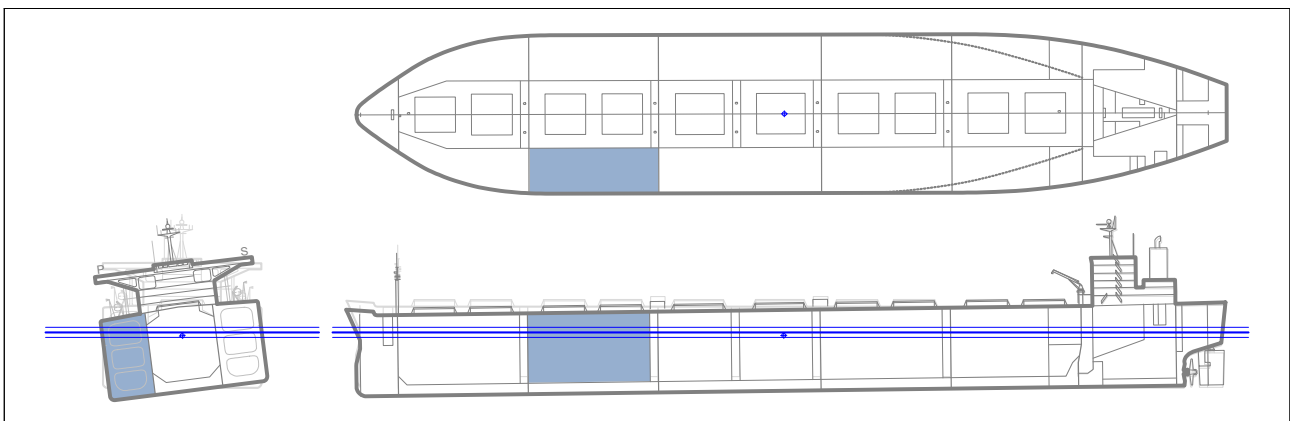
[Figure 36] The hull's immersion and posture if WBT No. 2 (P) were damaged⁵¹⁾

- 4.1.3.8 The calculations also showed that if WBT No. 2 (P) were damaged under the actual loading condition at the time of the accident, the ship would heel over about 7° and submerge about 1.2 m further as demonstrated in [Figure 36].

51) When it was assumed that damage was made to an area of 1 m x 4 m on the lower shell plate of WBT No. 2 below the waterline, the results showed that it took about 500 seconds to reach 90% of the ship's final state since the flooding had begun. (Here, the blue line indicates changing waterlines at an Hs of 3.7 m.)

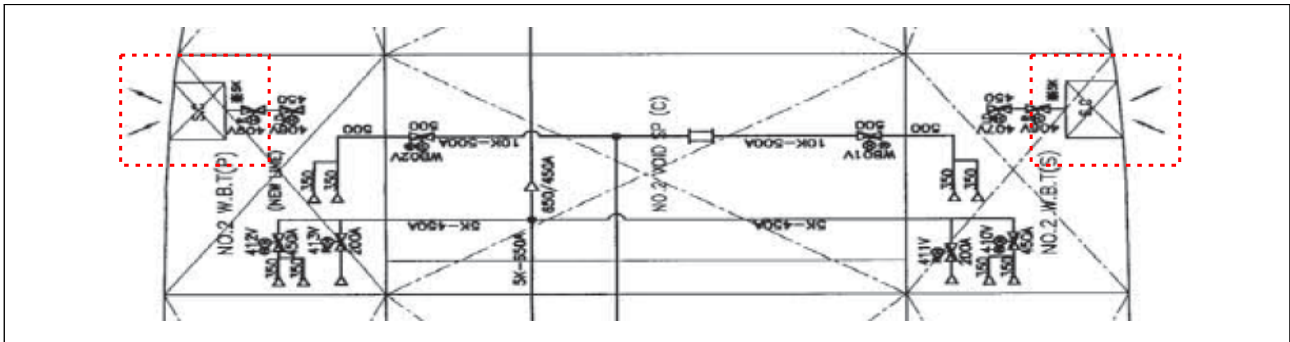
[Figure 41] Diagram of sea chest valves and pipeline of WBT No. 2

4.4.2.2 KR focused on the sea chest valve for reasons behind the flooding of WBT No. 2 (P). WBT No. 2 (P/S) were fitted with a separate pipeline⁷⁸⁾ directly connected to sea chest valves on the floor. Seawater could be poured in or discharged from these tanks by gravitation through this pipeline. Therefore, even when the hull is not damaged and the valve of WBT No. 2 (P) is open, seawater could enter the tank.

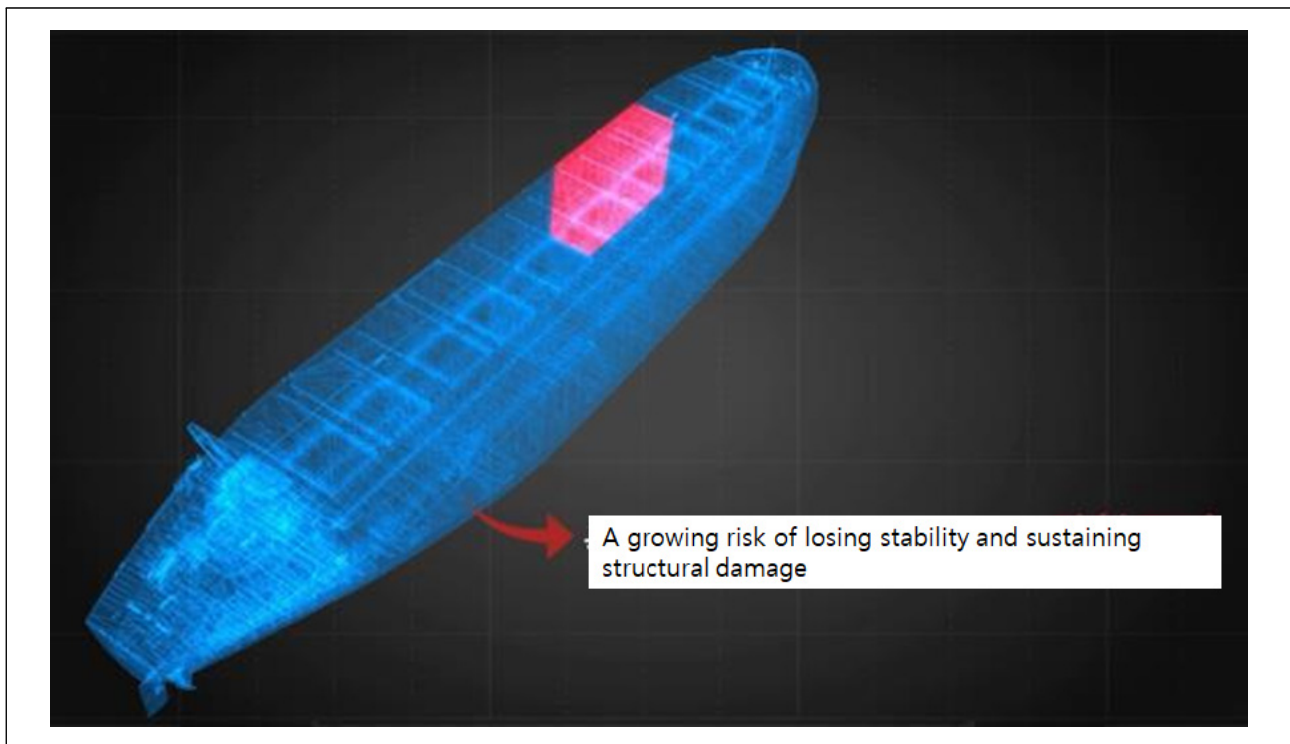
[Figure 43] Risk if WBT No. 2 (P) were flooded

4.4.2.4 According to the analysis conducted by her RO, the flooding of WBT No. 2 (P) would lead to the following results: the ship's BM would increase about 30%; the torsional moment would occur together with a heeling event resulting from asymmetric loads; the ship would experience roll motion and acceleration depending on asymmetric distribution of weight; the ship's shell plate would face higher wave pressure; and the cargo would have greater inertia.

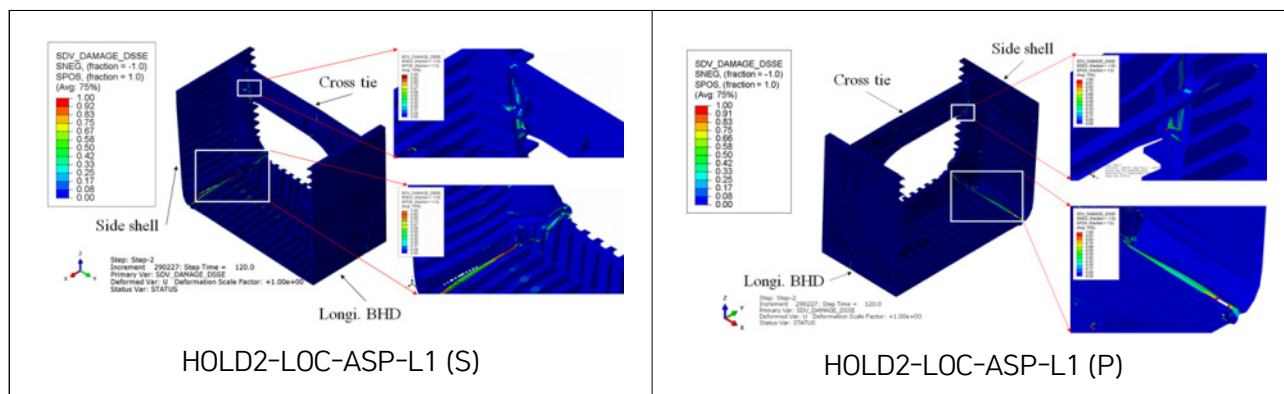
[Figure 60] Visualization of damage to L1 of C/H No. 2

4.4.7.7 In addition, when the ASP was applied from the ship's starboard side, both the port and starboard sides experienced similar damage in the local model, L1. Even when the ASP was applied from the port side, the result was the same as the former.
