Marine Safety Investigation Report on Containership Sawasdee Bangkok

– Fatality of a crew member –

Date of Accident: 31 December 2017

**Korea Maritime Safety Tribunal
Marine Safety Investigation Team**

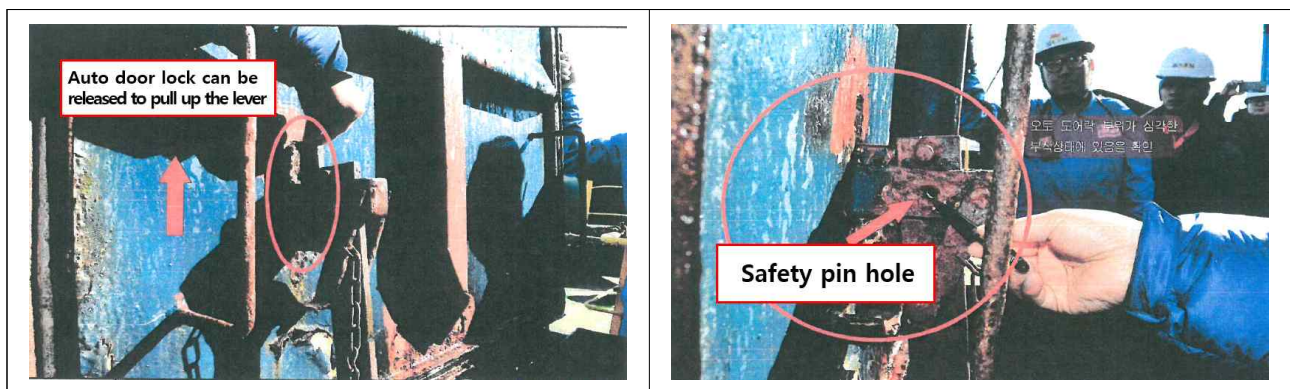
<Figure 5> Inside of the bosun store small hatch on the forecastle deck

- 2.6.1 The hatch coaming of the bosun store stands about 80 centimeters above the forecastle deck. The square small hatch measures about 140 x 140 cm, and this steel cover weighs about 100 kilograms⁴⁾.
- 2.6.2 The bosun store small hatch is equipped with two devices to prevent it from closing by itself: an automatic door lock and a safety pin. Both are installed inside the small hatch.
- 2.6.3 When the small hatch for the bosun store is open, the automatic door lock, located inside the small hatch, comes down by itself and holds the small hatch open, even if a person does not grasp it by hand. Once the small hatch is secured to open, if the safety pin is inserted into a hole below the holding mechanism, the door lock cannot be released.

- 2.6.4 To close the small hatch, meanwhile, the locking devices are released simply by removing the safety pin from the hole and lifting the automatic door lock. The small hatch automatically closes from its own weight. If the safety pin is still in the hole, the automatic door lock cannot be released, making it impossible to close the small hatch.

2.6.5 In addition to these locking devices, a spring on the outer hinge of the small hatch controls the closing speed of the small hatch so that it does not shut too fast on account of its weight.

4.3.2 The small hatch is installed with dual locking devices: once persons open the small hatch by lifting it, an automatic door lock keeps the entrance open mechanically; and then, if they manually insert a safety pin, the automatic door lock cannot be released. However, it is assumed that the Sawasdee Bangkok crew used only the former without knowing the fact that the latter was missing when the accident occurred.

4.3.3 The C/O stated that the automatic door lock was rusted from long-term corrosion at the time of the accident. That is why the lock functioned only loosely, not tightly.

4.3.4 He added that the small hatch's spring was very old and completely lost its capability to slow down the closing action of the small hatch.

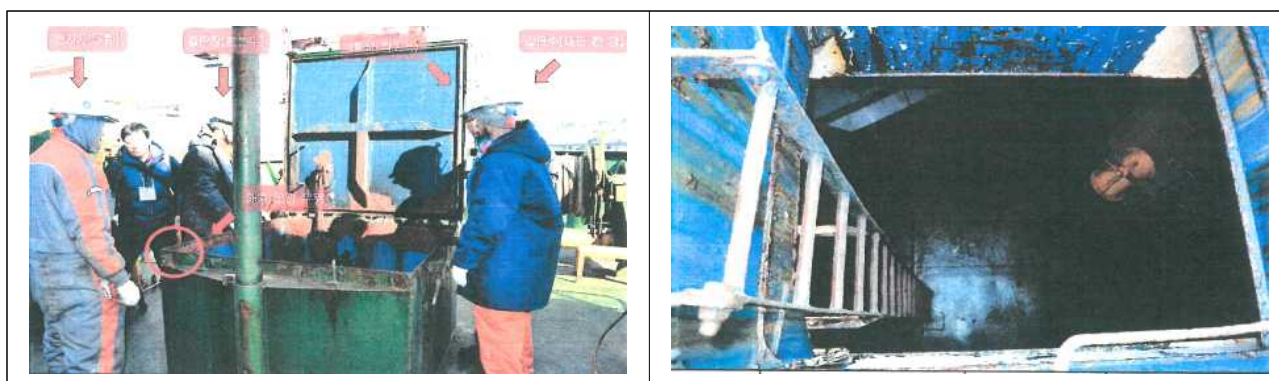
<Figure 6> The opened bosun store small hatch and its access ladder

4.3.1 The bosun store small hatch of Sawasdee Bangkok is a lifting type which requires persons to lift the small hatch to open and go down via the access ladder.

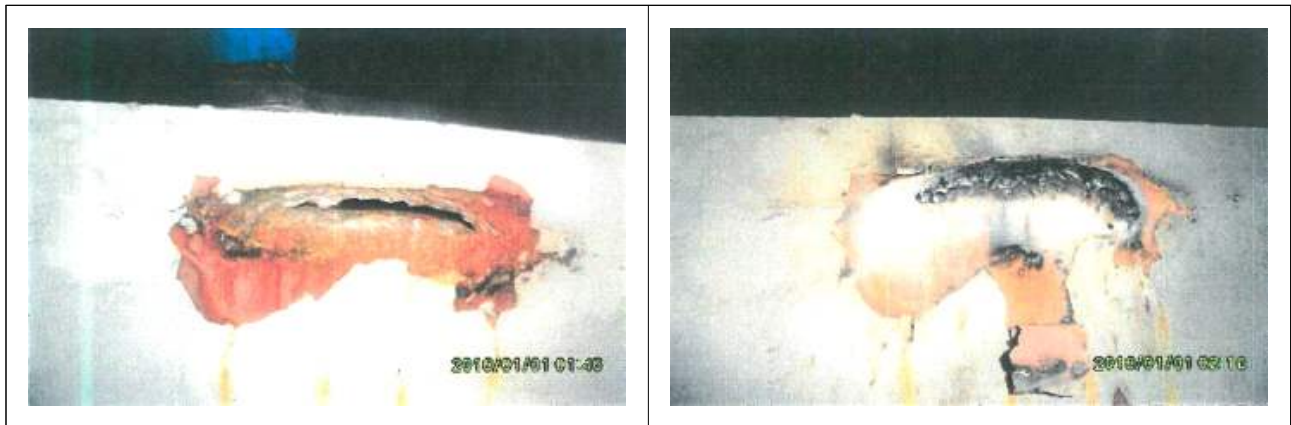
<Figure 9> Cracked area (before & after repair)

3.2.3 After reaching the forecastle deck, the 2/O confirmed that the containers were fine. However, he noticed that the port anchor was not tightly secured and housed, causing its anchor crown to bang against the hull. Thus, he discovered a crack in the hull⁷⁾ and the leakage of seawater into the bosun store through this crack.

7) The C/O stated that he had slightly lowered the anchor to prepare for emergency anchoring when departing from Ho Chi Minh Port on 30 December 2017. After departure, however, the anchor was not properly housed. When the hull was rolling, so was the anchor, and its crown hit the hull. He stated that the crack could have been made at that moment.

3.2.6 At 16:10, the C/O opened the bosun store small hatch to look closely at the cracked area. The bosun went inside and identified a crack 7 centimeters long.

3.2.8 At 16:30, the master checked the conditions of wind, waves, and hull roll. Despite relatively high wind and waves, he determined that it would be possible to repair the hull, and he ordered the C/O to take temporary measures to plug up the cracked area with wedges and cloths.

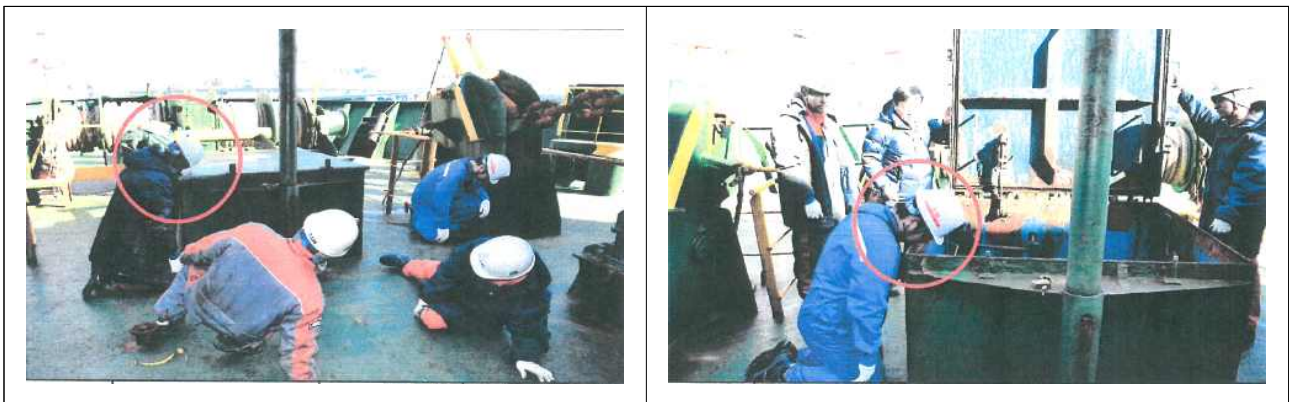
<Figure 10> Reenactment of the accident

- 3.2.11 Huge waves struck the bow area of the ship twice at this time. After the second hit, the ship experienced a huge slamming. As the waves washed the crew over the bulwark, they lost their balance and fell down. And, the small hatch they had been holding slipped out of their hands.

- 3.2.12 At that moment, the C/O heard someone screaming, "Argh!" He discovered that the small hatch had closed and the head of the OS was trapped between the small hatch and the hatch coaming. The C/O opened the small hatch immediately, laid the OS down, and checked his injury. The OS had a long and diagonal cut (cleaver wound) on his face down to his nose.

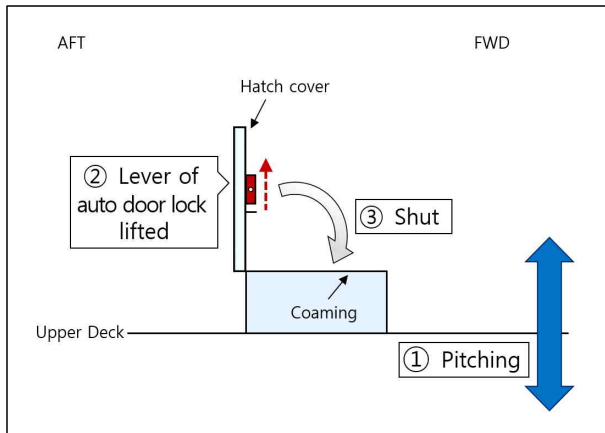
<Figure 13> Closing procedures of the bosun store small hatch

4.3.5 All things considered, including the structure of the automatic door lock and the statements given by the crew, it is determined that the small hatch was held open only by a slack automatic door lock, while the safety pin had not been inserted. Thus, the hull slammed by the waves and the impact of the waves over the bulwark could have released the automatic door lock. In addition, the worn spring did not function properly and failed to slow down the closing speed of the small hatch.

- 5.3 Under such circumstances, the crew opened the small hatch and were conducting maintenance. While doing so, the hull was slammed by waves, releasing the automatic door lock. At the same time, the crewmembers were knocked down by the seawater as washing over the bulwark on the bow, losing the small hatch they had been holding. Thus, it is determined that is why the opened small hatch suddenly slammed shut.

- 6.1.1 The steel-made deck fittings are susceptible to corrosion due to their exposure to seawater, degrading their function. And, if the corroded fittings are neglected for a long time, parts can go missing.
- 6.1.2 Therefore, the person responsible for their maintenance and repair should regularly maintain the deck fittings in accordance with their maintenance plan, and in particular, check whether their safety devices function properly.
- 6.1.3 Also, the crew responsible should take immediate action, such as reporting to the company the need for repairs, if any deck fittings are aged or broken. And, the company should actively support the ship for her safe operation.

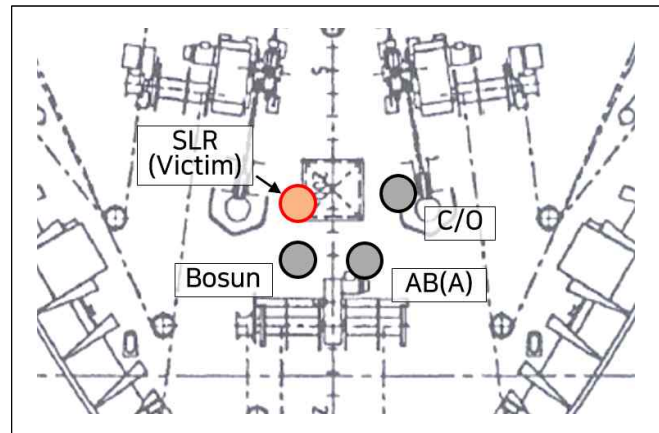
<Figure 14> Positions of the crew during the accident

3.2.10 Meanwhile, the C/O, under the master's order, moved to the forecastle deck along with the bosun, the AB, and the OS. Upon arriving, they opened the bosun store small hatch. The C/O was holding the right side of the small hatch, and the AB and the OS were holding its left, as the bosun placed tools inside the bosun store.

- 4.5.5 Given the fact that the crewmembers were told to hold the left and right side of the small hatch, it seems that the C/O was somewhat aware that the automatic door lock was slack, and thus, the small hatch might shut on its own. Still, he did not take additional actions, such as putting in the safety pin or lashing the small hatch with a rope.
