[MSI Report 2022-006]

Marine Safety Investigation Report on General Cargo Ship YUJIN ACE

– Fatality of a crew member –

Korea Maritime Safety Tribunal
Marine Safety Investigation Team

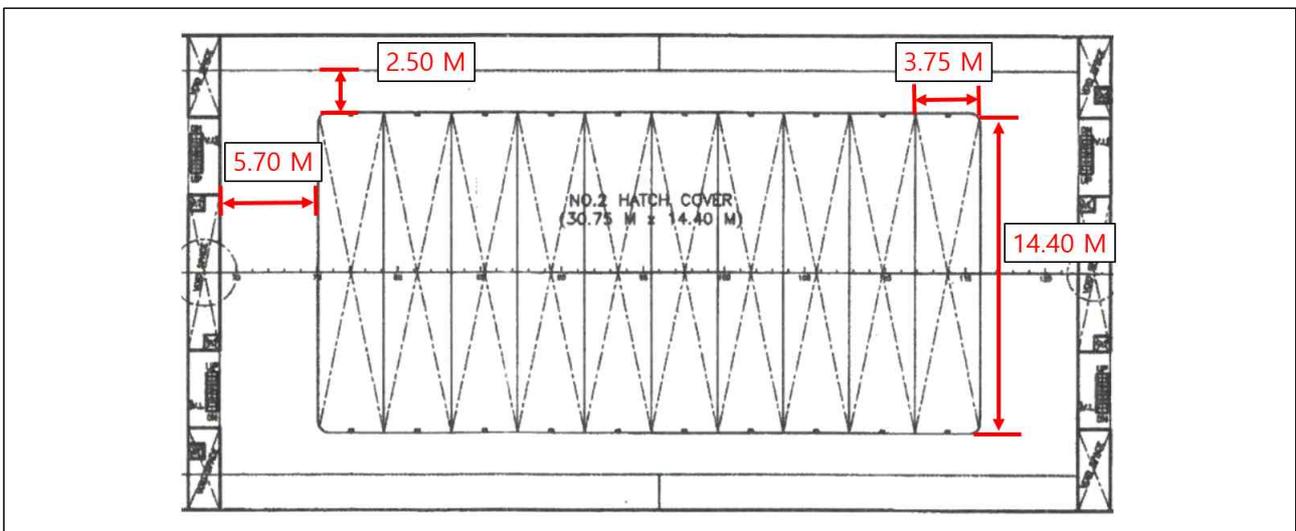
<Figure 4> Lower Deck Plan of No. 2 Hatch Cover (Normal Arrangement)

2.5.4 No.2 hatch cover of the lower deck consists of 10 Pontoons. Because the No.2 cargo hold is placed in the middle of the ship in longitudinal direction, the shape is rectangular and each pontoon size is about 3.75 × about 14.40 meters.

2.5.5 The Hatch Cover lifted for cargo handling can be laid ashore, or stacked on forward (looking forward) or backward (looking after) of the lower deck in the Hatch Cover, in case only a part of the Hatch Cover pontoon is lifted. The No.2 cargo hold has about 5.7 meters wide where the Hatch Cover can be stacked, and when the pontoons are loaded, about 2 meters of the space is left enough for people to pass by.

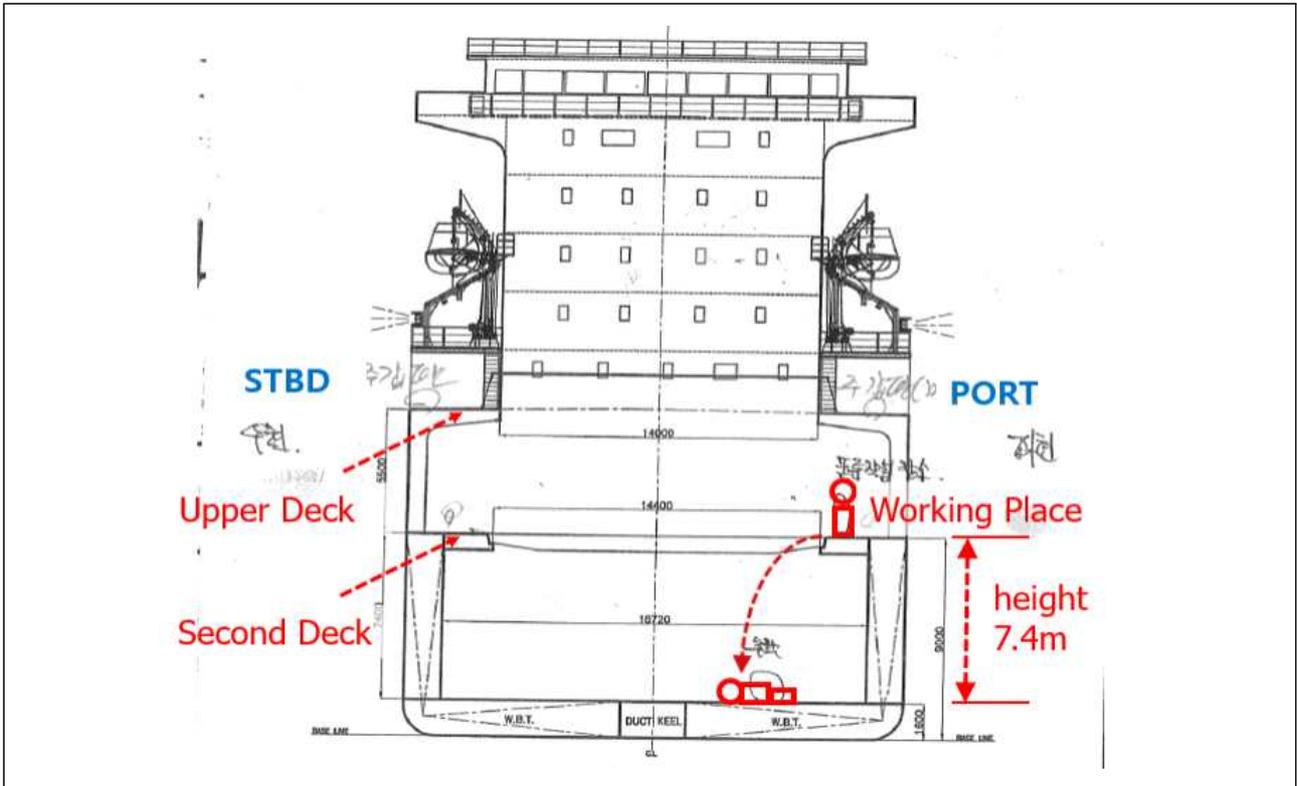
<Figure 7> The work and falling site at the accident time

- 4.1.4 Therefore, considering the crew's statement, the accident report, and the autopsy report comprehensively, the Able seaman seemed to have died by falling from the lower deck to the cargo hold floor(tank top), due to losing balance by stumbling or getting stuck on the floor⁴⁾, after completing the work of latching the hook to close the Hatch Cover.

- 4.2.1 The lower deck that the Able seaman was working on is placed between the upper deck and the cargo hold floor(tank top), and the lower deck is around 7.5 meters high from the cargo hold floor(tank top). So, If the cover is not closed, it is liable to fall in working without a cover because the deck structure is the parts except the outline have a hole.

- 6.1 The Chief Officer should assess ahead the risk and safety of 'working at height' or 'Entering the Cargo Hold during Unloading Work' before starting to work, and train ahead thoroughly to the whole working crews about the way and potential hazards of the work. Also, the captain should conduct to continuous training and education so that the crews must thoroughly conform to safety procedures.
- 6.2 The crews undertaking the work with potential fall hazards should be cautious and alert in working as even a minor mistake can lead to fatal accident. Also, the captain, the Chief Officer, should designate and place the supervisor leading and monitoring the work situation.
