[MSI Report 2023-001]

Marine Safety Investigation Report

– Fatal Accident on LNG Tanker Hyundai Technopia –

Date of Accident : 16 June 2021

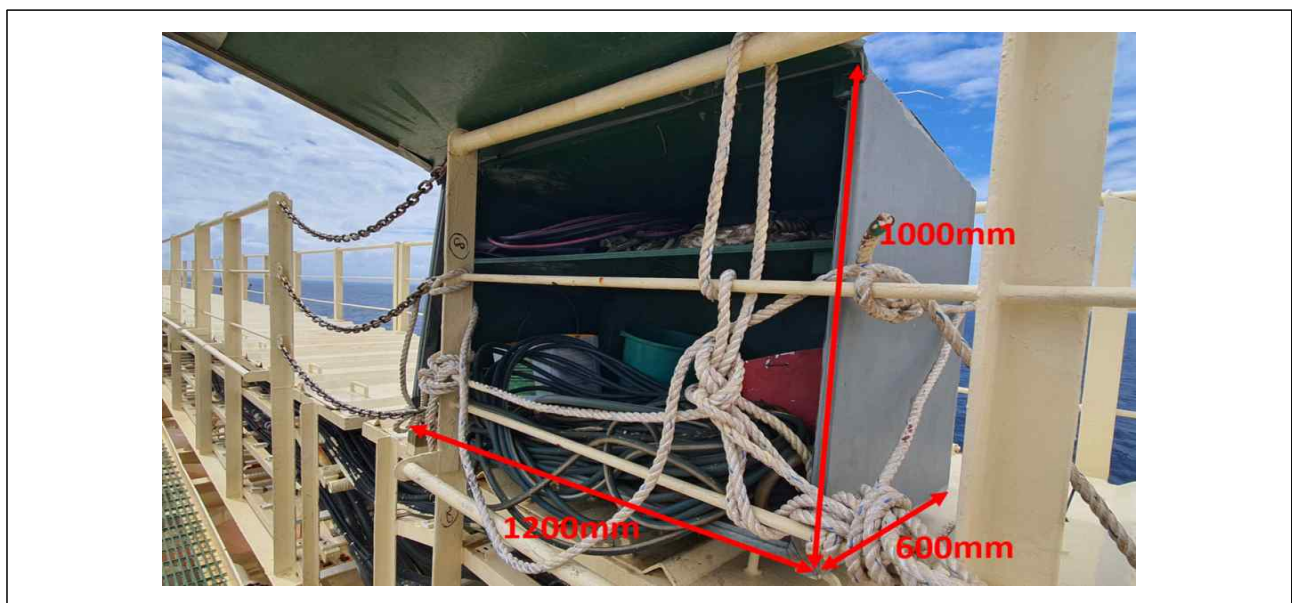
<Figure 10> Uncovered toolbox (fitted on a different tanker of the same company)

3.2.4 At 16:40, When the C/O was patrolling on the catwalk, he noticed that a toolbox⁸⁾ had shifted from its original place atop the electrical cable tray over Cargo Tank No. 3. He assumed that workers at the shipyard had moved while fixing steel plates and supporters of the electrical cable tray. The C/O felt the toolbox might move and even fall during bad weather, so he wanted to secure it.

3.2.7 Along with OS A and B, the AB arrived at the electrical cable tray where the toolbox was located and prepared to tie it down. While doing so, they were unable to shut the cover of the toolbox as it was caught in the railing nearby. Thus, they decided to move it about one meter towards the bow and secure it.

8) This toolbox is a type of wooden boxes covered with canvas. It was not built on board, but produced at a shore-based store and sent to the tanker(ship). Other tankers of Hyundai LNG Shipping were also using similar types of the product.

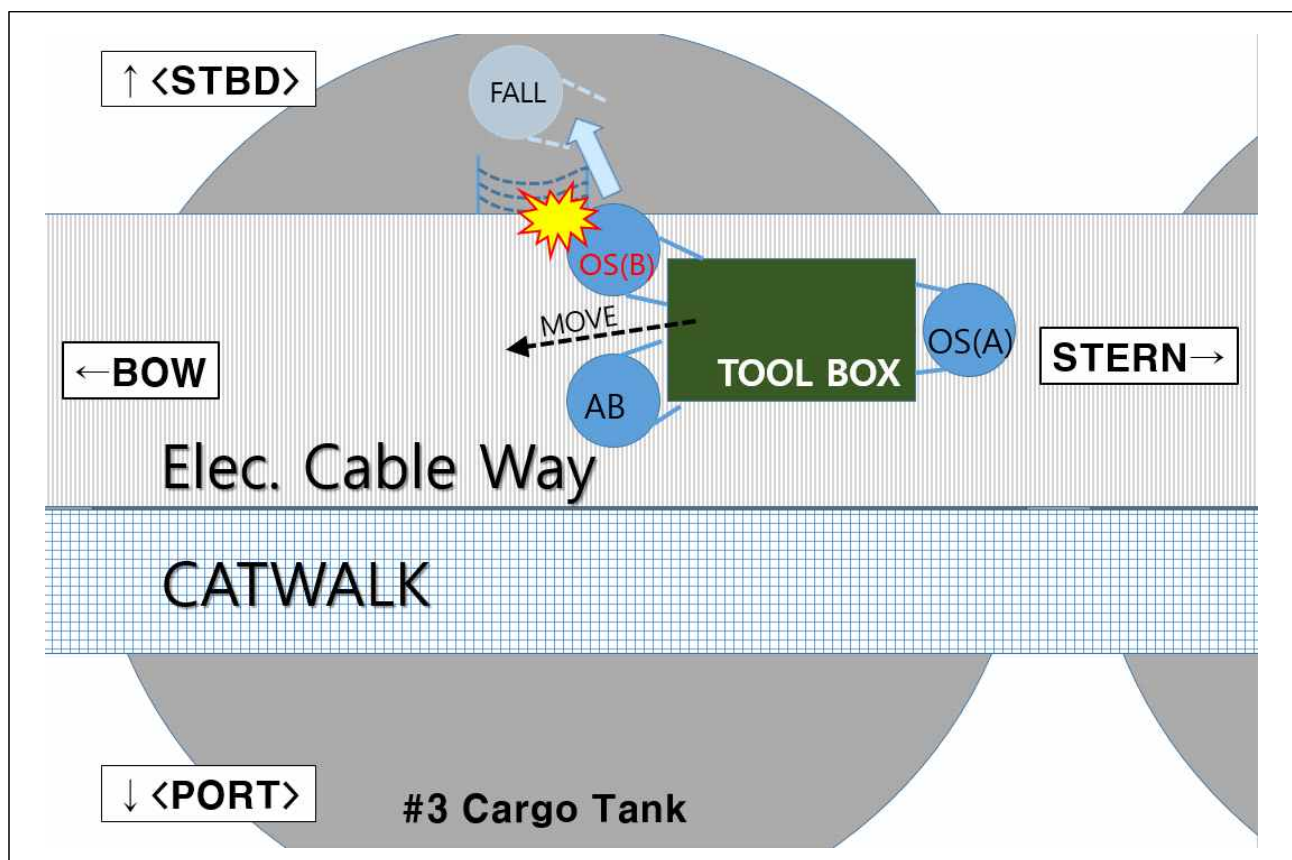
<Figure 11> Situations at the time of the accident (bird's-eye view)

- 3.2.8 The toolbox contained chain blocks, spanners, bolts, nuts, air hoses, and various ropes. These items weighed some 30–40 kilograms¹⁰⁾, so the AB decided to take out several of the heavy tools before moving the toolbox. At 16:45 on the same day, he started the operation.
- 3.2.9 OS B was a new arrival on the ship, so OS A told him, "Don't come up to the tray; stay where you are." Although this was the first time for OS B to be aboard the tanker, he voluntarily came up to the electrical cable tray from the catwalk to help the others to take the tools out of the box.
- 3.2.10 After removing some tools from the box, the AB, OS A, and OS B agreed to assume a position on the port bow, in the center of the stern, and on the starboard bow of the toolbox respectively, facing one another, and lift the toolbox and shift it fore.

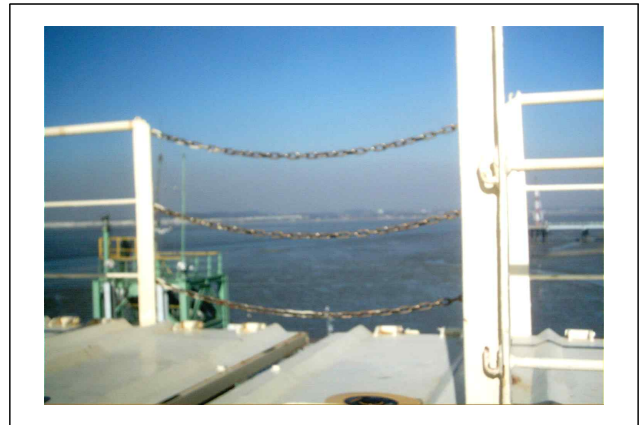
<Figure 13> Chain railings

3.2.11 When those three crewmembers tried to lift and move the toolbox together, OS B lost his balance and fell over three chains hung on his left side.¹¹⁾ At the same time, among those, two chains hung in the middle and the lowest became unhooked, creating a void through which OS B fell. It was 16:52.

- 6.3.1 Hyundai Technopia's electrical cable tray railings are basically made of steel. However, intervals in them are connected via chains, and these chains do not reach high enough, which may result in an accidental fall.
- 6.3.2 Therefore, the company should ensure the chain railings are at a safe height of one meter or above in order to prevent any risk of falling, install them as a carabiner type²⁷⁾ to ensure that chains cannot become unhooked unintentionally, and review how to improve the hooks, such as changing them into a closed eye type, so as to prevent the chains from coming loose.

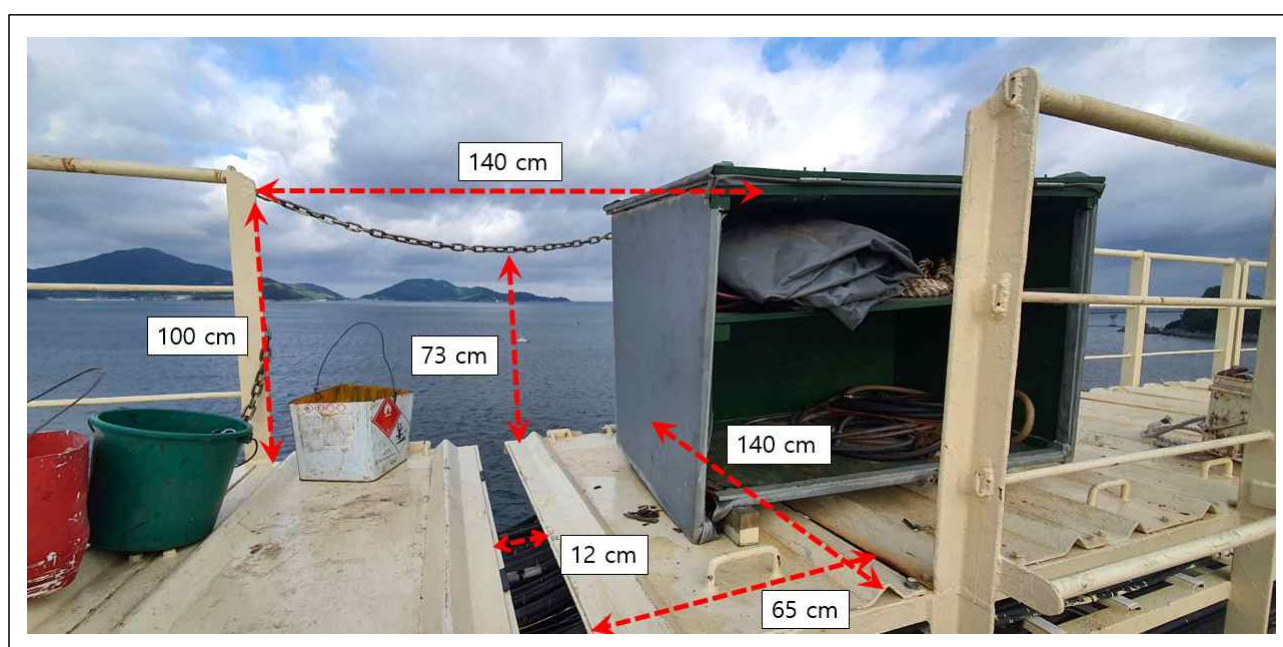
<Figure 16> Photo taken right after the fall accident

4.2.2 Although this electrical cable tray was not originally built for passage or movement of the crew, steel railings are fitted at the edge on both sides on the tray floor. Those railings are not continuously linked along the tray ; at some intervals the steel railings are connected by chains.¹⁴⁾

4.2.3 The width of the chain railings fitted at the fall accident site span a space about 1.4 meters (140 centimeters) wide. The three steel chains were hung horizontally, one above the other, onto U-shaped hooks (with the upper part open) on both sides of the interval between the steel railings.

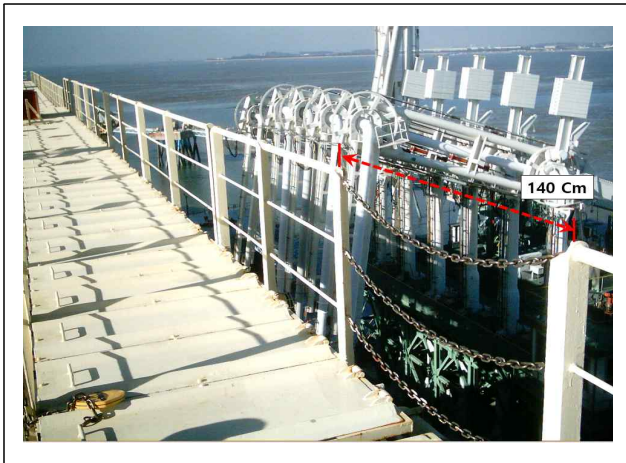
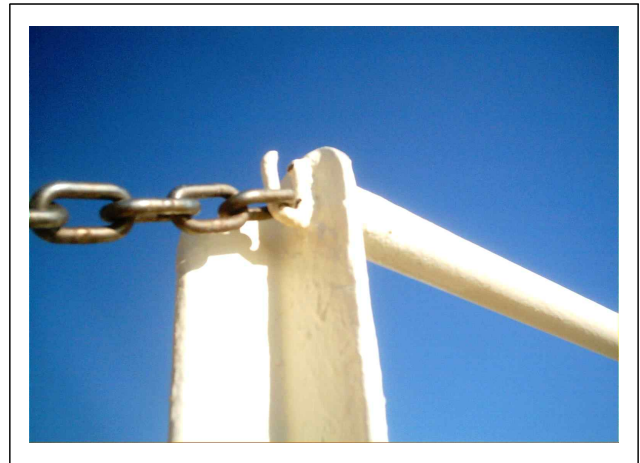
- 4.3.3 The chain hook is U-shaped with its upper part open, allowing the chain to be hung from top to bottom. If the chain is pulled upward or a force is applied upward to the hook, the chain can be released.
- 4.3.4 Under these circumstances regarding the hooks, that chains could have become unhooked at the time of the accident if OS B had lost his balance and lifted the middle chain with his left hand while pushing it. At the same time, some part of his body, such as an ankle, could be gotten hung up in the lowest chain, pushing the hook upwards and possibly unhooking the chain.
- 4.3.5 Likewise, it has been determined that chain railings are incomplete railing structures, as the chains can easily come loose depending on a passer-by's posture against them.

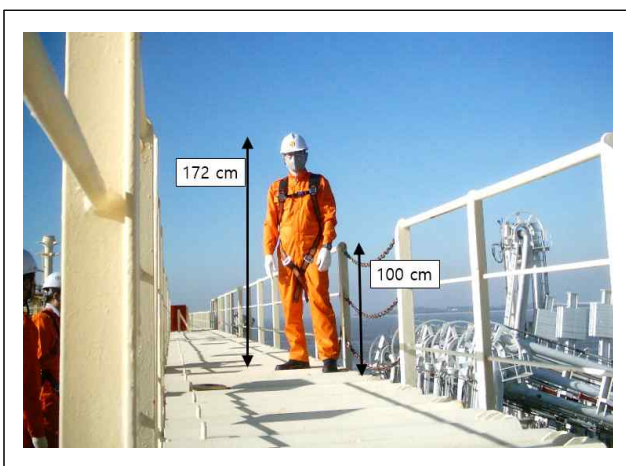
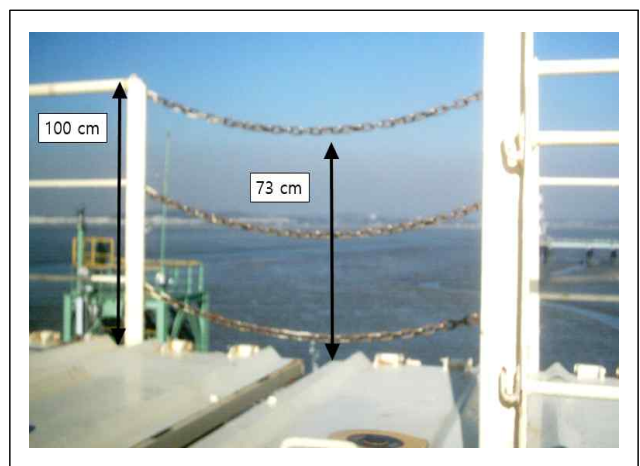
4.2.4 The chain railings fitted along the top of the electrical cable tray are supposed to be one meter high, equal to a minimum height of railings required at all exposed areas, such as the upper deck and the superstructure deck, in order to prevent crew from falling according to both International Convention on Load Lines, 1966 (ICLL)¹⁵⁾ and the domestic regulation, Standards for Ship's Facilities¹⁶⁾.

4.2.5 However, the height of the top chain hung between the steel railings at the accident site was 0.73 meters (73 centimeters) at its lowest point, less than one meter.

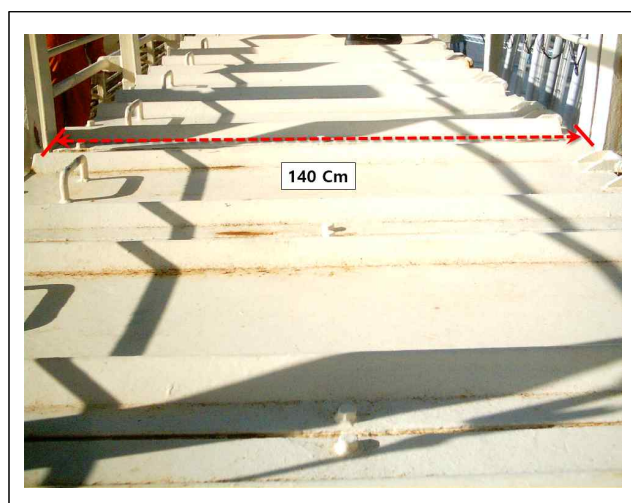
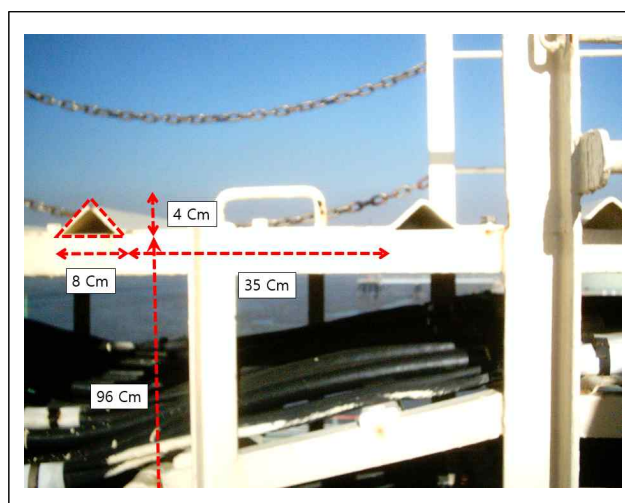
4.2.6 Also, the electrical cable tray floor was made of steel plates¹⁷⁾ layered one after another over the cables fitted atop the cargo tanks. Those steel plates were also about 12 centimeters apart, considering bending stress during ship operation. Moreover, some parts of the floor have a triangular protrusion (approx. four centimeters high) to disperse the stress applied on the plates.

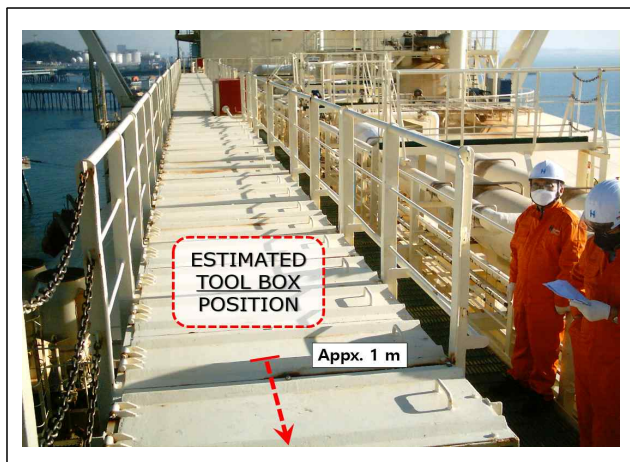
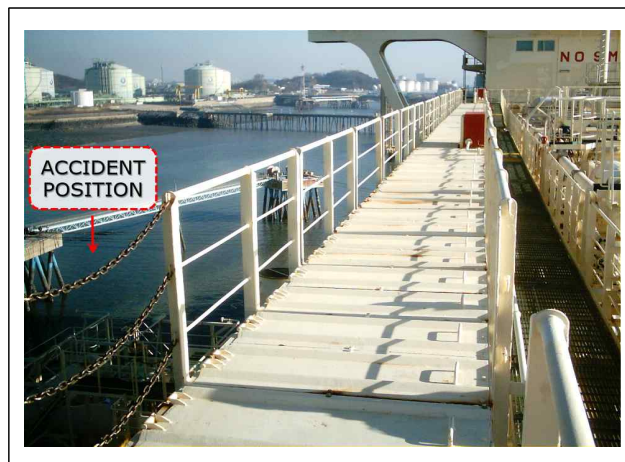
4.3.1 Before the accident occurred, three chains had been hung at an interval along of the electrical cable tray.¹⁸⁾ At the time of the accident, the chains hanging in the middle and the lowest one became unhooked, thereby failing to prevent OS B's fall.
