# **Marine Safety Investigation Report**

## **– Fatal Accident aboard Research Vessel Isabu –**

Date of Accident: 5 July 2022

**Korea Maritime Safety Tribunal**  
**Marine Safety Investigation Team**

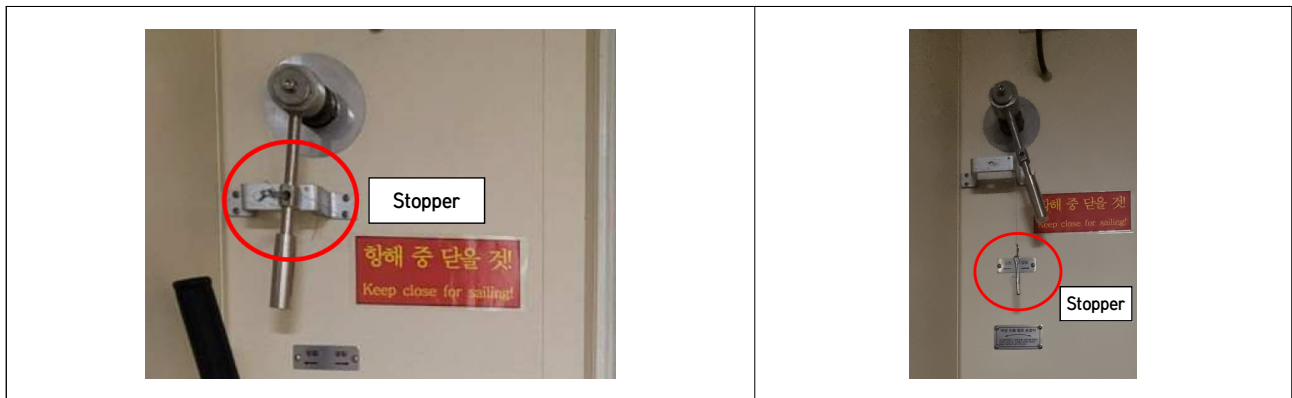
<Figure 10> Stopper in (left) and stopper out (right)

13) If she had released the control lever, the watertight door would have closed. That is because the solenoid valve and the limit switch which control the door's opening and closing do not work without power, returning the watertight door to the Close direction as designed in the basic circuit. The solenoid valve, the limit switch, and alarms of the actuating system are connected to the 24-volt emergency power of the vessel.

- 3.2.5 While standing in the middle of the watertight door frame, she pushed the corridor-side control lever with her left hand in the Close direction. The residual hydraulic pressure then caused the door to return to the Close direction. The chief electrician tried to put the stopper into the control lever while the door was closing.

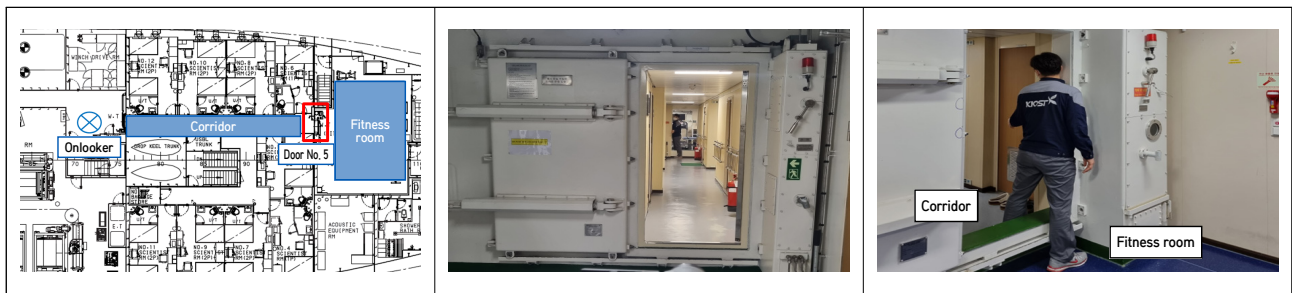
<Figure 11> Positions of the first person on the scene and the watertight door (left); from the onlooker's view (middle); and reconstructing the victim's posture (right)

3.3.2 When the chief electrician was first discovered, she was facing the corridor of the accommodation area while standing pressed against the closing watertight door with each of her feet on a different floor: her right foot was in the fitness room; and the left one was in the corridor. Her body did not move.

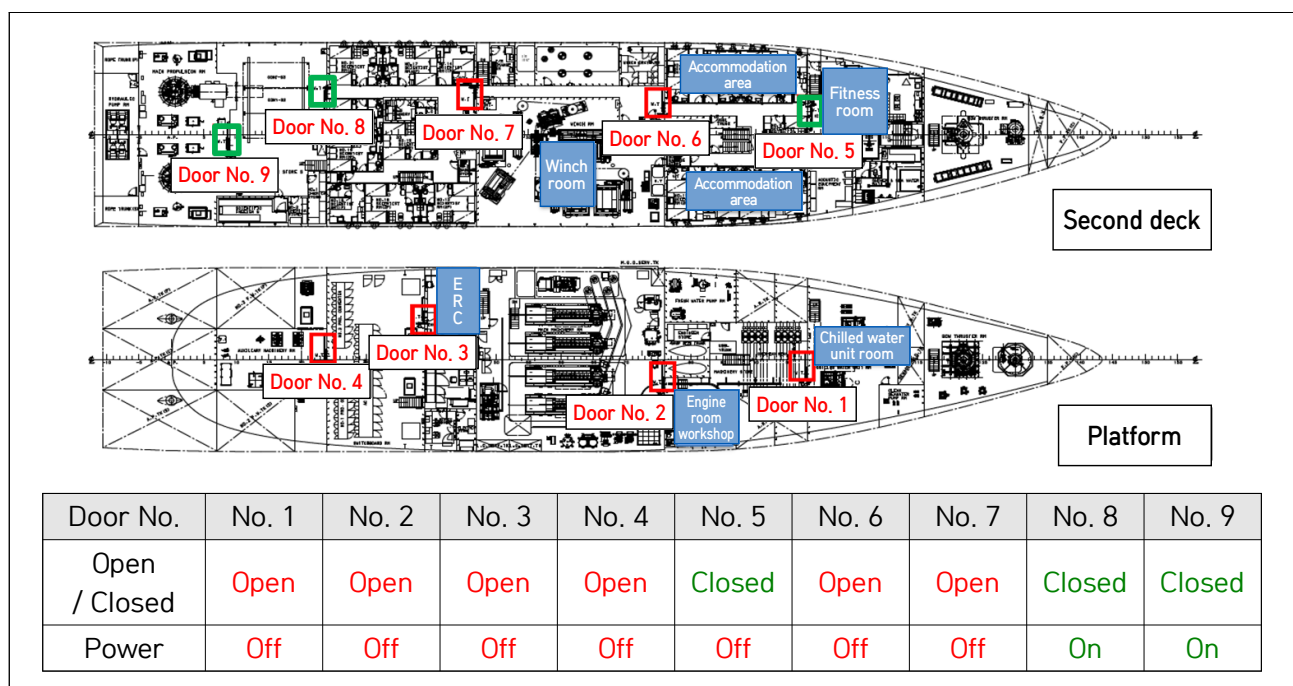
<Figure 12> Ordinary condition of watertight doors

- 4.1.1 According to the vessel, Isabu, three of the vessel's nine watertight doors were normally kept closed while the other six remained open. The closed doors were Watertight Door Nos. 8 and 9 on the way to the machinery space on the second deck and Watertight Door No. 5 at the fitness room on the bow, where the accident occurred. The four doors on the platform and the two on the second deck were always open.
- 4.1.2 In addition, individual power switchboards connected to the watertight doors were all turned off, except those for Watertight Door Nos. 8 and 9. The following shows the ordinary condition of opening and closure and power supply of the Isabu watertight doors.

- 4.1.3 A watertight door shall always be kept closed under the regulation II-1/22.1 of the International Convention for the Safety of Life at Sea (SOLAS). SOLAS regulation II-1/22.3 also stipulates that even if it is opened to permit passage or work, the door must be immediately closed when the transit through the door or the work is finished.

- 6.1.3 A watertight door is important equipment that helps a ship to maintain buoyancy and safety of the hull by preventing water ingress when the ship faces flooding due to hull damage. Therefore, the door should always remain closed with the exception of watertight doors under maintenance.

- 6.1.4 However, as in the case of Isabu, if a majority of watertight doors are always kept open with their switchboards turned off and not ready for immediate operation, they could not be closed swiftly in the event of flooding, resulting in significant property damage and loss of life, which needs to be changed.

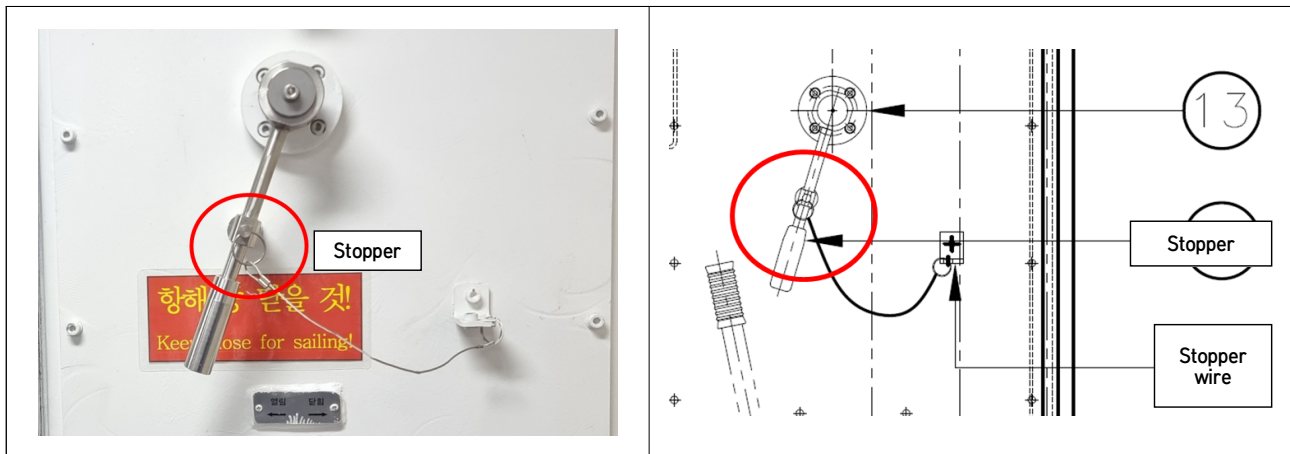
<Figure 13> Stopper in the Open direction (left) and stopper in the diagram (right)

- 4.2.1 This accident is assumed to have occurred when the chief electrician re-inserted a stopper, which was set in the Close direction of the door control lever in the corridor. Therefore, understanding the usage of this stopper is key for analyzing the cause of this accident.
- 4.2.2 First, the watertight doors of Isabu have a stopper which fixes control levers in the Open direction. The stopper was manufactured and attached to the watertight door after the door was installed on the vessel. It is located only at the actuating system.

- 4.2.3 A stopper at the actuating system is installed to set a door control lever and prevent potential malfunction of the watertight door should the door need to remain open for a long time for inspection. When it is opened, its control lever is in neutral, and as long as the lever is not switched to the Close direction, the door remains opened.<sup>21)</sup> If the lever is activated due to negligence or malfunction, thereby closing the watertight door, an accident is likely to occur. That is why a stopper was installed so that a watertight door can remain opened while work is being carried out.

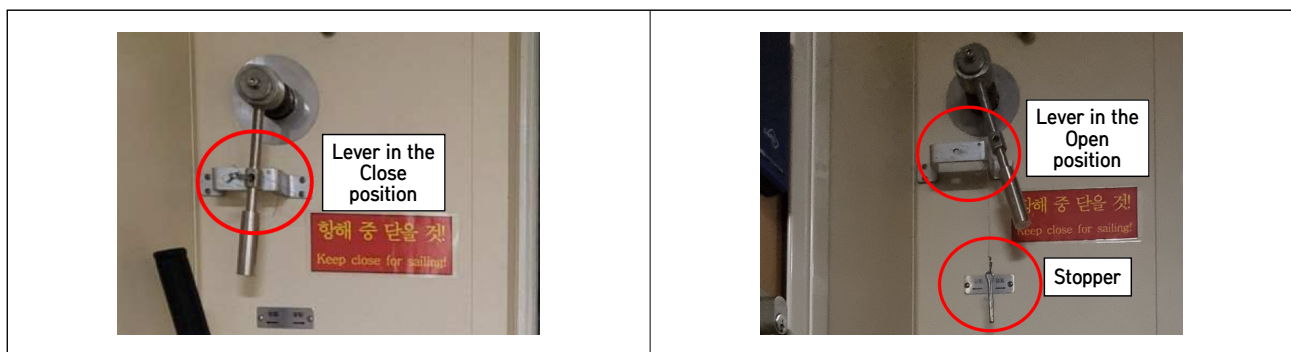
<Figure 14> Closed control lever in the corridor (left) and opened lever (right)

4.2.6 According to Isabu, Watertight Door No. 5 adjacent to the accommodation area was kept closed and its control lever in the corridor was fixed with the stopper due to noise from the fitness room. And, as researchers, who were not familiar with operating watertight doors, were mostly staying there, the door was kept closed, except special occasions such as classification surveys, to prevent accidents. Also, the power switchboards of the watertight doors were all turned off, meaning that Door No. 5 was normally closed, or practically sealed off.

- 4.2.11 It is hard to deny that this accident was caused by the chief electrician who had made the wrong decision while passing through the moving watertight door. However, the stopper randomly installed in Watertight Door No. 5 is also considered a potential risk factor as presented her with the extra task of inserting it into the hole of the control lever.

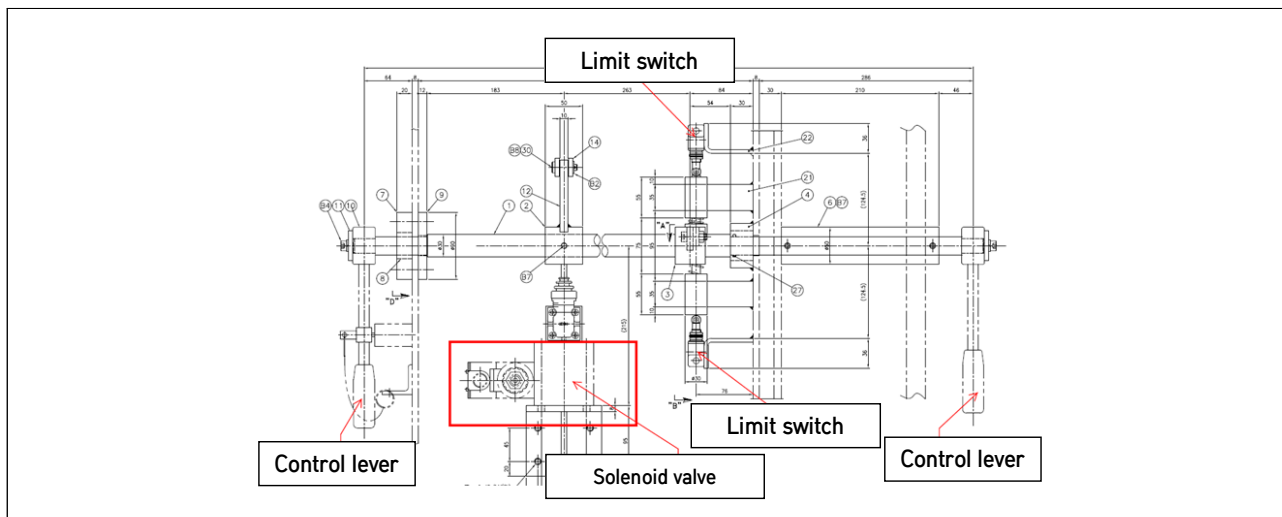
<Figure 15> Solenoid valve and limit switch in the diagram

- 4.3.9 Meanwhile, it was found out that Watertight Door No. 5 did not operate normally during the investigation. In principle, when a person moves a watertight door's control lever to the Open or Close direction, a limit switch sends out opening or closing signals to a solenoid valve. Then, the valve operates hydraulic lines to open or close the door. However, the on-site investigation identified that if a person had switched its control lever to the Open direction while the watertight door had been closing, the door would reopen. And, when the lever was in neutral, the door would reclose.

- 4.3.10 When asked, the manufacturer confirmed that there could be the case where a control lever failed to send opening or closing signals due to the defected solenoid valve or limit switch in the actuating system, requiring the lever to be repaired.<sup>27)</sup>

27) The manufacturer said that parts can be supplied and directly replaced on board.

4.3.11 This accident occurred when the switched-off watertight door was being closed by the residual oil pressure, meaning that the defect of the power-driven parts are less likely to have caused this accident. However, such a defect may affect smooth operation of the door. Thus, it seems appropriate for the vessel to conduct regular operation inspections and, if necessary, to carry out maintenance or repair so that watertight doors are kept in normal condition.

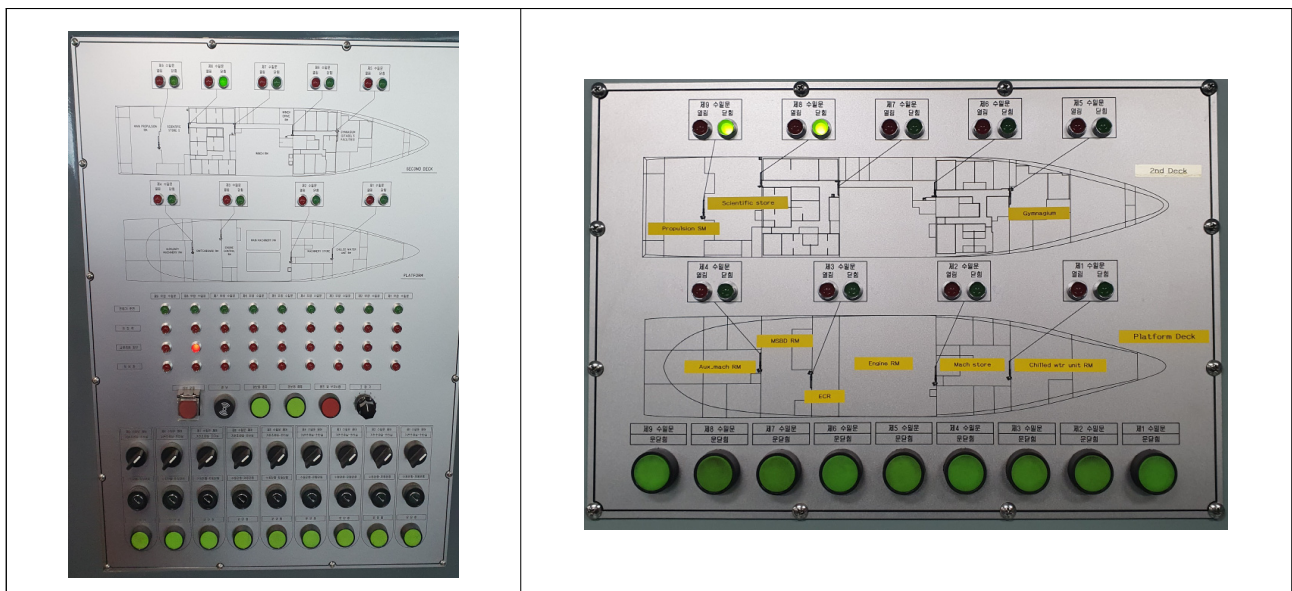
<Figure 16> Remote control console of the bridge (left) and ECR (right)

4.6.2 The remote operating system of the bridge and the ECR can only close the doors. The doors can be closed from the bridge in the following three ways: First, if a person pushes the red Emergency Close button with a cover attached on the console, all the watertight doors will close at once. Second, if a person sets the key switch<sup>34)</sup> for each watertight door on an Automatic Close mode, the doors will close individually. Third, when a person pushes the green Door Closing button for an individual door, it will close. However, the ECR has only a green Door Closing button.

4.6.6 Also, as pursuant to SOLAS regulation II-1/13.6, the remote operating positions shall only be "at the navigation bridge and above the bulkhead deck." However, Isabu is designed to allow the watertight doors to be closed at the ECR, and this demands attention as it leaves a possibility that the vessel's watertight doors can be operated differently.<sup>35)</sup>

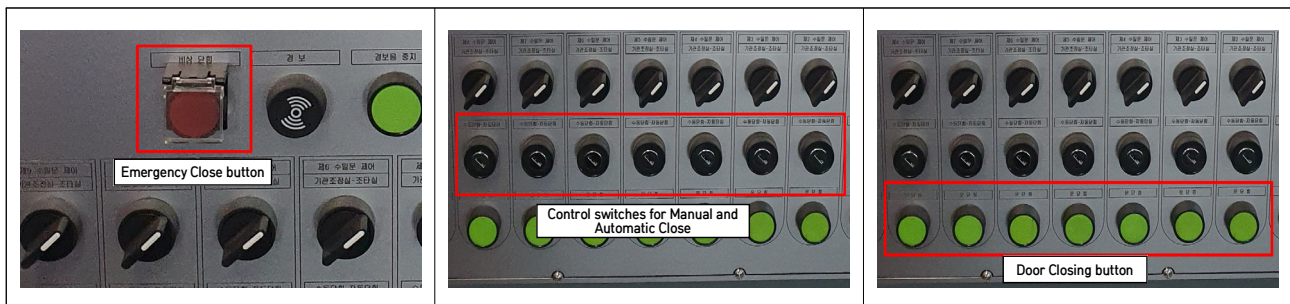
<Figure 17> Emergency Close button (left); Automatic Close switch (middle); and Door Closing button (right)

4.6.3 Under SOLAS regulation II-1/13.8.1, the central control console at the navigation bridge shall have a Master Mode switch with two modes of control, a Local Control mode and a Doors Closed mode. However, the control console of Isabu has slightly different terms and functions: its red button is labelled Emergency Close instead of Doors Closed, and the Manual Close mode of individual doors means a Local Control mode.

4.6.5 It seems that the various functions of the control console on Isabu are likely to confuse the crew when they fail to understand their differences and functions. Therefore, it is considered important to provide sufficient training for the crew and
