# **Marine Safety Investigation Report**

## **on Oil/Chemical Tanker *New Bright***

**- Explosion -**

**Date of Accident: 21 December 2023**

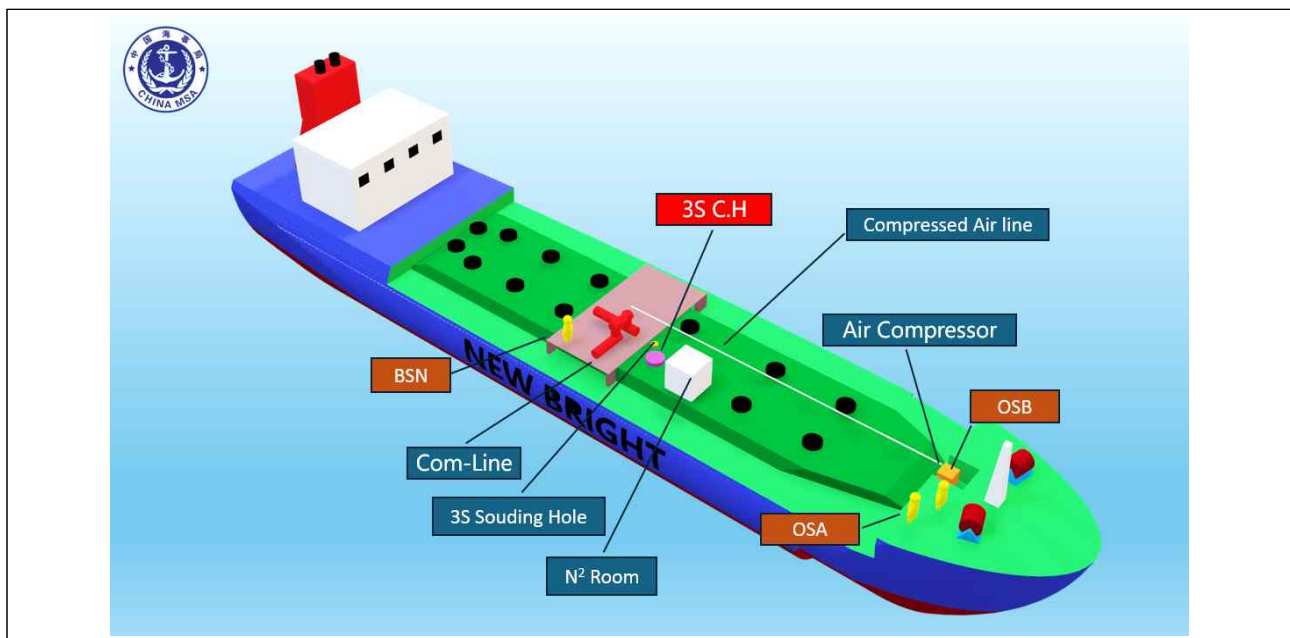
<Figure 8> Major arrangement of pipelines related to the accident (quoted from the Chinese MSA's documents)

3.2.4 At around 14:45 on the same day, the bosun and two OS, who were standby at the forward anchor station for passing under the Sutong Bridge, returned to the deck, connected the compressed air line to the common line of the center manifold, put a portable rubber hose into the drain pipe of this common line as well as the other side of the hose into the hatch of CT No. 3 (S), and started to pump compressed air into the cargo tank (air blowing).

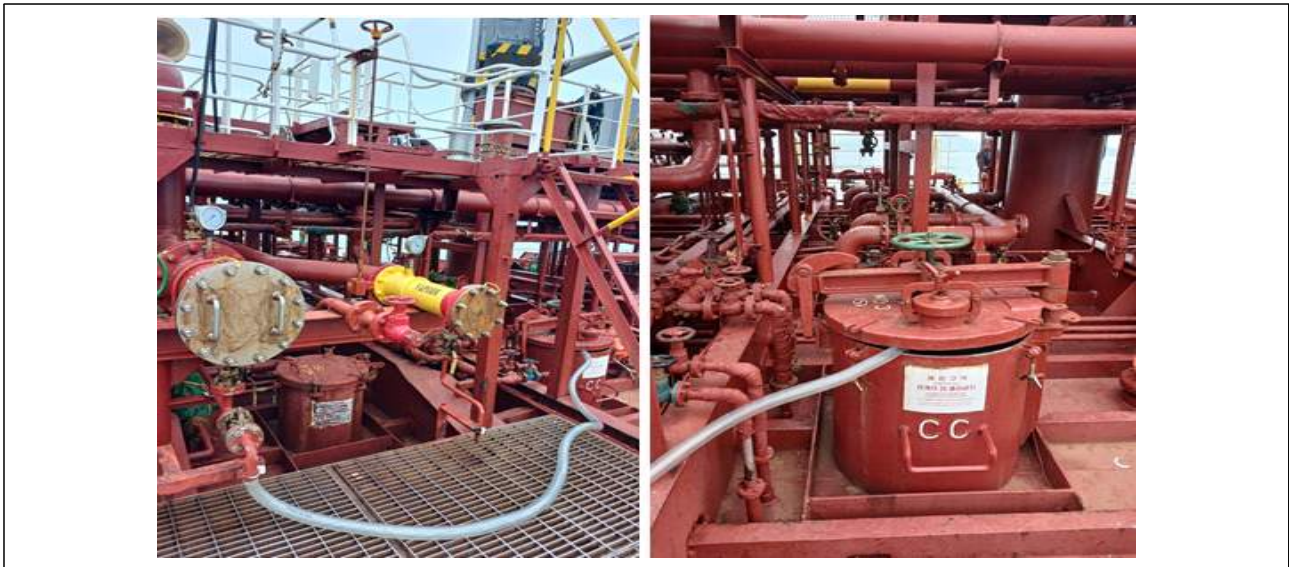
**<Figure 9> Recreating the operation of connecting hoses for air blowing on board New Global (which belongs to Seongho Shipping; and the photos were quoted from the company's documents)**

- 3.2.5 This air blowing operation was not among the five instructions written by the C/O. He stated, "I never directed this work (air blowing)." According to the written statement given by the bosun, however, he conducted such a task after the C/O had instructed that the "tank cleaning should be set up in advance."

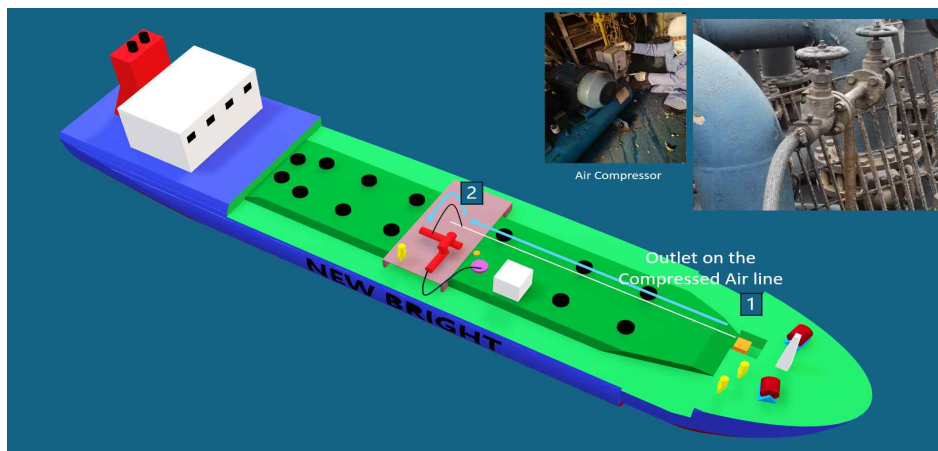
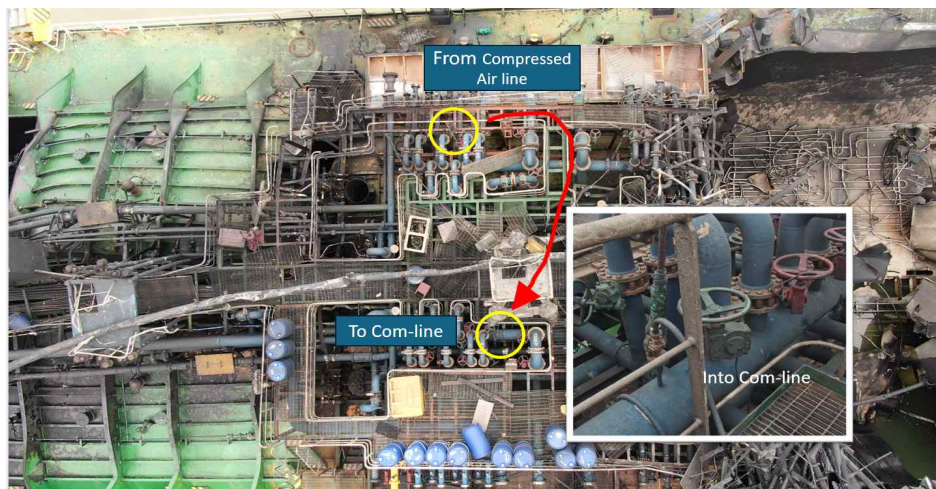
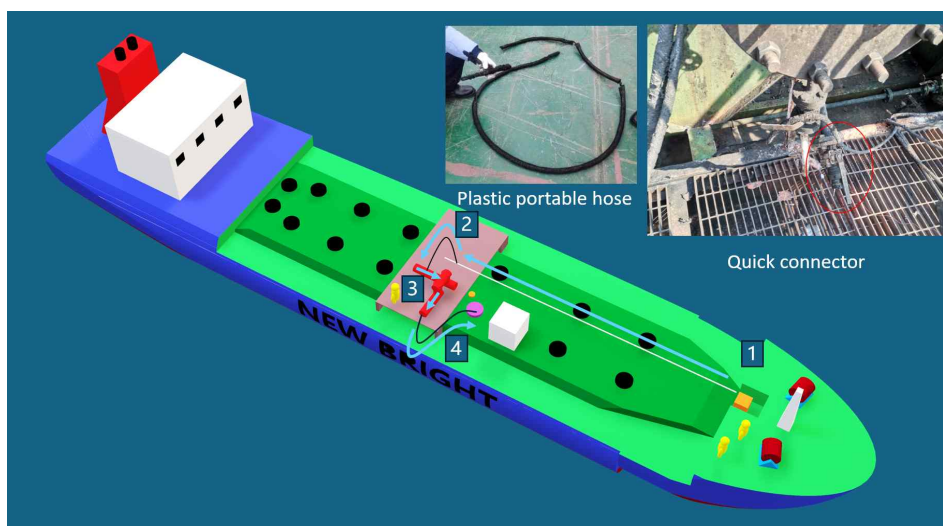
**<Figure 10> Process of connecting pipes related to the accident on board New Bright (quoted from the Chinese MSA's documents)**

- 3.2.7 While watching the cargo residue flow out from the cargo pipeline through the hose, the bosun went to the bow for a while and informed of this air blowing operation the two OS who were on standby for emergency anchoring. After that, he came back to the site and checked the status of air blowing, when the cargo tank exploded.

① Operating the air compressor at the bosun store → ② Connecting it to the compressed air line

② Connecting the compressed air line to the common line (after explosion of New Bright)

- ③ Connecting a rubber hose to the quick connector of the drain line, which is to release residues from the common line
- ④ Putting the rubber hose into the hatch of CT No. 3 (S) and supplying the compressed air

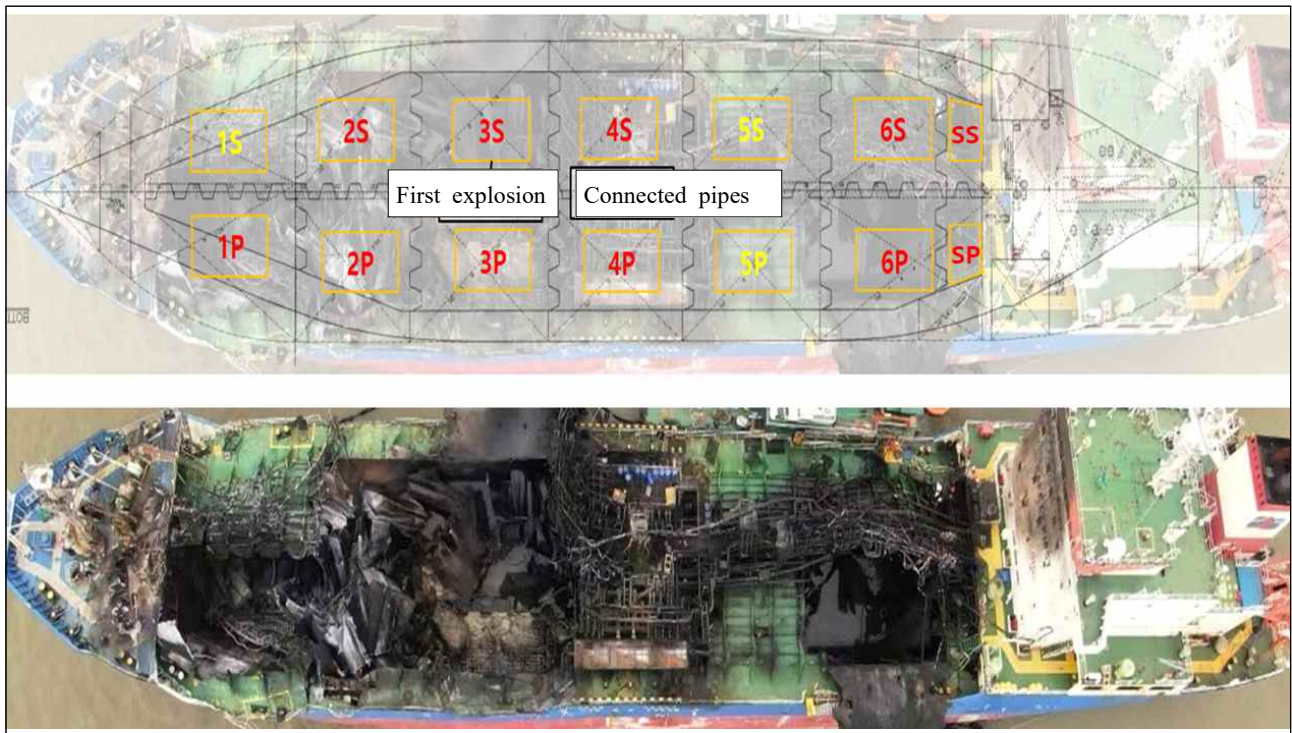
<Figure 13> Comparison of the photo of New Bright after hull explosion and cargo tank layout (quoted from the Chinese MSA's documents)

3.3.5 The accident caused the tanker to suffer severe damage to her cargo tank, deck, bulkhead, and cargo

pipes as well as partial damage to the accommodation area. There were no fatalities, but three crewmembers suffered burns or other injuries.

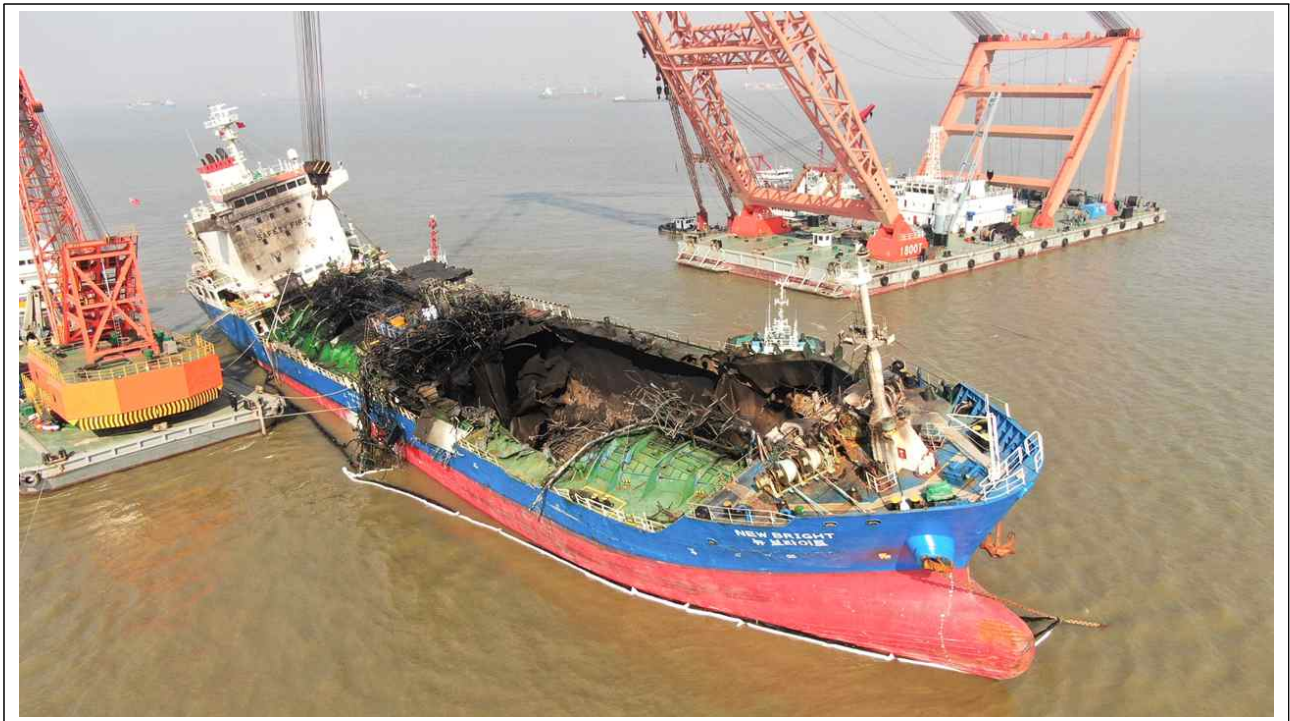
**<Figure 14> Photo of New Bright on the floating dock after explosion (quoted from the Chinese MSA's documents)**

- 3.4.2 This on-site investigation enabled the KMST to identify the first explosion location (CT No. 3 (S)) and the damaged hull condition. However, the bulkheads of all cargo tanks were damaged, and the upper deck was massively impaired, making it dangerous for investigators simply to access the CCR and certain other areas. Thus, their investigation was limited.

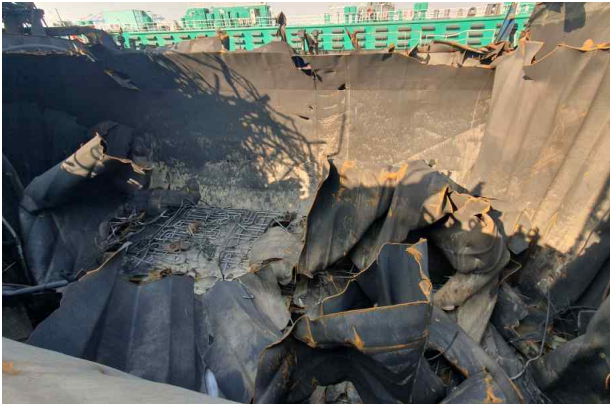
| Damaged cargo tanks (Nos. 2 & 3) | Bridge & accommodation area |

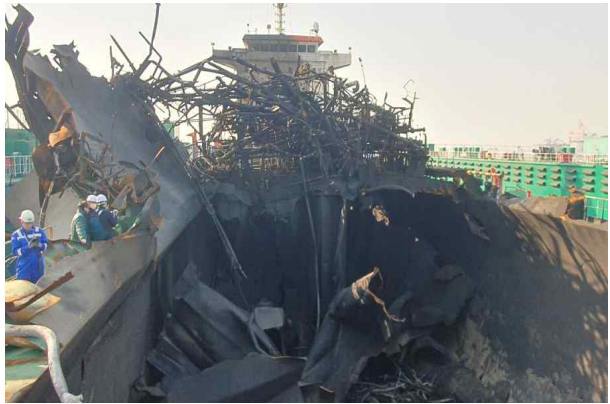
| Deck area viewed from the port bow | Deck area viewed from the starboard bow |

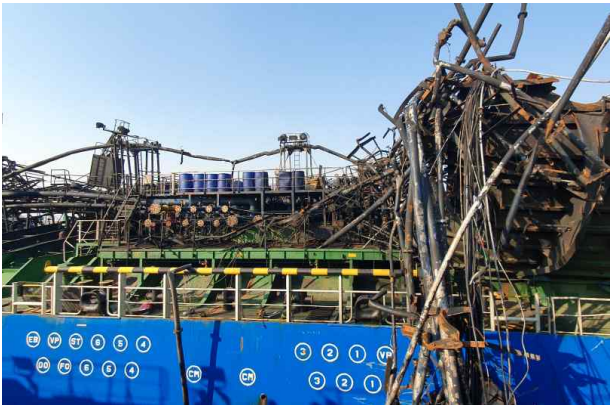
| Starboard manifold | Opening of the cargo tank |

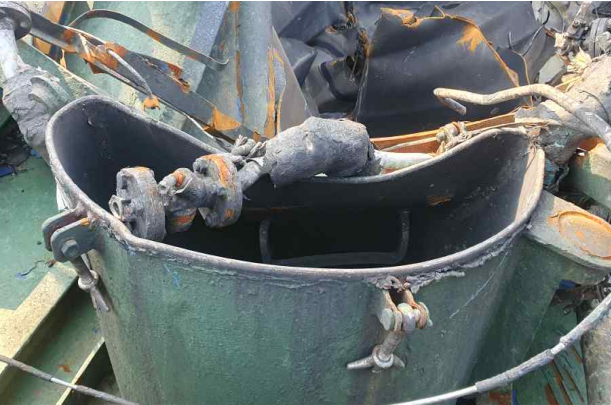
- 4.1.1 The bosun opened the cargo tank a crack as instructed by the C/O. This action most likely allowed outside air to enter the cargo tank while flammable vapor inside the cargo tank was let outside. Moreover, a flammable gas mixture was presumably created inside the tank or on the deck.

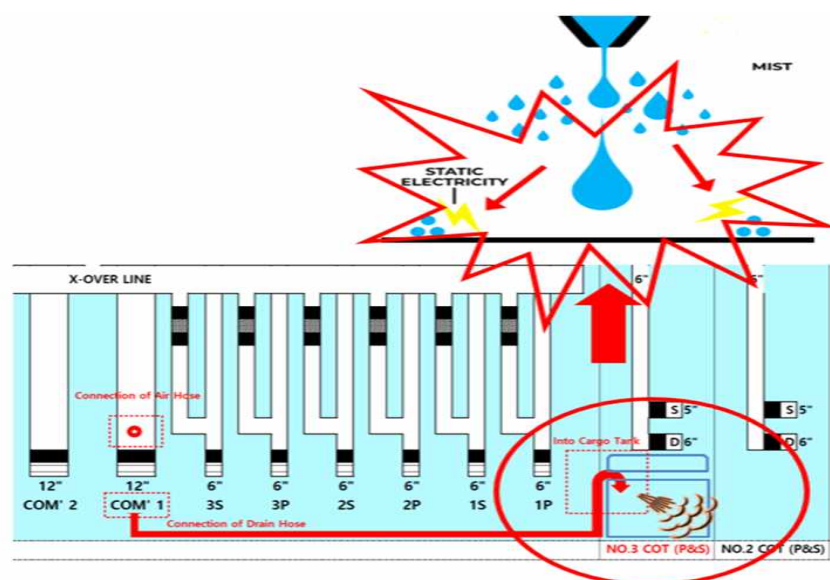
**<Figure 16> Cargo residue ejection from the rubber hose connected to CT No. 3 and the explosion (quoted from the company's document)**

\* The rubber hose was lowered about one meter down from the top of the hatch cover of CT No. 3. (Total height of CT No. 3 is about 10 meters)

4.1.4 Once the air blowing was initiated, air and cargo residue rushed, probably adding high pressure to the end of the rubber hose. When liquid pours from a pipe with a small cross-section area, its friction may cause a surge in static electricity (electrostatic discharge<sup>13)</sup>), which is assumed to be a major cause of the explosion. If not, the exposed metal wire at the end of the hose may have generated sparks while contacting the inner side of the cargo tank. Or, bits of residue may have free-fallen from the top of the cargo tank to the bottom, collided against one another and generated static electricity<sup>14)</sup>.

- 5.1 The New Bright bosun cracked open the hatch of CT No. 3 as instructed by the C/O, probably resulting to the creation of a flammable gas mixture inside the tank. The bosun regarded the crack opening as a preparation work for tank cleaning, and thus he connected a portable rubber hose to the hatch of CT No. 3 (S) and pumped in the compressed air (air blowing) so that the residue could be removed from the cargo pipe. In this process, it is presumed that static electricity was generated inside the cargo tank and it ignited an explosion after meeting with a flammable gas mixture.
