## LESSONS LEARNED FROM MARINE SAFETY INVESTIGATION REPORTS

SUB – COMMITTEE ON  
IMPLEMENTATION OF  
IMO INSTRUMENTS  
5TH SESSION  
2018

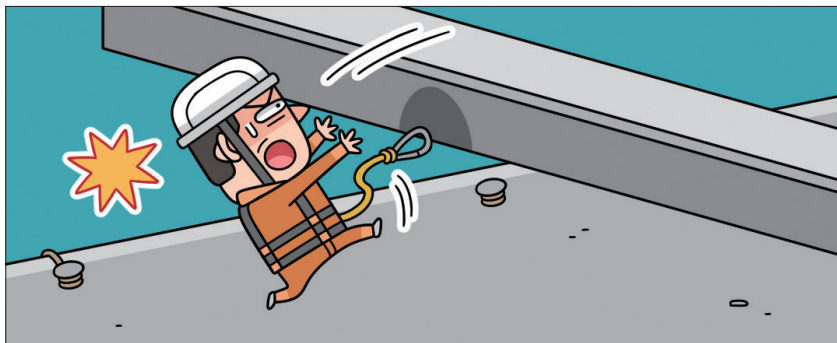
The bosun of a 36,000 GT bulk carrier was fatally injured when he fell about 6 metres from a cargo crane grab while preparing to descend from the grab where he had been working. The ship was carrying a cargo of coal and was at sea. A number of its crew had been tasked to replace the wire rope of a cargo crane grab stowed on its stowage platform on the main deck. The weather was fair and working at height precautions, including completing a ship's "permit to work aloft", had been taken. The work started in the morning and was completed in the evening. Two seafarers first descended from the grab. The bosun then prepared to descend. Shortly after unclipping his safety harness lanyard, he lost his footing and fell about 5 metres onto the platform railing and a further 1 metre onto the deck below. He suffered a head injury. The bosun was given first aid, moved to the ship's hospital and the ship's master sought radio medical advice. However, he died about an hour after the accident.

- The bosun lost his footing just after unclipping his safety harness to descend from the grab. The ship's procedures did not refer to hazards related to access/egress from a worksite at height, and it could not be determined if the risk of going up and down from the grab had been assessed.
- The shape, size and position of the grab meant poor hand and foot holds, and it was concluded that the bosun probably perceived the risk involved as acceptable and within his control. The fall prevention equipment on board was not ideal for vertical movements, whereas the use of equipment such as a double-legged energy absorbing lanyard would have been more appropriate. The equipment was of a type that necessitated unclipping the safety harness lanyard to ascend or descend the worksite.

- Suitable fall prevention equipment, such as a double-legged energy absorbing lanyard, should be provided on board ships to adequately address the risk of falling from height.
- Shipboard procedures and permits to work at height should address the risk of falling at all stages of the work, including the risk when ascending/descending the worksite.
- An objective and robust risk assessment process can ensure individual risk perception of working at height is not a factor.
- Seafarers should recognize the dangers of unclipping prematurely and not disconnect their safety devices until such time as they are in a safe position to do so.

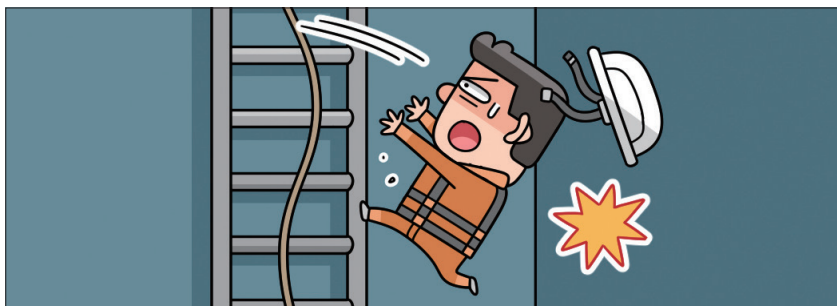
Hold-cleaning operations were being conducted during a ballast voyage in the East China Sea. The weather conditions were favourable – Force 3 wind and a low swell. The crew were using a high-pressure washer to remove previous cargo residue from the sloping bulkhead that formed part of the hold hopper construction. The crew were using a ladder resting flat against the sloping bulkhead to access the upper portion of the bulkhead. The ladder was secured by rope at the top and was being supported by a crew member at the bottom. A crew member then scaled the ladder and directed the waterjet onto the bulkhead to remove the cargo residue. While on the ladder the crew member was supported by a safety line that was attached to his safety harness. The safety line led through a pad eye on the bulkhead above and was controlled by another crew member from the tank top below. This was a long-established method for cleaning the cargo hold. In this case the crew member on the ladder was climbing down to the tank top in order to reposition the ladder for the next section. The crew member was about 1 metre from the tank top when he stopped and disconnected himself from the safety line. He then immediately lost his balance and fell backwards onto the tank top, striking his head, and became unconscious. The injured crew member was evacuated by helicopter. However, despite the first aid efforts of the crew and the medics on board the helicopter, he was declared dead on arrival at the hospital. The cause of death was attributed to a head injury.

- The crew member disconnected himself from the safety line before he reached the tank top.
- The crew member's safety helmet was not secured by the chin strap and dislodged during the fall. Although this factor did not cause the accident, had the helmet remained attached to his head it could have provided sufficient protection to lessen his injuries from a fall from such a relatively low height.

- Even falls from low or moderate heights can result in serious injury or death. Seafarers should not become complacent about the dangers of working at height, particularly when using ladders.
- Seafarers should recognize the dangers of unclipping prematurely and not disconnect their safety devices until such time as they are in a safe position to do so.
- A hard helmet will provide a greater level of protection if it is secured by a chin strap.
- There is an element of risk when seafarers are working with ladders of any description. While ladders are necessary for providing access, it is not considered good safe industry practice to use them as a work platform.

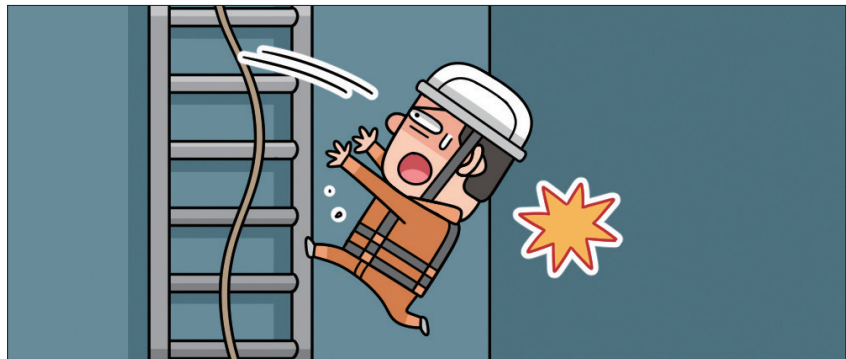
A bulk carrier was at anchor to carry out hold cleaning operations. The chief officer ordered two seamen to clean No.1 Cargo Hold and issued a permit to work for the activity in accordance with the ship's SMS. The activity included the cleaning of the hold bulkhead corners by hand, which required the use of a portable aluminium ladder for working at height. One of the seamen ascended the ladder and carried out his task at a height of 4 metres above the cargo hold's tank top. On completion of his task, the seaman, who was wearing a safety harness and lanyard, unclipped the lanyard. He then lost his balance, fell 2 metres onto the sloped side bulkhead, and then rolled a further 2 metres to the tank top. The seaman was taken to the ship's hospital and later transferred to a hospital ashore, where he subsequently died of his injuries.

- There were several trip hazards where the seaman had been standing.
- The bulkhead against which the portable ladder was positioned was uneven.
- After unclipping the lanyard, there were no means to prevent the seaman from falling when he lost his balance.
- There was nothing in place to arrest the seaman's fall.
- The perception of the ship's crew was that personal care and vigilance were sufficient to avoid falling from the ladder once the lanyard had been unclipped.
- The activity was not supervised.
- The risk of falling in the cargo hold was neither specifically discussed in the ship's SMS nor identified in the ship's risk assessments.

- An activity that poses a reasonable risk of falling a distance liable to cause personal injury should be properly planned and supervised.
- When identifying the safety controls required to reduce a risk of falling, the hierarchical principle of "avoid, prevent and minimize" should be applied.
- If a risk of falling cannot be avoided, measures are required to minimize the distance and consequences of the fall, such as the use of a fall arrestor and/or safety net or air bag.
- Seafarers should recognize the dangers of unclipping prematurely and not disconnect their safety devices until such time as they are in a safe position to do so

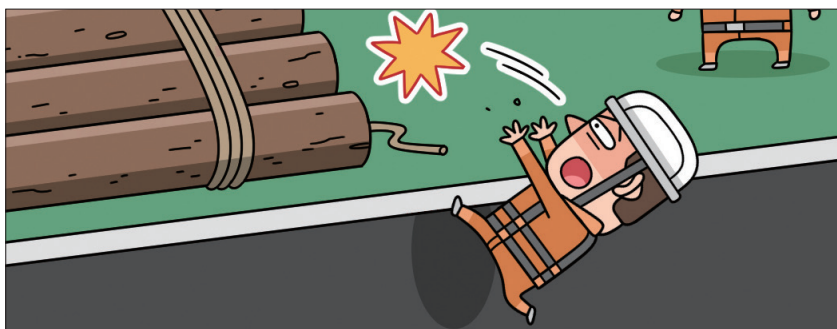
A bulk and log carrier was loading logs at an anchorage. Loading logs on deck above number one hold were complete. The ship's crew were lashing the logs above number one hold while loading continued at other holds. While lashing, one of the ordinary seamen fell overboard into the sea. Another member of the deck crew jumped into the water to search for the ordinary seaman. Despite an extensive search over several days, involving several other vessels, the ordinary seaman was never found.

- What caused the ordinary seaman to fall overboard was not established. He was wearing coveralls, gloves, a safety helmet and studded overshoes.
- The ordinary seaman was not an experienced seaman and, not only was he not experienced in log lashing operations, he had received no training or briefing from senior crew members as to the risks involved in working on log stacks.
- No guard lines or rails had been erected and nor was the ordinary seamen wearing a safety harness attached to an appropriate fall arrestor, so there was nothing to prevent or arrest his fall when he fell from the log stack.
- The ordinary seaman was not wearing a lifejacket or buoyancy aid to aid his survival when he fell into the sea.
- Nothing in the ship's SMS manual required the crew to rig safety lines or wear safety harnesses when working on top of log stacks.

- Working on top of log stacks is a potentially hazardous operation that involves working at height. Crew need to take all necessary precautions to mitigate the risks involved.
- When working at height on top of log stacks, crew should be protected at all times by either guard lines or safety harnesses attached to an appropriate fall arrester system.
- When working near the side of the vessel on top of a log stack, crew should be wearing an appropriate buoyancy aid to improve their chances of survival should they fall overboard.
- The company should identify and assess all risks to its ships and personnel, and establish appropriate safeguards based on robust hazard identification and risk assessment. All necessary safeguards should be addressed through procedures in the ship's SMS.

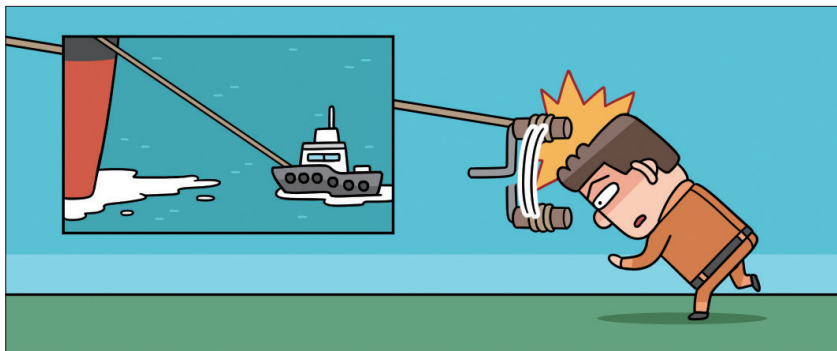
A 16,000 GT bulk carrier was waiting at the anchorage for berthing when the ship's crew were involved in a routine abandon ship drill. The enclosed davit-launched lifeboat was being recovered when it failed to operate. The ship's electrician was summoned to the boat deck to identify the reason for the winch controller's failure. In the interim, the master instructed the bosun, ordinary seaman (OS) and another crew member to recover the boat manually. The crew inserted the manual crank handle to hoist the boat. The electrician, on being told by the bosun about the motor, went to the switch board location to restore the power. At the lifeboat deck, the motor started to turn. Along with it, the manual crank handle, which was still inserted into the hoisting slot, turned a few rounds and hit the bosun and the OS who were standing in close proximity to the handle. The bosun received injuries to his skull as the rotating handle struck his head while the OS sustained minor bruising to his hip. The bosun succumbed to his injuries on board.

- The lifeboat's electrical system was found to have been bypassed to overcome an inoperable or malfunctioning limit switch so as to facilitate the winch motor to operate. In order to restore the power, the electrician had to bypass the existing jumper or short circuit, thereby compromising the safety interlock which was designed to prevent accidents. During this process the lever for hoisting remained engaged in the stowed position while the bosun and the crew continued to hoist the boat manually using the manual crank handle. This condition allowed for the winch to operate when the electrician restored power to the breaker.

- The crew on board the vessel were not well versed with the interlocking system of the lifeboat. Although the manual and drawings of the lifeboat system contained instructions and warnings, there were no warnings at the operation area to warn the users of hazards that may occur during launching / recovery of the lifeboat.

- There was inadequate supervision of the boat deck when the officer in-charge left the station to look for the electrician. A routine drill recovery process was not upgraded to a high-risk operation when the hoisting mechanism failed to operate.

- Despite the conduct and participation of crew in routine and regular safety drills, familiarity of alternative recovery modes was not routinely exercised.

- Crew must fully understand the operating mechanism of the equipment on board the ship and ensure that safety interlocks are not bypassed under any circumstances.
- Work performed by shore contractors should be supervised by the ship's staff and verified.
- Procedures in the SMS for the operation and maintenance of ship's systems and equipment should take into account the recommendations and hazard warnings provided by the manufacturer.
- Alternative modes for recovery of survival craft should be regularly incorporated into mandatory drills.
- The benefits of pre-briefings and debriefing of the crew in relation to mandatory drills should not be underestimated for crew training and familiarization.

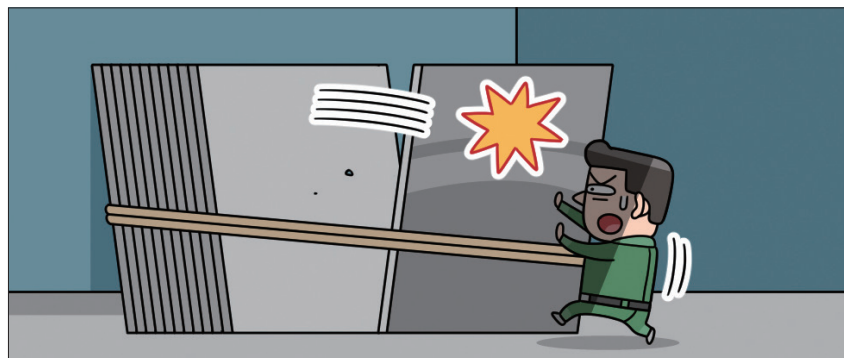
A 12,000 GT chemical/products tanker was waiting at the anchorage for her next port orders, on completion of loading of chemical. The engine-room crew commenced preparation for some fabrication work. The work involved shifting of steel plates to the engine-room workshop to fabricate rail guards for the ship's crane. The 11 plates had been stowed vertically against an engine-room structure in the compartment next to the steering gear room, and held together with steel cables to prevent them from falling down. Three personnel from the engine-room, of which two were engineer officers and one engine-room seaman, began removing the steel cables. As the cables were removed, the vessel experienced some rolling as a result of beam seas and the plates fell towards the crew. While the two officers stationed at each end of the plate managed to move out of the way of the falling plates, the seaman who was in the middle of the plates could not. The plates, weighing about 900 kg, fell on the seaman causing multiple injuries. The seaman was evacuated from the engine-room using a stretcher and transferred to a speed boat arranged by the agent to be taken ashore for treatment. Attempts to resuscitate the seaman were unsuccessful and he died of his injuries on the way to the hospital. A tool box meeting had been conducted by the team prior to the task.

- The vessel had anchored at the outer anchorage awaiting orders. The anchorage did not offer protection from seas and swells as compared to the inner bay anchorage. Although the harbour rules conveyed through the agent to the vessel instructed vessels not to perform dangerous tasks that required movement of heavy equipment due to the open nature of the anchorage, the tool box meeting conducted by the vessel's crew did not take account of the location where the vessel was so that appropriate risk mitigating measures could be implemented to minimize the risk of injury if the task had to be undertaken.
- The steel plates were stowed in the vertical position with a small inclination angle, instead of the horizontal position (flat on deck), causing risks of the plates falling abruptly when the cables used to secure them were released.

- Ship management companies' safety management system procedures regarding the planning and carrying out of the activities of storage and movement of weights on board, associated tool box meetings and risk assessments should be reviewed and take into account the vessel's location in port and at sea.
- Crew should be aware of risks associated with jobs on board which may appear not to be hazardous and adopt safe work practices at all times.

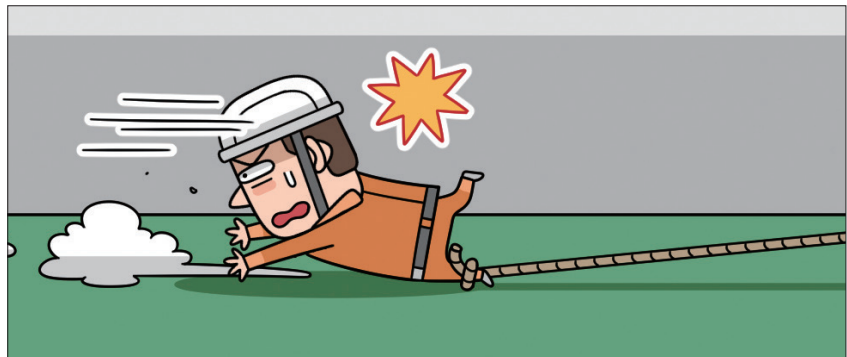
A 21,000 GT chemical/products tanker was approaching the berth under pilotage with the assistance of tugs. The forward tug was to be released from the tanker's bow as the vessel was required to turn to starboard. The tug line's eye had been secured to the bollard on the forecastle. The eye had a messenger rope attached to it. The tug's line was slackened to facilitate its release. The ordinary seaman (OS) eased the rope out through the closed chock (Panama Lead) and had taken a turn of the messenger rope around the bitts. As the tanker's turn to starboard for berthing continued, and the tug's line was in the water, the messenger rope's exit speed from the closed lead started to increase. The officer in charge of the mooring operation warned the OS to step clear from the messenger rope. The OS moved between the bitts from port side to the starboard side, as rope's speed around the bitt quickened. He fell on the deck and was dragged with the rope entangled around his leg. His body hit a structure near the single point mooring chain stopper before he was dragged overboard through the Panama Chock. The OS was recovered from the water by the tug boat, and received first aid and CPR. Emergency services subsequently transported the OS to hospital, but the OS died the next day.

- The messenger rope's speed increased as a result of the increasing separation between the vessel due to the vessel's sternway and moving away from the tug's position, thereby increasing the relative distance between the two vessels. This increased speed of the messenger rope was not anticipated by the crew of the vessel, as the OS continued to hold on to the messenger rope's end.

- When the officer in charge instructed the OS to step clear from the rope, the OS hastily moved to another location, but fell on deck. The long messenger rope's slack likely caught his leg as the rope's exit continued dragging him towards the Panama Chock and then overboard.

- Although the company's safety management system manual (SMS manual) established that tug lines must be let out in a controlled manner so that they do not fall onto a tug boat's deck or to avoid it becoming entangled with the propeller, the dynamic situation of tug separation was not anticipated. The officer in charge did not instruct the OS to keep a safe distance from the messenger rope's turn, such as tending the rope from the end, in case unexpected tension on the messenger rope occurred, which would have allowed for a safety margin in case of unexpected increase in the rope's exit speed.

- Shipboard operations are extremely dynamic in nature. Mooring operations of all kinds, including those involving tugs, should be undertaken with utmost care. All personnel involved must fully understand the various possible scenarios that can occur, owing to their dynamic nature.
- Specific and clear instructions must be given beforehand, as a part of a pre-job brief and a person in supervisory capacity should always assess risks and anticipate that circumstances and situations could change, so that mitigating measures can be communicated timely to members of his/her team.

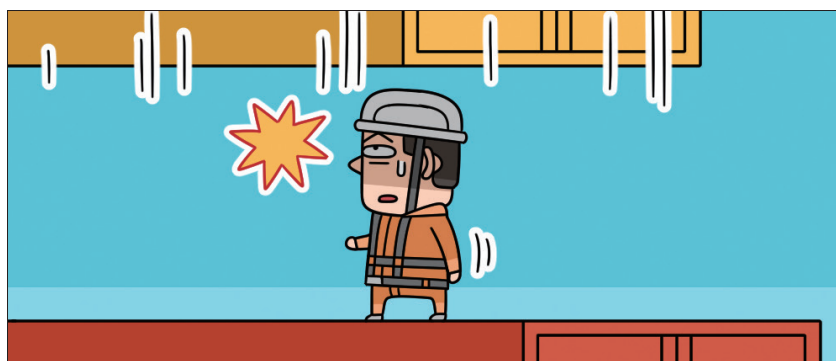
A crew member (able seaman (AB)) lost his life by being crushed between two cargo containers when a fork-lift driver was conducting a manoeuvre to avoid the lifted container striking an adjacent stack of containers and in preparation for loading it onto a waiting trailer.

- The AB was probably unaware of the fork-lift truck driver's intention to manoeuvre the container in preparation for loading it onto the waiting trailer. It is therefore unlikely that he anticipated the container would subsequently move towards him.

- The fork-lift driver did not anticipate that the AB would move forward to remove the container's twistlocks before he had realigned the container and had given a signal for him to proceed.

- The locally arranged signalling procedure was not effectively briefed and enforced, and was potentially unsafe in that it did not require the fork-lift driver to stop his vehicle when the twistlock operator was no longer in his field of vision. The routine nature of an unsighted crew member to remove the twistlock between containers, and the informality and lack of enforcement of the locally arranged signalling procedure, introduced complacent practices on board the ship. This lack of a safe system of work led to an ambiguous situation where two operators on the same task had different expectations of each other's actions.

- The locally arranged signalling procedure did not feature in the ship's SMS, was not covered in the familiarization process and was neither briefed nor enforced, suggesting that an underlying cultural safety issue existed within the company.

- The SMS risk assessment related to working was insufficient. It did not identify the specific hazard of a crew member being crushed by a moving container, or the need to address the risk of an unsighted crew member being positioned in the container's path.

- Implementation of SMS procedures should be strictly fulfilled: some procedures were not implemented according to the ship's SMS, e.g. briefings were not carried out by the C/O to the twistlock operators and vehicle drivers.

- All aspects should be assessed in the risk assessment: there was no identification of specific hazard of a crew member being crushed by a moving vehicle or container; and no address of an unsighted crew member being positioned in the container's path.

- Communication between ship crew and embarked vehicle team and locally arranged signalling procedure should be maintained. The SMS should be reviewed to include safety needs of cargo operations, e.g. the "Cargo Operations Procedure" needed to take account of the other employers' (the embarked team of drivers) risk assessments. The company was required to provide proper familiarization to new personnel, including the embarked team of drivers, on their respective duties.

- It requires more precaution because the limitation of using closed-corner trailers necessitated crew members working in close proximity to suspended containers. Small gaps between containers stowed on the deck and the use of trailers with rear bumpers required fork-lift truck drivers to conduct manoeuvres that were difficult for assisting crew members to anticipate.

- It is unsafe to lift a container not fitted with fork pockets, using a forklift truck.

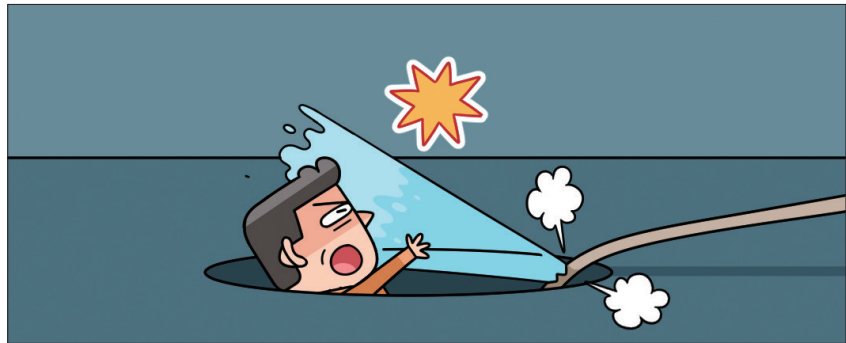
Upon the vessel's early morning arrival, a water leak was detected by an engineering watch officer coming from the main engine turbo charger drain. Suspecting a water leak in the boiler/economizer, the chief engineer ordered it be shut down so that it could be inspected for leaks and repaired later that morning during normal working hours. About 5 hours later the second engineer, along with a fitter, entered the boiler space from the bottom manhole door after they were satisfied with all safety precautions having been taken for man entry. They identified a leaky boiler tube and plugged it from the bottom. Next, their plan was to plug the same tube from the top of the boiler and then restart the boiler. While the second engineer was exiting the bottom manhole door with the fitter right behind him, the inserted boiler tube plug fell off along with a small broken section of the water tube causing hot water from the boiler water drum, steam and smoke to leak out upon the fitter, killing him instantly.

- Lack of SMS boiler work risk assessment process. Failure of the engine-room team to identify all hazards involved for the intended procedure. Failure of the engine-room team to adequately and effectively check that the boiler was drained of water and depressurized. Likely fatigue of the second engineer.

- The dangers of working around, with, and on pressurized boiler systems.
- The value of having SMS procedures for working on pressurized systems such as boilers, as well as following those procedures.
- The dangers of relying on and making assumptions based on gauges.
- Risk assessment forms for this repair evolution were generic in nature and do not identify specific hazards associated with individual tasks.
- Boilers should only be depressurized when boiler water blow down commences to ensure all water from the drum is emptied overboard.
- Engineers should not solely rely on steam being emitted from the stack as the only indicator that a steam drum is empty. The boiler vent on top of the boiler should also be opened to check that a boiler is depressurized.

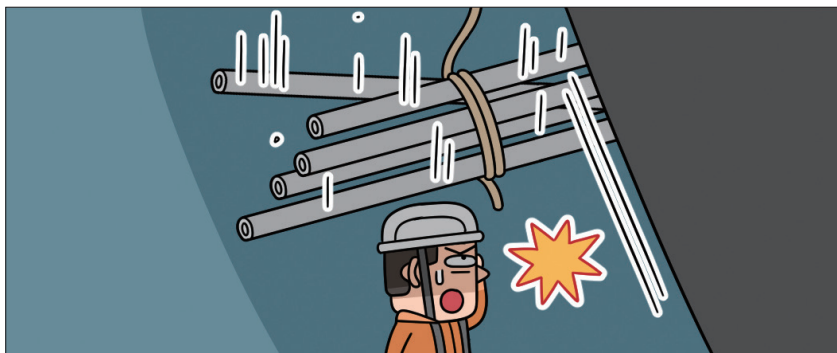
While alongside a wharf, the vessel was loading a cargo of heavy stainless steel pipe bundles. Suddenly, and without warning, the vessel lurched, the suspended pipe load swung uncontrollably in the vessel's cargo hold, crushing three longshoreman between the suspended load and side wall; two died and one was seriously injured.

- The underside of the vessel's fenders on the starboard shoreside amidships hull caught and hung up upon the top of the wharf's fenders. As the tide fell and the vessel's draft increased due to loading of the cargo, the vessel's list increased to a point where the ship's fenders suddenly released from the wharf causing the vessel to quickly and heavily roll. This caused the hoisted pipe bundles to swing in the cargo hold, striking the stevedores who were trapped between the swinging cargo hoist and the vessel's side wall.

- The dangers of working in, on or around a vessel subject to ever-changing and dynamic forces.
- Hazards of working with suspended cargo in a confined cargo space.
- The value of critically evaluating a vessel's condition while alongside a dock, paying particular attention to identifying and eliminating snag hazards and tending mooring lines.
- The value of establishing cargo work plans to consider the possibility of sudden hull rolling and identifying worker refuge areas.

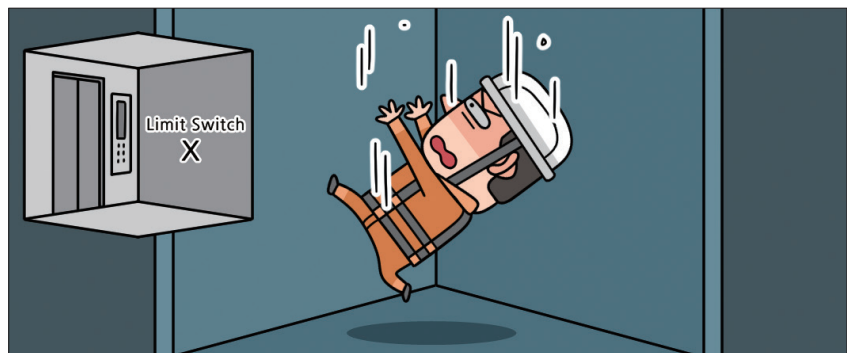
A messman was found entrapped in the shaft of a provisions lift on board a bulk carrier. The lift was found off the guard rails with the lift motor still running. Following the recovery of the trapped messman from the lift shaft, it was confirmed he was deceased. How the messman came to become trapped in the lift shaft is unclear.

- The lift doors were not fitted with limit switches to prevent operation of the lift when the doors were open, although they were shown in the original circuit diagram.
- The lift controls only required a single touch to operate; they were not required to be constantly pressed.
- Neither ship nor company staff had noticed that the door limit switches had been missing since the ship was built.
- The provisions lift was not included in the ship's maintenance system and was not routinely inspected.

- Shipboard operational maintenance routines should address the maintenance and inspection of lifts, taking into account the instructions of the manufacturer, if available.
- The importance of delivering appropriate lift operation familiarization to a ship's staff.

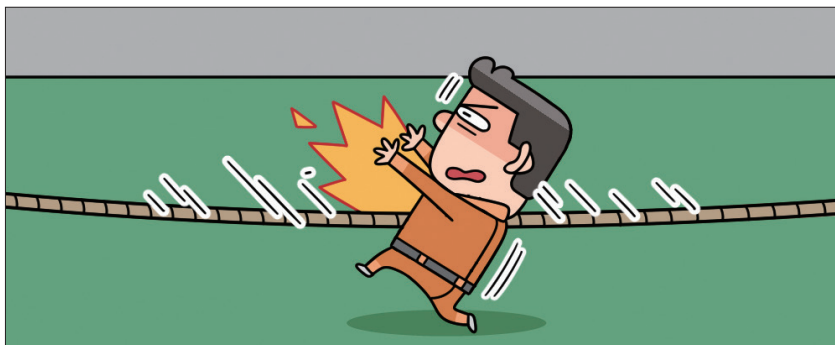
A container ship was in the process of unberthing and a ship's mooring line was paid out from the ship's aft mooring deck to the waiting tug below. Once the line was secured, the tug pulled away causing the line to come under tension suddenly. The mooring line jumped out from the bitts on the aft mooring deck and hit a seafarer, who was standing nearby, in the chest, fatally injuring him.

- The seafarer was standing in the snap back zone.
- The seafarer was not adequately supervised.
- The officer in charge of the aft mooring deck was unfamiliar with using a ship's mooring rope as the towline rather than a tug's line.
- No risk assessment had been conducted to ensure adequate precautions were in place.
- There was ineffective communication between the tug and the ship.

- The need to risk assess unfamiliar operations to establish suitable precautions.
- The importance of supervising junior staff.
- The need to employ the principles of good seamanship in paying out lines in a controlled manner.
- The need for clear and unambiguous communication between tug and deck crews when securing a tow line.

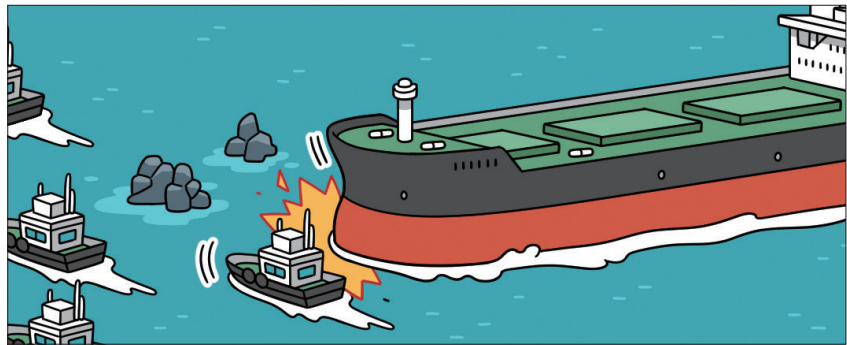
The 40,000 GT bulk carrier was on her way to the next loading port. Around midnight the bridge was manned with the officer of the watch (OOW) and one lookout. At the same time the 240 GT fishing vessel sailed from the fishing grounds to her home port with a crew of 15. In a distance of about 6 nm the fishing vessel appeared on the radar screen of the bulk carrier and it was optically visible on the starboard bow. There were about 25 fishing vessels in the vicinity. During this time the bulk carrier ran with a speed of about 14 knots, the fishing vessel with a speed of about 9 knots. The OOW of the bulk carrier detected that the fishing vessel would pass the bow from starboard to port side. Both vessels met in a crossing situation in which the bulk carrier was the give-way vessel. During the approach of both vessels the closest point of approach (CPA) decreased, although the bulk carrier had started a small course alteration to starboard. The bulk carrier continued with a bigger course alteration to starboard. Shortly afterwards the fishing vessel made a course alteration to port which led to the collision of both ships. The fishing vessel was struck by the bulbous bow of the bulk carrier on the starboard side amidships and suffered severe damage with a massive intake of sea water. This caused the foundering of the fishing vessel shortly thereafter. Only two crew members of this vessel survived. None of the bridge team was rescued. The bulk carrier continued her voyage without any activities as they thought nothing had happened.

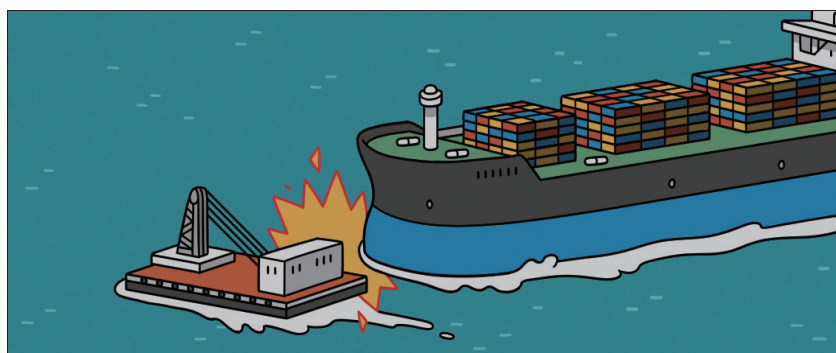
The 3,000 GT cargo ship was leaving the port through a dredged fairway during the early hours of the night. At the same time the 960 GT dredger was entering from the opposite side. The visibility was good. The wind was moderate. The bridge of the cargo ship was manned with the captain and an AB as helmsman. After finishing the aft mooring station, the second officer also went to the bridge. There he switched on the AIS device and was responsible for the engine telegraph. Therefore the AIS signal was only available 1.5 minutes before the collision. The bridge of the dredger was only manned with the master. After entering the dredged fairway, the captain checked the situation ahead by radar, which was switched to the 2.5 miles range. He did not detect any radar target. During the approach of the only bend in the channel, the dredger neared the middle of the fairway and then cut the corner at the bend and sailed on the wrong side. In the meantime, the attention of the captain was distracted by a small boat which crossed his way from starboard to port. The captain of the cargo ship was aware of the dredger and his approach to the wrong side of the fairway from the beginning. The captain assumed that the dredger would alter the course to the right side in time. As he noticed the top lights of the dredger in a line, the captain of the cargo ship became aware of the danger of collision. He used the whistle and he flashed with the daytime signal lights. In the meantime a VHF call was made to the dredger. But there was no reaction. Then the captain ordered to let go the laid out anchor and to take full astern. The captain of the dredger started to turn the ship shortly before the bend. During the course alteration he realized the close quarter situation of the cargo ship. The captain of the dredger neither noticed the whistle blasts nor the light signals. Assuming the cargo ship would turn to the port side, he switched to manual steering, put the rudder hard to port and the engine to full astern. Both ships collided shortly afterwards. The cargo ship struck the dredger on the starboard side midships. This resulted in a bigger hole in the cargo hold of the dredger and he capsized subsequently. Later on, the dredger was declared a total loss. The cargo ship suffered only minor damages to the bow and the bulbous bow. The crews remained unharmed. An oil spill damaged a seaweed farm in the vicinity.

- The ship's command of the cargo ship assumed for too long that the dredger would alter the course to the right side of the fairway. Therefore they neither altered the course to the outer right side of the fairway nor reduced the speed or gave signals or made VHF calls in good time.
- The captain of the dredger was alone on the bridge. His attention was neither appropriate to the radar nor to the fairway in front of the ship. The ship sailed on the wrong side of the fairway.

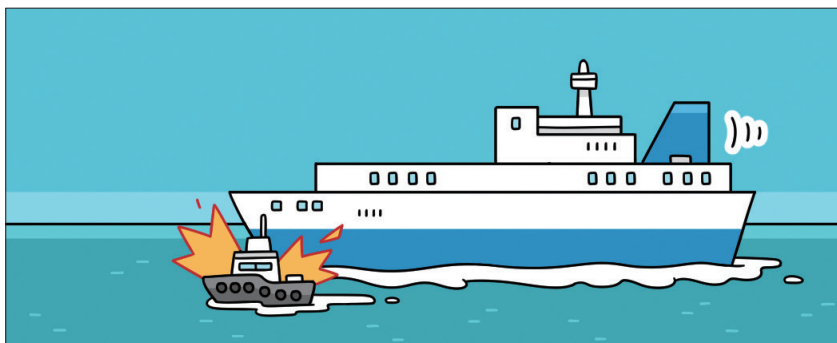
The tug had been engaged to assist the ro-ro passenger ferry to berth in high winds. There was no harbour pilot on board the ferry because the master held a pilot exemption for the port. The tug was manoeuvring close to the port bow of the ferry while attempting to establish the tow, when the stern of the tug collided with the ferry's bulbous bow. As a result of the collision the tug became broadside on in front of the ship, heeled dangerously to port and took on water. The tug capsized and two of its crew died.

- The pilot-exempt master of the ferry was not required to have undergone additional training for tug assistance, which was usually requested during adverse and difficult weather conditions.

- Establishing a tow between a tug and ship should be conducted at as low speed as practicable in the circumstances and conditions in order to give the tug greater manoeuvrability and avoid it having to depart from the "safe zone" where dynamic interaction is less likely to occur.
- Ship masters (especially pilot exempt masters) and tug masters must have a thorough understanding of both the theoretical and practical aspects of safe tug/ship operations.
- Tugs should be fit for the purpose they are being used, with sufficient power and manoeuvrability for the intended operation and comply with stability requirements at all times.
- Down-flooding will quickly erode any reserves of stability and will be a major factor contributing to a capsizing. During critical or high-risk operations all doors and other openings that need not be open should be securely closed.

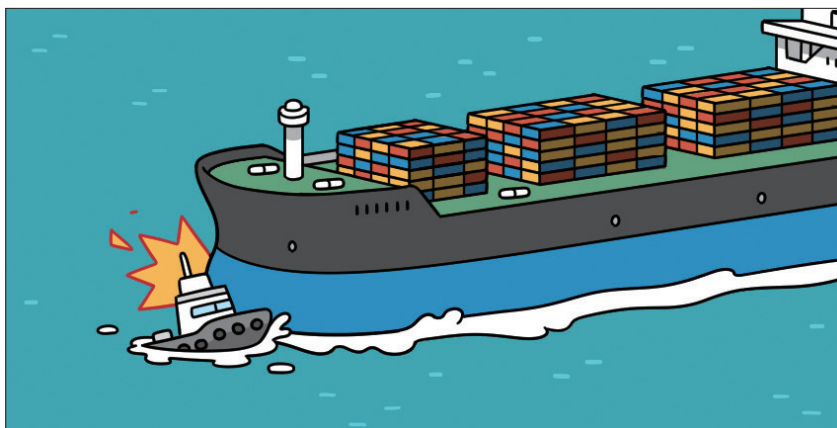
A 3,200 GT general cargo vessel, travelling at about 8 knots under mandatory pilotage and hand-steered by the master, collided with a 115 GT tug boat travelling at a speed of about 7 knots, steered by its AB under the command of its skipper. The collision occurred at night, in a fairway, after both vessels had reported their respective positions and passage at the reporting point. The master of the general cargo vessel, in accordance with his passage plan, altered his vessel's course, first by gradually moving to the centre of the fairway and then to its eastern side. Some minutes later, the general cargo vessel's bulbous bow struck the port side midship hull of the tug boat causing the latter to lose its buoyancy and sink. Four (4) crew and one (1) passenger of the tug boat found themselves in water, where after several minutes they were rescued by a pilot boat and a rescue boat launched from a SAR vessel in the vicinity.

- The pilot, during the transit in the fairway, also did not intervene when the general cargo vessel's course was altered to port so as to navigate the vessel on the wrong side of the fairway.
- On board the tug boat, the radar was not switched on and investigation revealed that its crew were busy talking in the wheelhouse about non-navigation related matters while operating the tug boat under the influence of alcohol. This condition may have impaired their ability to assess the risk of collision with the general cargo vessel. Additionally, although not contributory to the collision, the tug boat was carrying a passenger who was not on the tug boat's manifest.

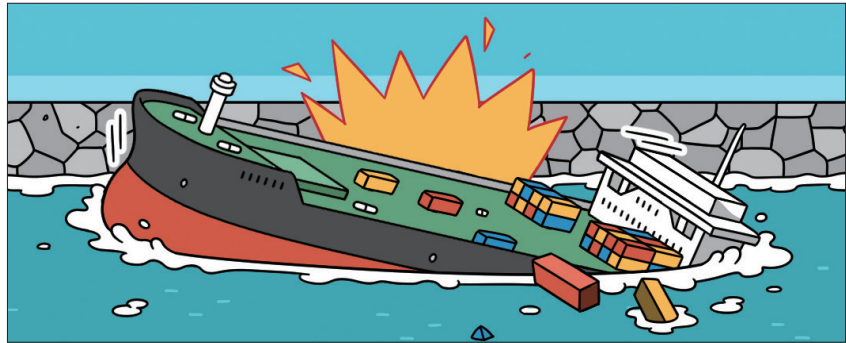
During early morning hours while the vessel was in a ballasted condition riding on a single anchor outside the port, the wind direction changed, its velocity increased and the sea state amplified. The vessel attempted to weigh anchor and put safely out to sea, but was driven by the wind and waves onto the port's sea wall where the vessel stranded and sank. The vessel was a total loss. There were no injuries or deaths of the 18 crew on board.

- Weather and sea state information was not adequately obtained by the master who assumed there were no signs of worsening weather based on the surface analysis and coastal wave analysis charts. The vessel's deck officers had very limited wintertime experience in the port, a port susceptible to high wind and large swells from the west and northwest during winter months as denoted by the sailing directions and states that, if an anchor might drag or fail, a vessel might be washed ashore. The master did not understand the vessel's limited manoeuvring characteristics for the prevailing wind/sea state while in a ballasted condition, attempted to put out to sea too late and was overcome by the weather conditions; it lost vessel manoeuvrability and was driven onshore and grounded.

- The need to consult port sailing directions to better understand a port's prevailing weather conditions and cautions for the seasonal periods transited/visited.
- The importance of maintaining awareness for local weather forecasts and alerts.
- The need for, and value of, vessel manoeuvring information to be readily available for ship staff.

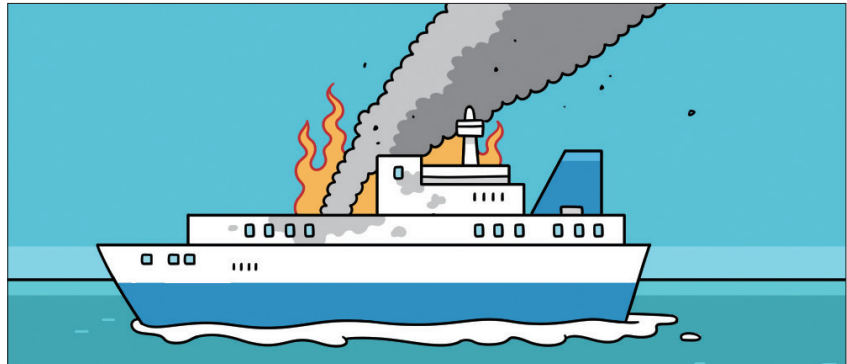
A RoRo passenger vessel was at sea with 417 passengers and 55 crew on board when fire broke out on the main vehicle deck. The fire most probably started in a truck conveying a refrigerated container. The truck's engine had been left running in order to supply power to the refrigerated container. The fire quickly intensified. The crew were unable to make a direct attack on the fire due to the intense heat; dense smoke, and the fact the vehicles had been stowed with little space between them. The crew activated the vehicle deck drencher system, but the incorrect valves were selected and water was directed to the deck below where the fire was located. The ship lost power to the main and auxiliary engines, resulting in a blackout. The master ordered the passengers and crew abandon the ship. Not all of the lifesaving equipment was able to be utilized. Most of the survivors were rescued by helicopters. The bodies of 11 people were recovered. A further 22 persons are missing, presumed dead. The ship was substantially damaged.

- The exact cause of the fire is not known. However, the truck in which the fire probably started had its engine left running because the refrigerated container it was conveying was unable to be plugged into the ship's power supply.

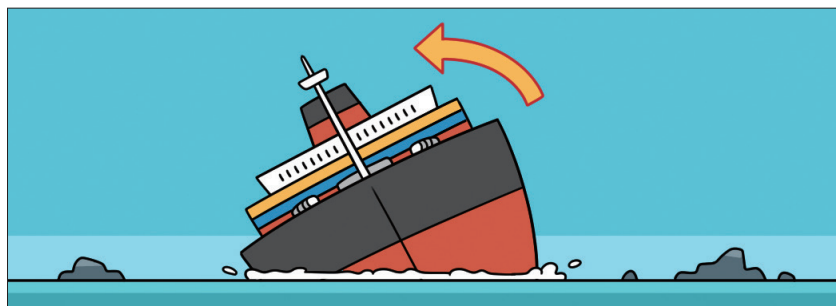
The ship had recently undergone a change of management company and a totally new crew joined the ship. Following a brief handover from the previous crew, the ship sailed with no cargo. The previous crew reported that all the double bottom ballast tanks were full and the wing ballast tanks were 60% to 65% full (about 80% total ballast capacity). The replacement crew did not verify the status of the ballast tanks. In the next port a total of 116 loaded twenty-foot-equivalent containers were loaded in the holds and on deck (estimated 1,900 tonnes in total). The crew made no changes to the ballast configuration, meaning that in addition to the loaded cargo the ship was still ballasted to about 80% total ballast capacity. The crew had still not verified the status of the ballast tanks. The ship departed for the next port, where it took on fresh water before departing for its final destination. Shortly after departing, the ship encountered heavy weather caused by a combination of the monsoon winds and a typhoon, which was tracking northwards through a strait. The ship was rolling heavily and developed a list of about 25 degrees to starboard, towards the wind and waves that were coming from the starboard side. After about 1 hour the list increased to 30 degrees. Without attempting to establish the cause of the list, the master issued a Mayday and ordered the 12-in-total crew to abandon ship into a liferaft. The crew were all safely retrieved from the liferaft by helicopter. When the crew boarded the helicopter, they noted the ship was listing about 45 degrees. All of the deck containers were still in place, and as they had left the main engine and generators running, the lights were still burning. The crew reported that there had been no noticeable failure of the ship's equipment or systems, and there had been no movement of the containers on deck. The crew assumed that there was no movement of the containers in the holds because the containers were so tightly packed athwart ships that no appreciable transverse movement would have been possible. Six days later a search found the ship still afloat and listing between 15 and 30 degrees to starboard. All of the deck containers were missing, but the hatch covers were in place and appeared intact. However, when a salvage tug arrived about 4 days later, the ship had sunk.

- The cause of the ship taking on a list and subsequently sinking was not conclusively identified. The crew were not fully aware of the severity of the forecast weather conditions and consequently, the ship had not implemented heavy weather procedures.

- The crew had not verified the amount of water in each ballast tank since they had boarded the ship more than 3 weeks before the casualty. Therefore, the pre-departure stability calculation made on the ship's stability computer might not have been a true representation of the ship's actual stability condition.

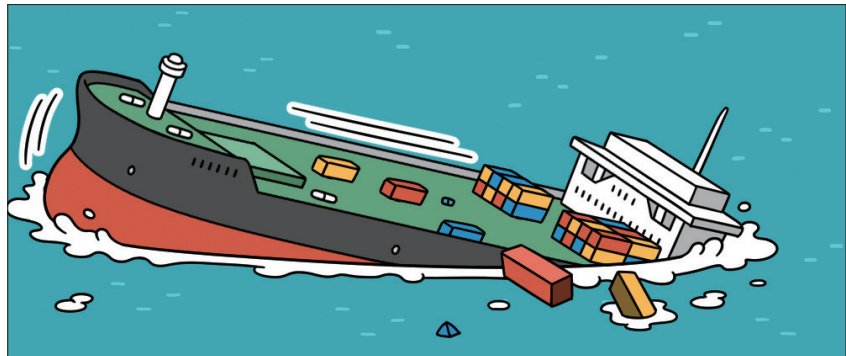
A dry cargo vessel was approaching port, and the vessel developed a severe port list due to cargo shifting and subsequently water entered the engine-room via a weathertight engine-room escape door being left open. This exacerbated the list and the crew abandoned ship. The main engines were left running and this caused the vessel to make circles and make boarding very difficult if not impossible. Eventually this led to the vessel's grounding on a shoal where she became a constructive total loss. It became evident during the accident investigation that the cargo was not stowed and secured as required by the vessel's cargo securing manual.
