LESSONS LEARNED FROM MARINE SAFETY INVESTIGATION REPORTS

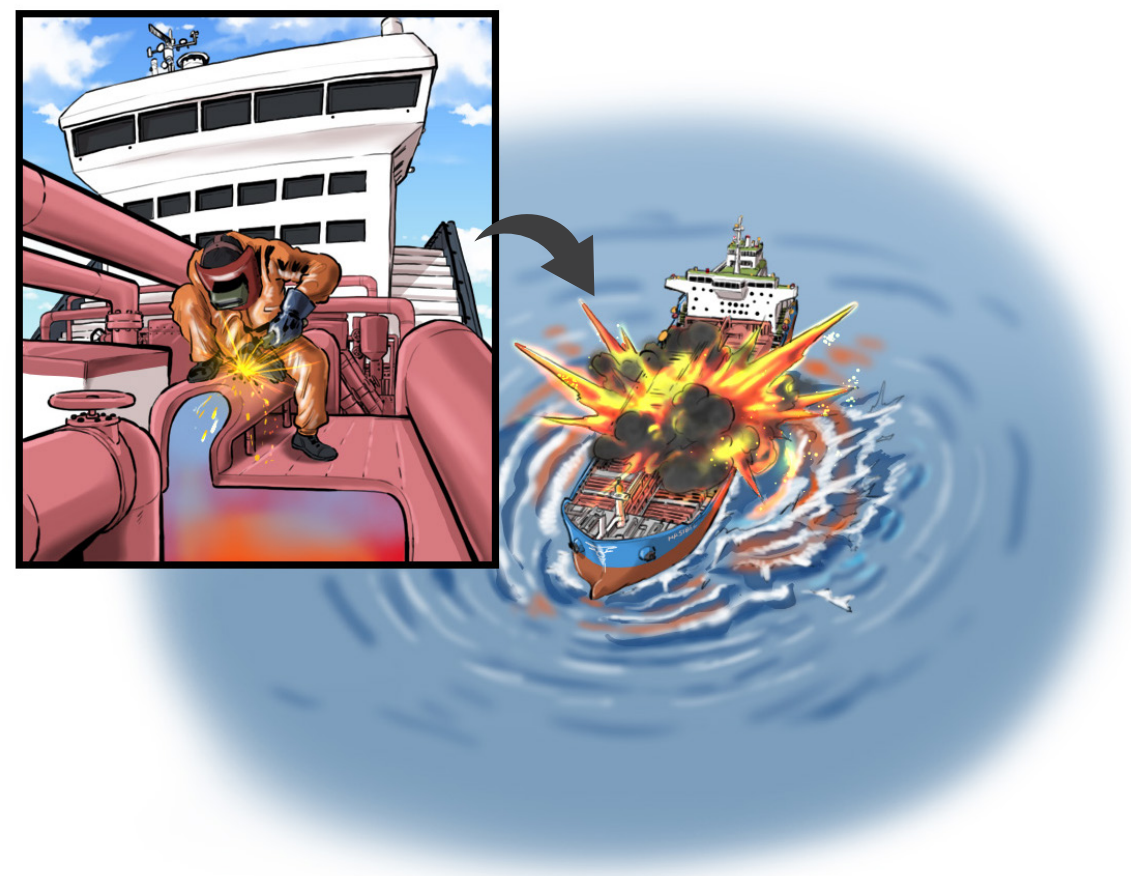
[1. EXPLOSION]

Explosion in tank, causing fatality

- Prior to the commencement of tank cleaning operations, the ship's crew did not flush the cargo tanks and pumps. During the tank cleaning operations, the base oil remaining in the cargo pumps likely sprayed onto the cargo tanks, became airborne in the ventilation duct, and vaporized. This vapour subsequently ignited when welding was conducted on the duct, causing the explosion.

- There was no procedure in the company's safety management system (SMS) to ensure that tanks were flushed to remove previous cargo contents prior to tank cleaning.

- The hot work procedures as per the company's SMS were not complied with. The advice of the second Engineer on the dangers of welding during tank cleaning operations was disregarded, due to the belief that the base oil was a high flash point cargo, that the area to be welded was small and that the job would be over quickly. None of the crew on board stopped the task, although it was deemed to be dangerous considering the tank cleaning operations.

- ✓ Flushing of cargo tanks, etc., prior to tank cleaning should be part of the work procedure when cleaning tanks after unloading petroleum products.
- ✓ Crew members should be instructed to conduct gas-free operations after preparing ventilation lines through which cargo pumps will be ventilated.
- ✓ Hot work procedures must be properly followed to ensure the safety of the ship and its crew.
- ✓ No task should be allowed to continue if Risk Assessments have not been properly conducted with a view to minimise the risk.
- ✓ When a crew member becomes cognizant of an unsafe condition, act, error, or omission or a lack of understanding that could result in an undesired result, the crew member must take measures to stop work together with the master and safety officer, if time is available, or independently if time is unavailable.

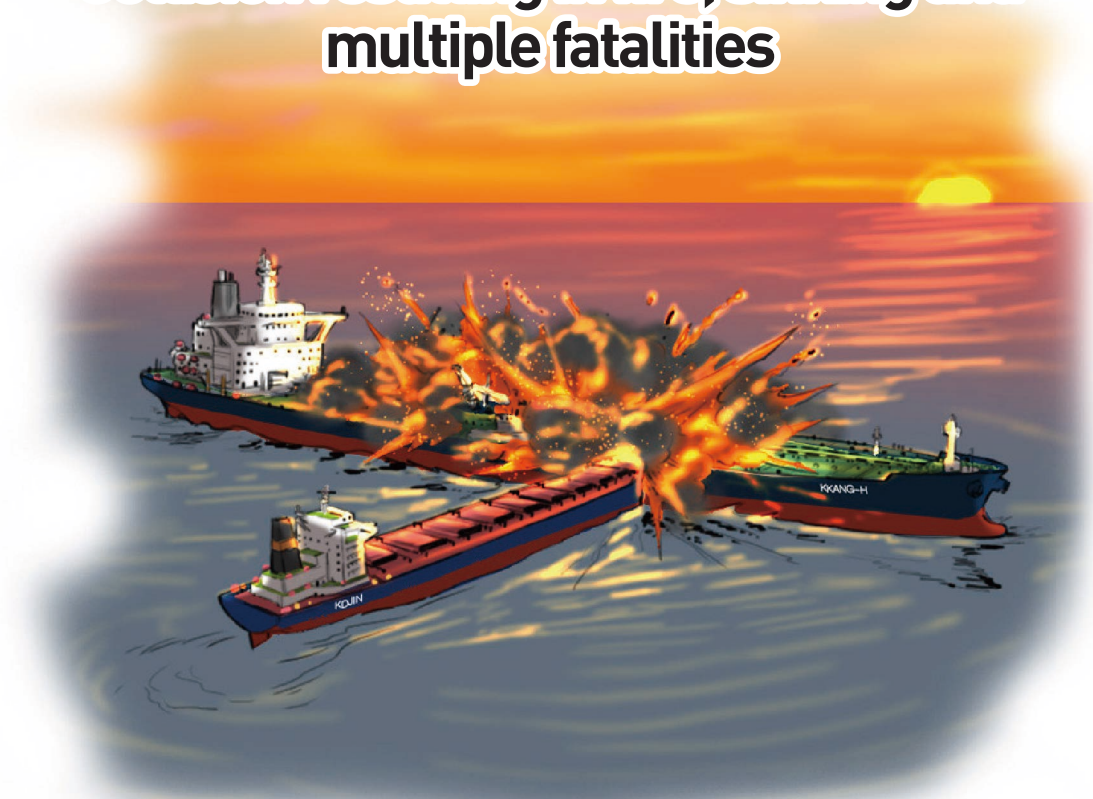
[2. COLLISION]

Collision resulting in fire, sinking and multiple fatalities

- The oil tanker's watchkeeping officer perceived the bulk carrier as a small vessel and appears to have believed that smaller vessels were to give way to big vessels like the oil tanker. The officer did not take action when the lookout advised him to do so.

- The bulk carrier's watchkeeping personnel had not noticed the oil tanker's presence up until the time of collision, nor the flashing signals given by the oil tanker, and they relied on the AIS as the sole means of collision avoidance. There were inadequacies in the bridge watch handover procedures on the bulk carrier.

- Neither vessel complied with the requirements of Rule 5 of the COLREGS to maintain a proper look-out by sight and hearing as well as by all available means appropriate in the prevailing circumstances and conditions and did not make a full appraisal of the situation and of the risk of collision. Both vessels failed to comply with the requirements of Rule 7 of the COLREGS to use all available means appropriate to the prevailing circumstances and conditions to determine if risk of collision exists.

- Alteration of bulk carrier's course to starboard, which started 15 minutes prior to the collision, developed the situation into a collision, which would have otherwise been clear. There was also a non-compliance with other COLREGS, i.e. Rule 16 (Actions by give-way vessel – by the oil tanker), Rule 17 (Actions by Stand-on vessel) when the two vessels were in a crossing situation.

- ✓ All vessels must use all available means to assess risk of collision and take appropriate collision avoidance actions as required by COLREGS.
- ✓ AIS alone should not be used for assessing risk of collision. Proper use of radar equipment for systematic observation is important to avoid decision-making based on assumptions and scanty information.
- ✓ Safety of navigation should be the primary responsibility of watchkeeping officers to ensure the safety of vessels under their charge while taking into account surrounding traffic conditions.
- ✓ Companies should encourage a lower authority gradient to allow crew to speak up and raise concerns when information or advice is disregarded by higherranking officers.

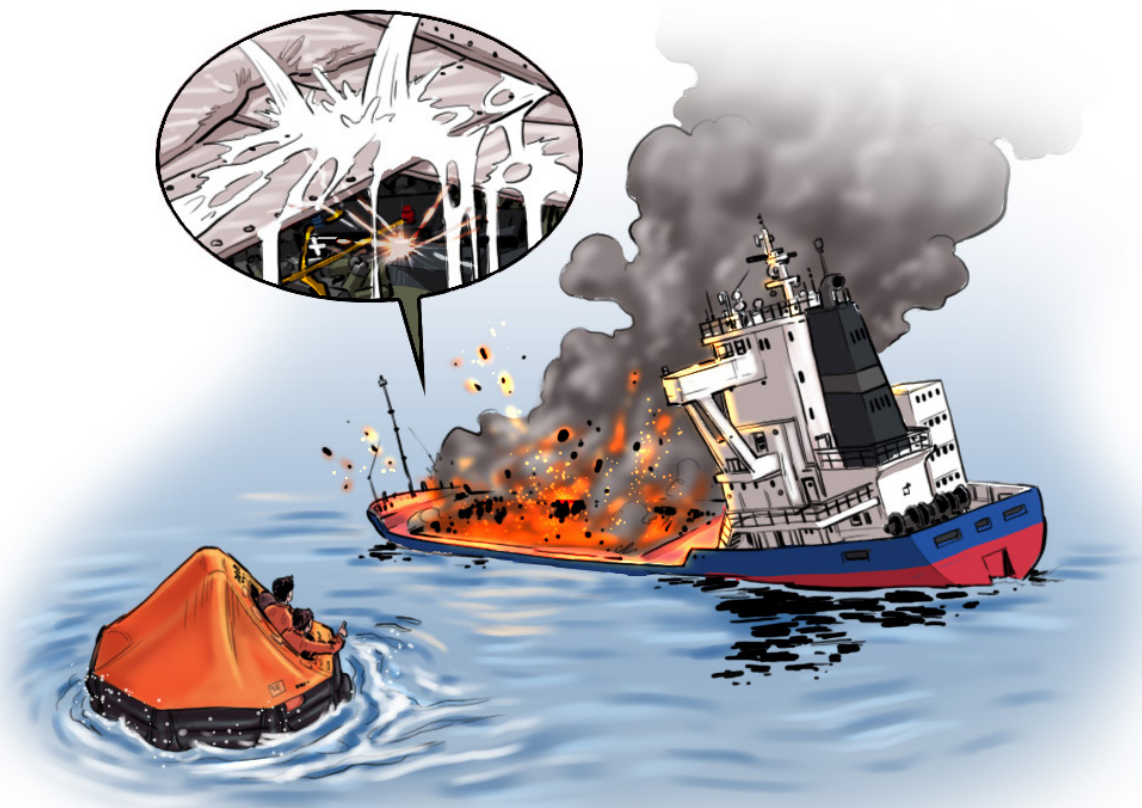
[3. FIRE]

Fire in a cargo hold and total loss

- A fire that broke out in the scrap loaded into the aft cargo hold spread because fire-fighting by water-spraying was ineffective and appropriate fire-fighting methods using the vessel's carbon dioxide fire-extinguishing system were not employed.
- The master did not think of using the carbon dioxide fire-extinguishing system. He did not have experience of fire drills for a fire in the vessel's cargo holds and information was not shared between the vessel and the shipowner regarding effective fire-fighting methods.
- The sprayed water was blocked by the scrap's surface layer and did not reach the fire's origin. It is fairly likely that a spark created by contact between metal objects, a battery, or similar was the source of the fire, and that the source ignited combustible material.

- ✓ Masters shall build a thorough system for appropriate and efficient fire-fighting in case of fire in consultation with the stevedoring company by considering and determining appropriate fire-fighting methods in accordance with the cargo's characteristics beforehand and by conveying this information to the stevedoring company.

- ✓ Masters shall pay full attention to the following points regarding fire-fighting methods for fires within piled scrap:
 - Fire-fighting by water-spraying may not be effective because the sprayed water can be blocked by the scrap surface layer and not reach the fire's origin.

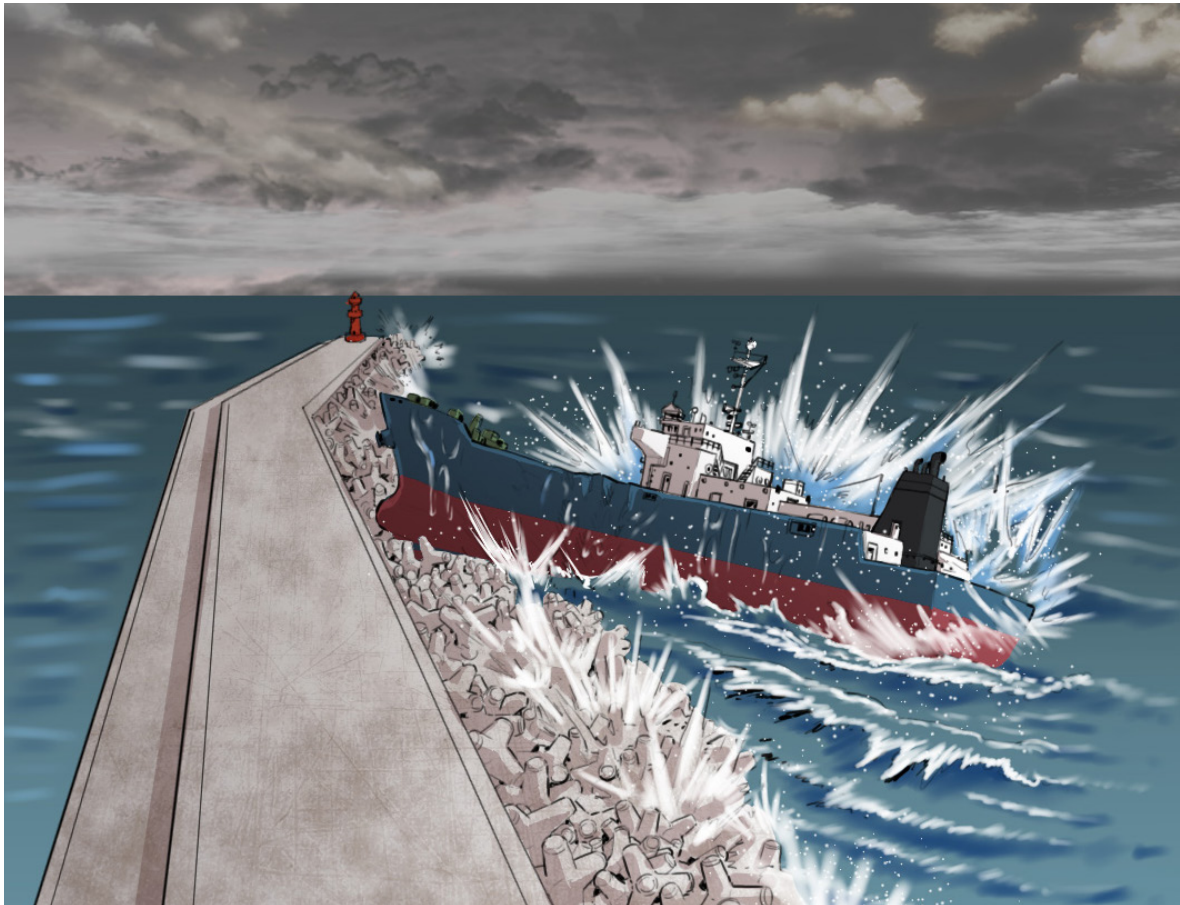
[4. GROUNDING]

Grounding and total loss

- The vessel drifted within the port because her mooring ropes broke and, although she attempted to head out of the port using her engine, she was subsequently subjected to wind and waves, ship manoeuvring became difficult, and she drifted and ran aground on wave dissipating blocks.
- She was subjected to wind and waves that expedited the hull's motion, as she was using mooring ropes with reduced strength due to fatigue degradation and age degradation, and consequently the load applied to the mooring ropes exceeded their strength.
- Although he added mooring ropes, the master's use of multiple mooring ropes of different diameters together and mooring of the ship with ropes made slack contributed to the breaking of the mooring ropes.

- ✓ For the use of mooring ropes, masters must conduct appropriate maintenance inspections, must not use ropes that have lost strength from degradation, and must not use ropes of different diameters together.

- ✓ Regarding the berth mooring method in heavy weather, masters must appropriately add mooring ropes so that load is distributed evenly.
- ✓ When heavy weather attributable to a typhoon or other phenomenon is predicted, masters must:

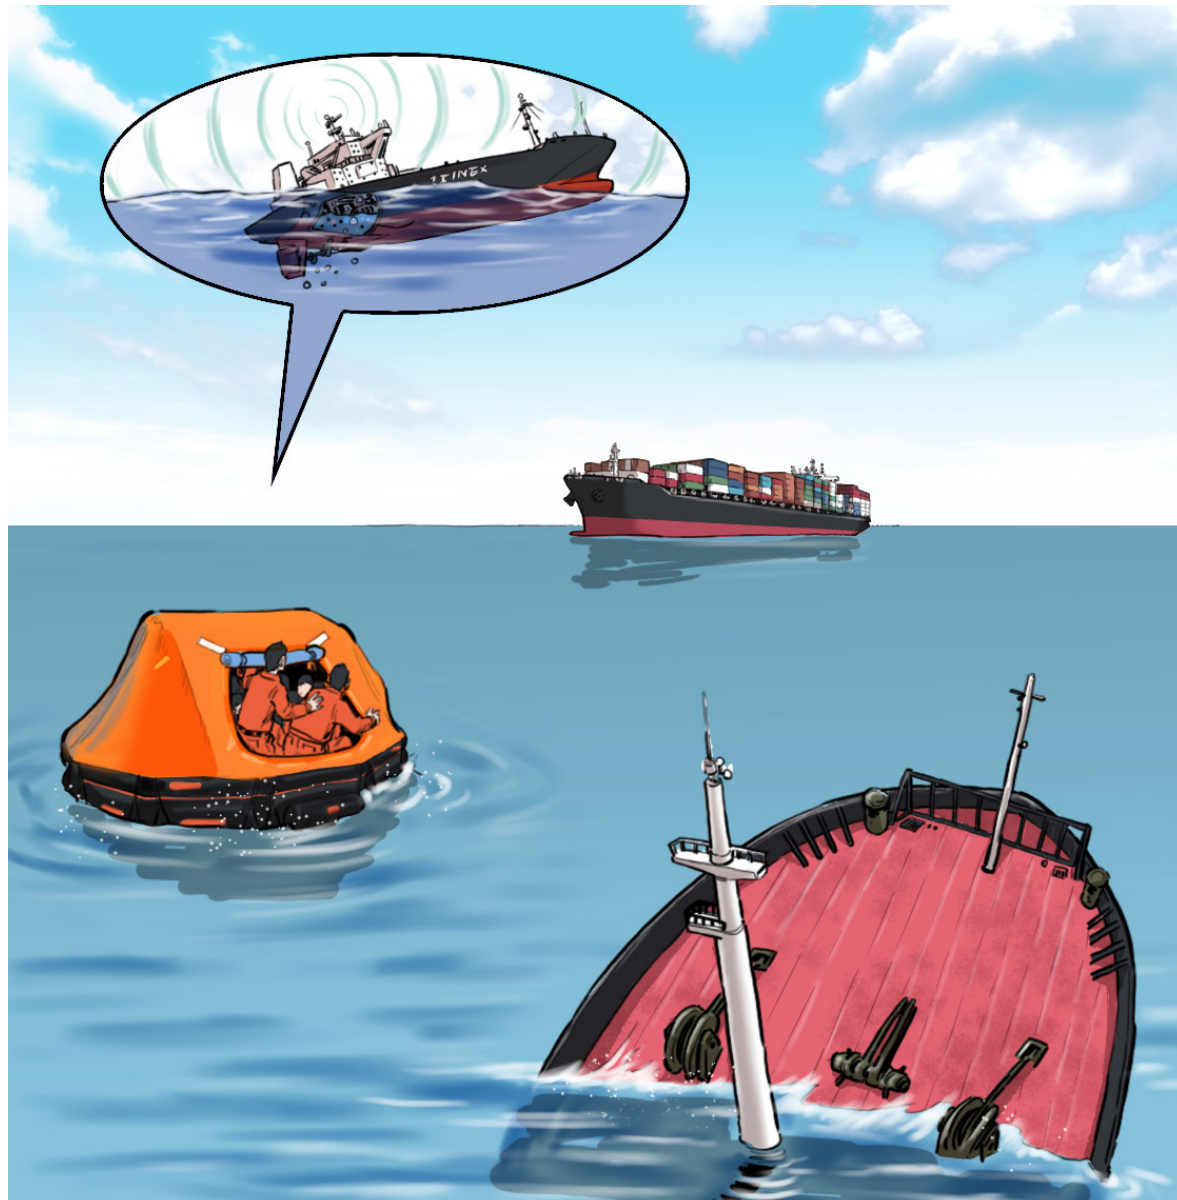
[5. FLOODING AND FOUNDERING]

Engine-room flooding and foundering

- However, considering the age of the vessel, it was postulated that corrosion, decay and failure in the sea water pipelines may have been contributory to the flooding.

- The Duty Engineer was working in the engine-room workshop when he received the bilge water alarm. He acknowledged the alarm, but he did not immediately investigate the source of the bilge water alarm. Later, when realising that the bilge alarm light had kept blinking, he went down to check the engine-room bilges, joined by the Chief Engineer.

- They were however not able to identify the source of the flooding, as the water level had risen above the engine floor plate. At this level, it was also impossible to start the bilge pump. To prevent damage, the Chief Engineer stopped the main engine, went up to the bridge, and apprised the Master of the situation in the engine-room.

- ✓ Pay particular attention to mechanical, structural or material failure due to the ship's age. Particular attention should be given to the seawater pipelines in older ships due to the higher probability of developing corrosion, decay and failure which could contribute to flooding.

- ✓ Keep effective engine-room watch and control. The Duty Engineer should not be distracted from performing his main engine watchkeeping duty. When he first received the alarm, the Duty Engineer was in the engine-room workshop. Immediate and prompt action at the first instance in identifying the source of the flooding would have provided sufficient time for mitigation actions to be taken.

- ✓ The importance of conducting regular and periodic training and drills. Had regular and periodic training and drills been done on board, the Master would have rung the general alarm and would have given instruction to close the water-tight compartments. The Master would also have ordered the launching of the 16-person life raft instead of the six-person rescue boat for the 10 crew members to abandon ship. The crew too would have been drilled to close the water-tight compartments, and to assemble at the Muster Point with their life jackets appropriately worn. Ringing the general alarm would also have made the crew more aware of the situation and the closing of the water-tight compartments would have slowed down the rate of sinking.

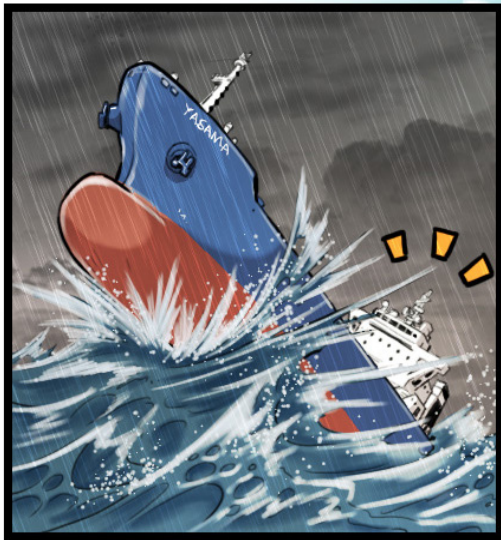
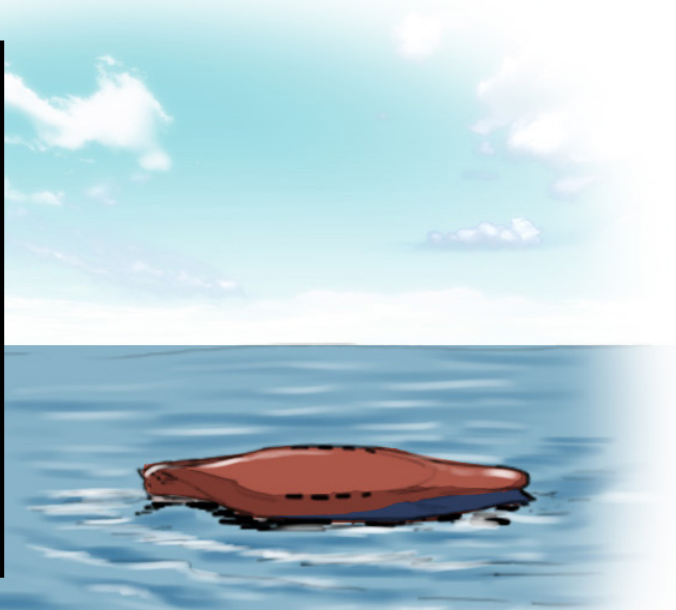
[6. CAPSIZE AND SINKING]

Capsize and sinking with loss of lives

- Although there is insufficient evidence to determine the cement carrier's exact stability condition at the time of the capsizing, there were shortcomings in its stability management. The ship was found to have been loaded improperly, not in accordance with procedures for loading cement cargoes, potentially increasing its vulnerability to capsize.

- The investigation found that the ship capsized when it encountered violent storm conditions created by a strong tidal stream and opposing gale force winds. This combination of factors created treacherous sea conditions that were impassable to small vessels. The ship had slowed down to reduce the effect of pitching and pounding in the heavy seas, but this had led to the loss of steerage control and probable capsize to port.

- The capsizing itself was likely exacerbated by a shift in the cement cargo when the ship heeled beyond 30°.
- Such extremely violent storm conditions were predictable and are commonly experienced. The onboard decision to enter the Pentland Firth was a result of insufficient passage planning and underestimation of the sea conditions.

- ✓ Passage planning requires that all hazards are taken into account and avoided; the extraordinarily violent and fatal sea conditions were predictable, well-documented in nautical publications, and could have been avoided.

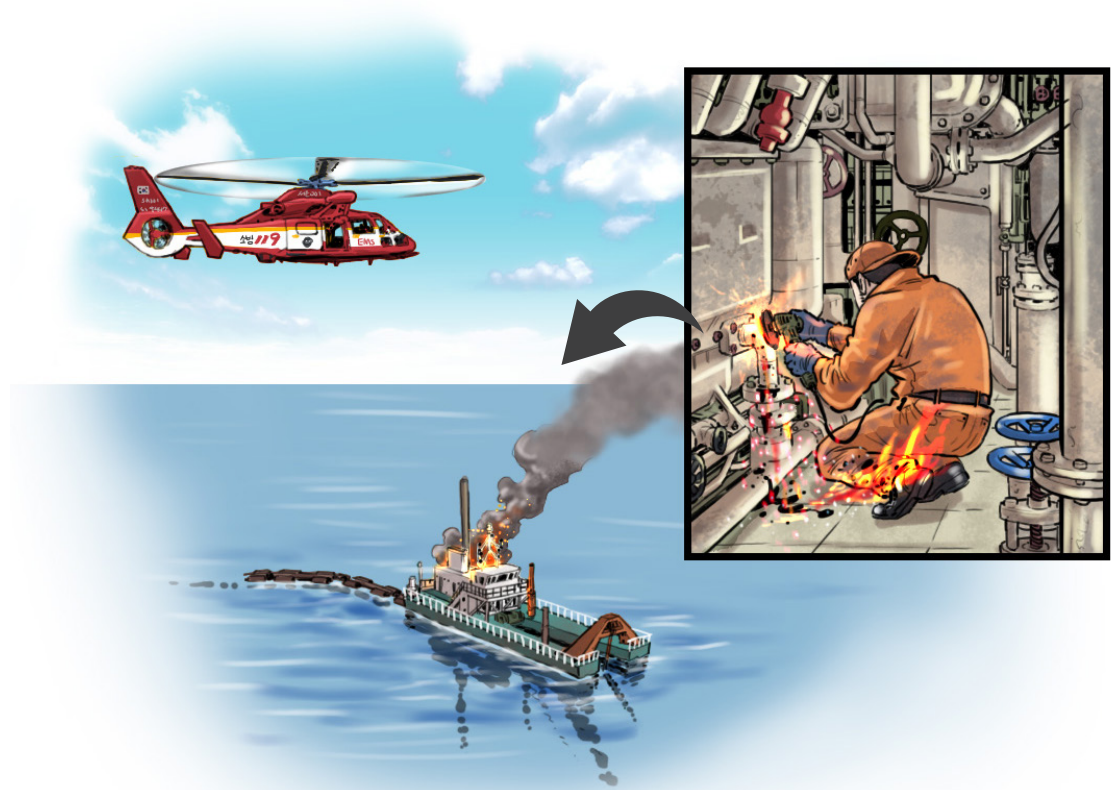
[7. FIRE]

Engine-room fire resulting in one fatality

- The brackets securing the low-pressure fuel lines had loosened in service due to corrosion and vibration, allowing fretting to occur and a hole to develop in a fuel line.

- The flag regulator had not promulgated the IMO circular, which recommends six-monthly inspections of low-pressure fuel lines. The operator's planned maintenance system did not require inspection of low-pressure fuel lines, nor had the generally poor condition of the low-pressure fuel system been detected through the Classification Society surveys.

- The use of an angle grinder was not included in the operator's list of hot-work activity, and consequently a work permit was not routinely issued for any time a portable grinder was used.

- The presence of atomised fuel coupled with the wicking effect of the engineer's diesel-saturated coveralls resulted in an extremely flammable garment susceptible to ignition by sparks from the angle grinder.

- ✓ It is important that surveyors, ship operators and ships' crew routinely inspect low-pressure fuel systems in accordance with IMO guidance to ensure that the systems remain fit for purpose at all times.

- ✓ The high-energy sparks generated by abrasive wheels during grinding and cutting operations (including portable angle grinders) contain sufficient energy to ignite flammable substances, and this should therefore be recognized and treated as hot work activities.

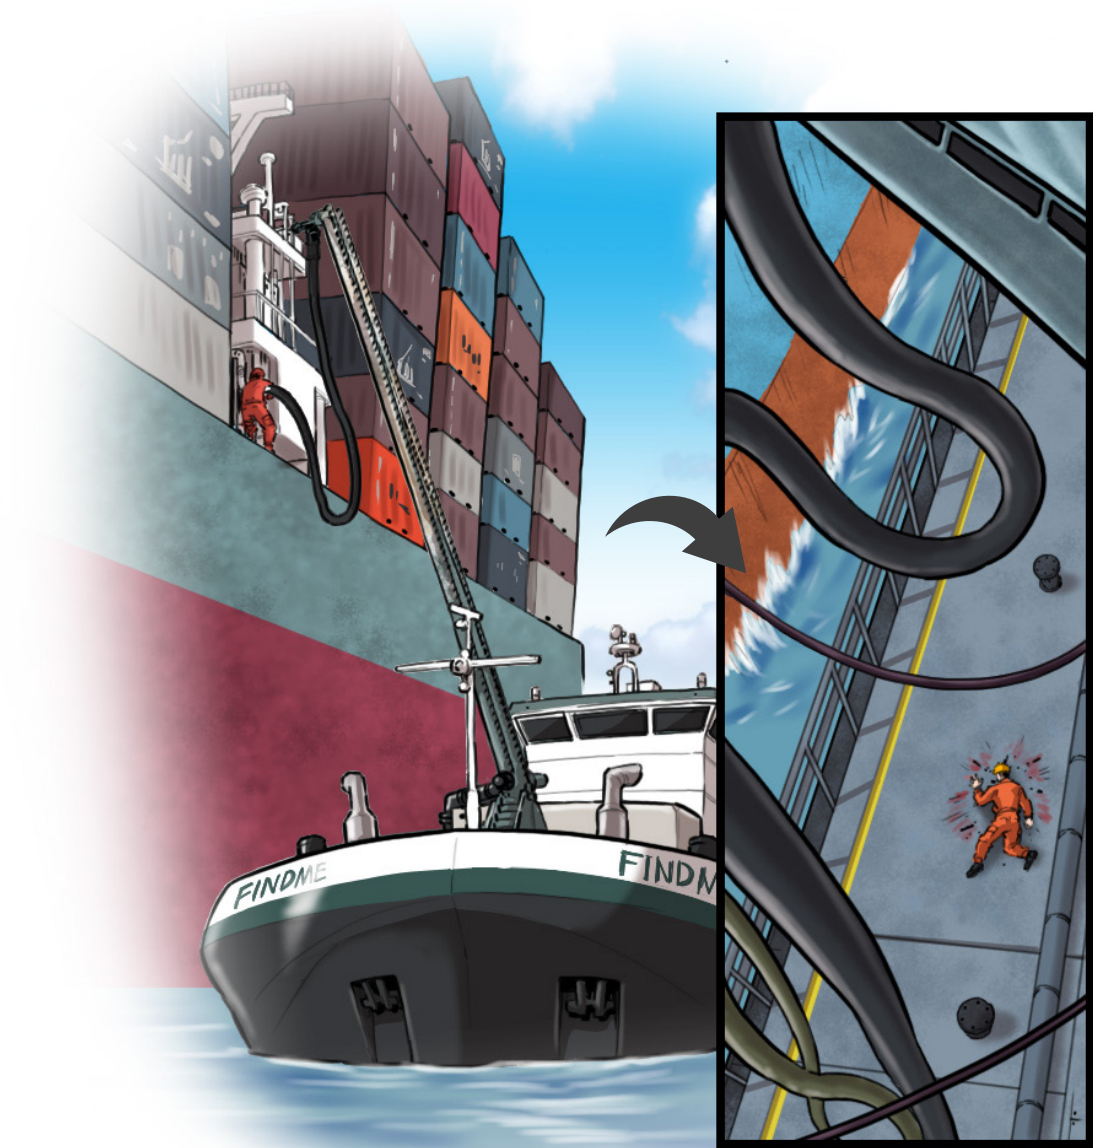
[8. FALL OVERBOARD]

Crew member dies when falling overboard onto bunker barge

- The head of the ship's stores crane, from which the bunker hose was suspended, was positioned out towards the ship's rail instead of directly above the bunker manifold, which resulted in the bunker hose swinging out towards the ship's rail once it had been disconnected.

- ✓ It is important when working with suspended loads to remain vigilant to the factors that will cause the load to shift.
- ✓ A safety line is an effective way of controlling suspended loads that may be liable to shifting unexpectedly.

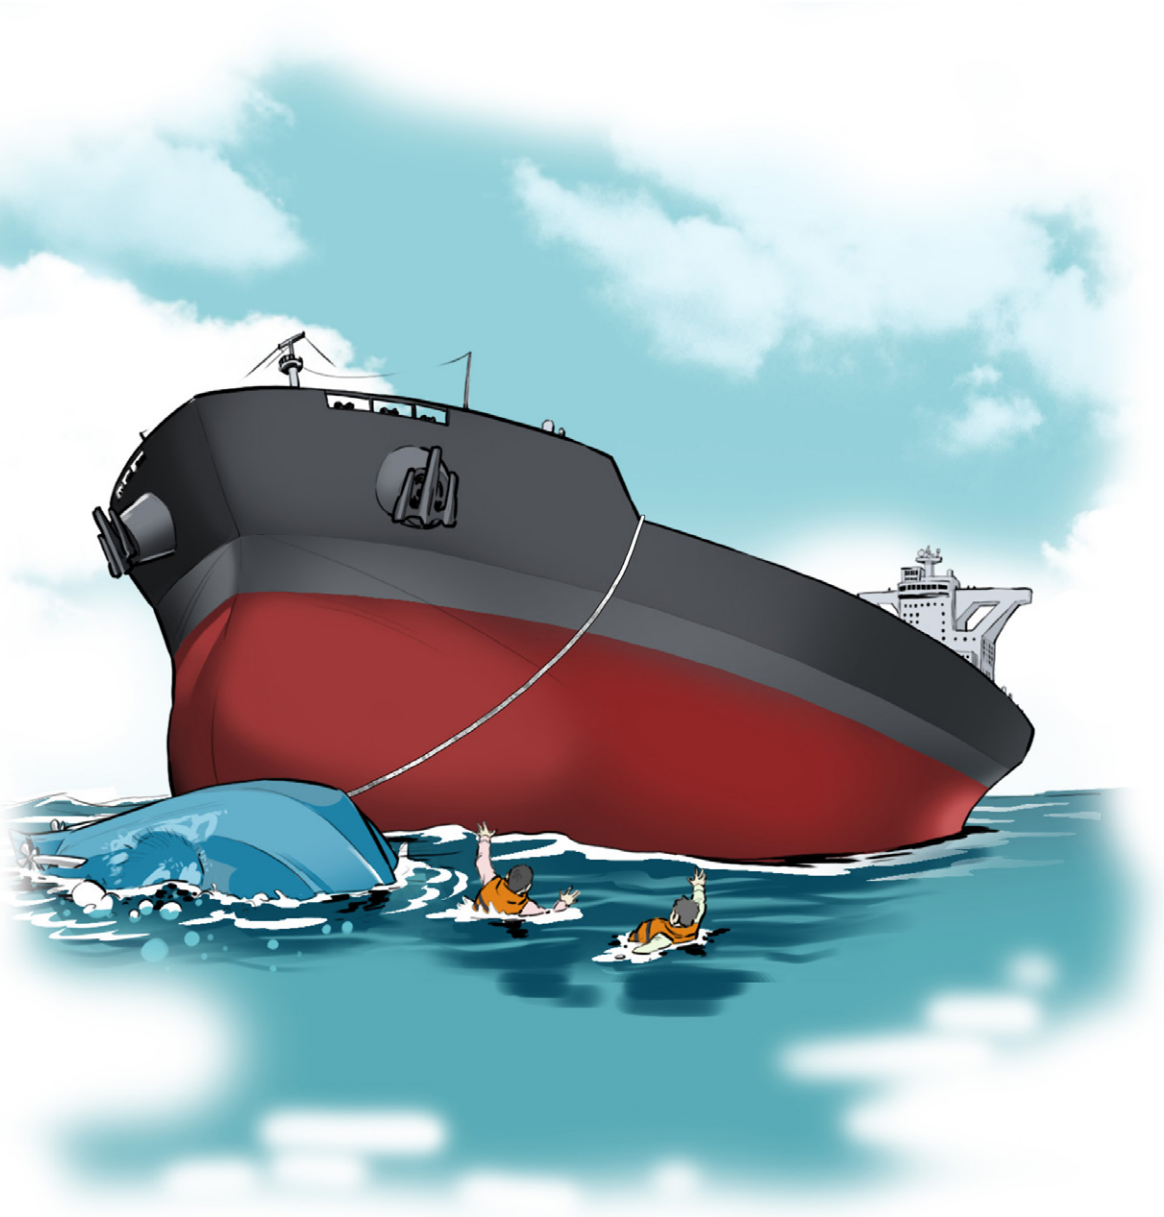
[9. CAPSIZE]

Capsizing due to hull-to hull interaction

- The work boat was manoeuvred in very close to the moving ship to aid the retrieval of the mooring line. In this position, close to the ship's hull, the coxswain of the work boat underestimated the interaction forces acting between the two vessels.

- ✓ Interaction forces between two moving vessels can be sufficiently large to seriously affect the manoeuvrability of either or both vessels. This is particularly important for small vessels when manoeuvring close to a larger vessel, as the forces can quickly cause a dangerous situation to arise.
- ✓ Masters and coxswains of all vessels, including port service vessels and work boats, should be fully aware of and trained in the dangers associated with hull-to-hull interaction.

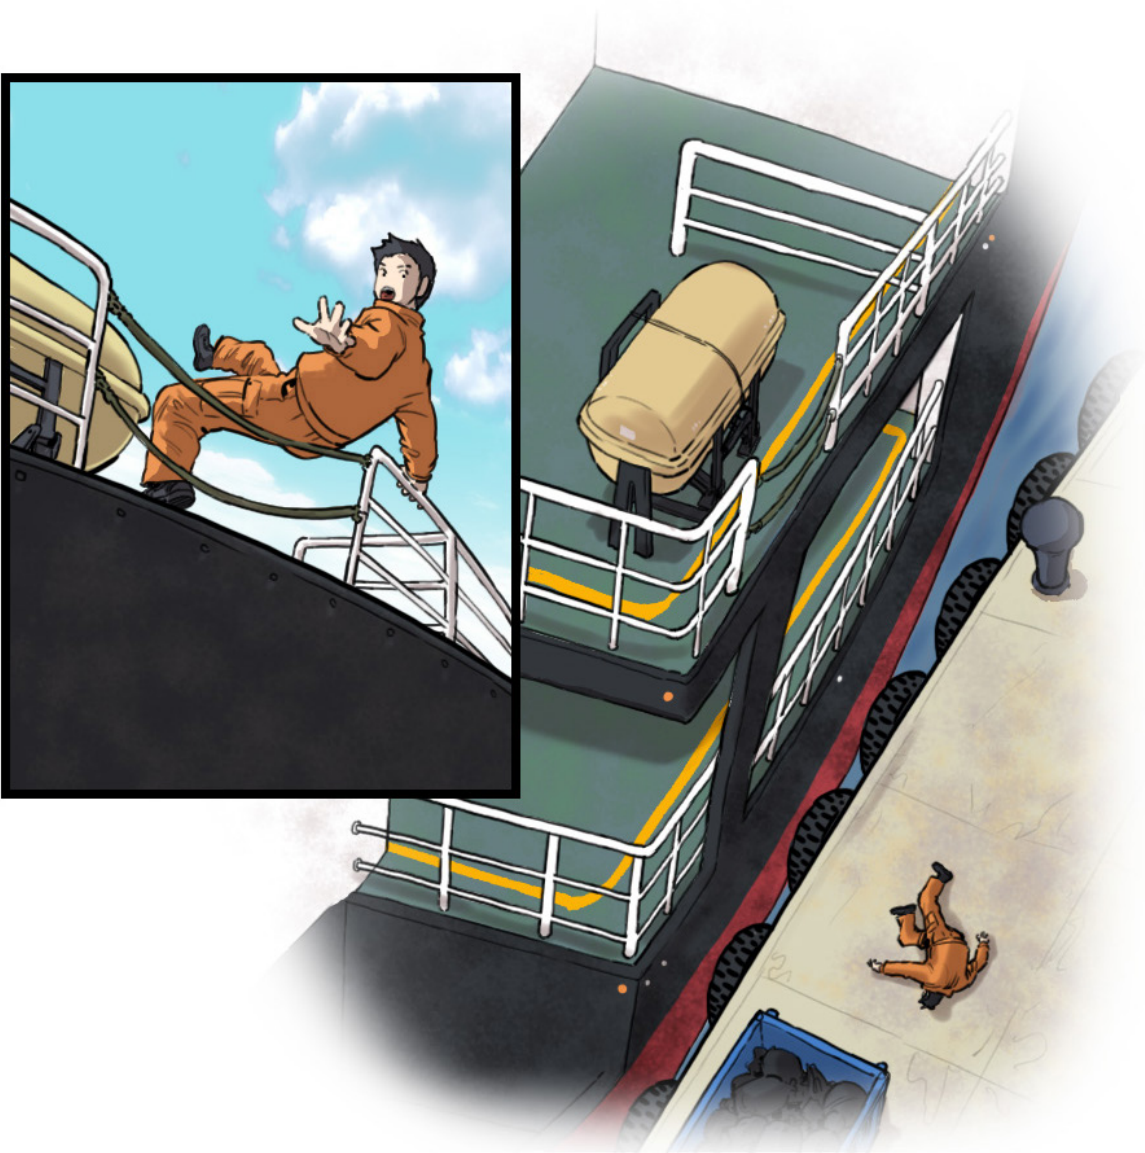
[10. FATALITY]

Crew member falling overboard onto wharf below

- The risks associated with the task had not been sufficiently well assessed and preventative measures to guard against a fall from height were not implemented.
- The chains in place protecting a gap in the handrails were insufficient to provide protection if leant or fallen against. The gap was more than two metres longer than it should have been. This had escaped notice since the ship was built.

- ✓ All shipboard activities should be considered from a risk management perspective.
- ✓ All work near the ship's side needs to be assessed in regard to the dangers of falling from height. This accident highlights how flexible barriers such as chains may be insufficient to prevent or arrest a fall.
- ✓ The risks involved in seemingly routine tasks can be perceived to be lower when the tasks are undertaken with a degree of autonomy, freedom of choice and are thought to be within one's own control. A positive illusion of control is established where the risk is underestimated and a person is therefore more willing to accept the risk and exposure to hazards.

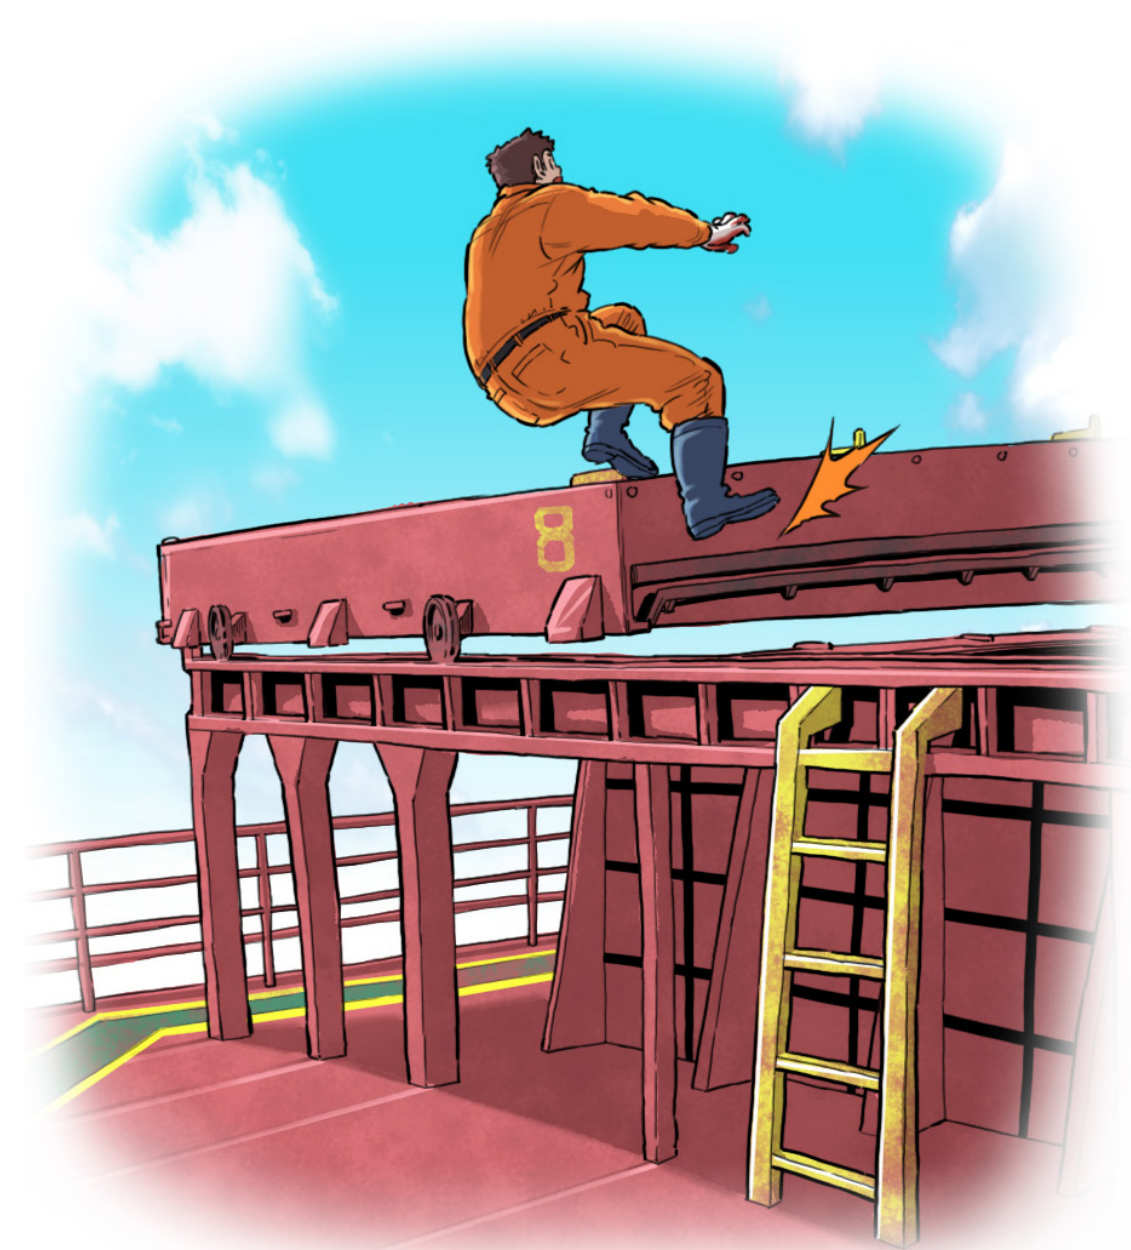
[11. FALL FROM HEIGHT]

- Of the six cases that were examined, five cases occurred on dry bulk carriers and one on a dry cargo vessel. Four cases occurred whilst cleaning a cargo hold, one occurred whilst work was done with a wire rope on a crane grab and one was a fall down a crane trunk. In one case, a permit to work aloft was issued, in one case it was not, and in another there was no risk assessment made.

- In three cases, the report concluded that the crew member was cleaning the cargo hold at the time of the accident. In all three cases, the crew member either slipped or lost their balance and fell after releasing the safety harness or safety line as they transferred from one point to another. There is also evidence that in all three cases, the crew member's perception of risk was low and they felt in control when they released their safety harness or safety lines at relatively low height. Heights ranged from 4 metres down to as low as 1 metre. In all three cases, the crew were using portable ladders and in 2 of the 3 cases they were transferring from one ladder to another when they released their safety harness.

- ✓ The use of portable ladders when working at height should where possible be avoided and other means of access be considered.
- ✓ There is a risk that crew members working at relatively low height can perceive the risk to be acceptable.
- ✓ Safety harnesses and safety lines should be released only after crewmembers are safely on the ground.
- ✓ Two lanyard harness is an effective tool to mitigate the risk of a fall from height if there is a need to unclip a safety harness when moving from one point to another.

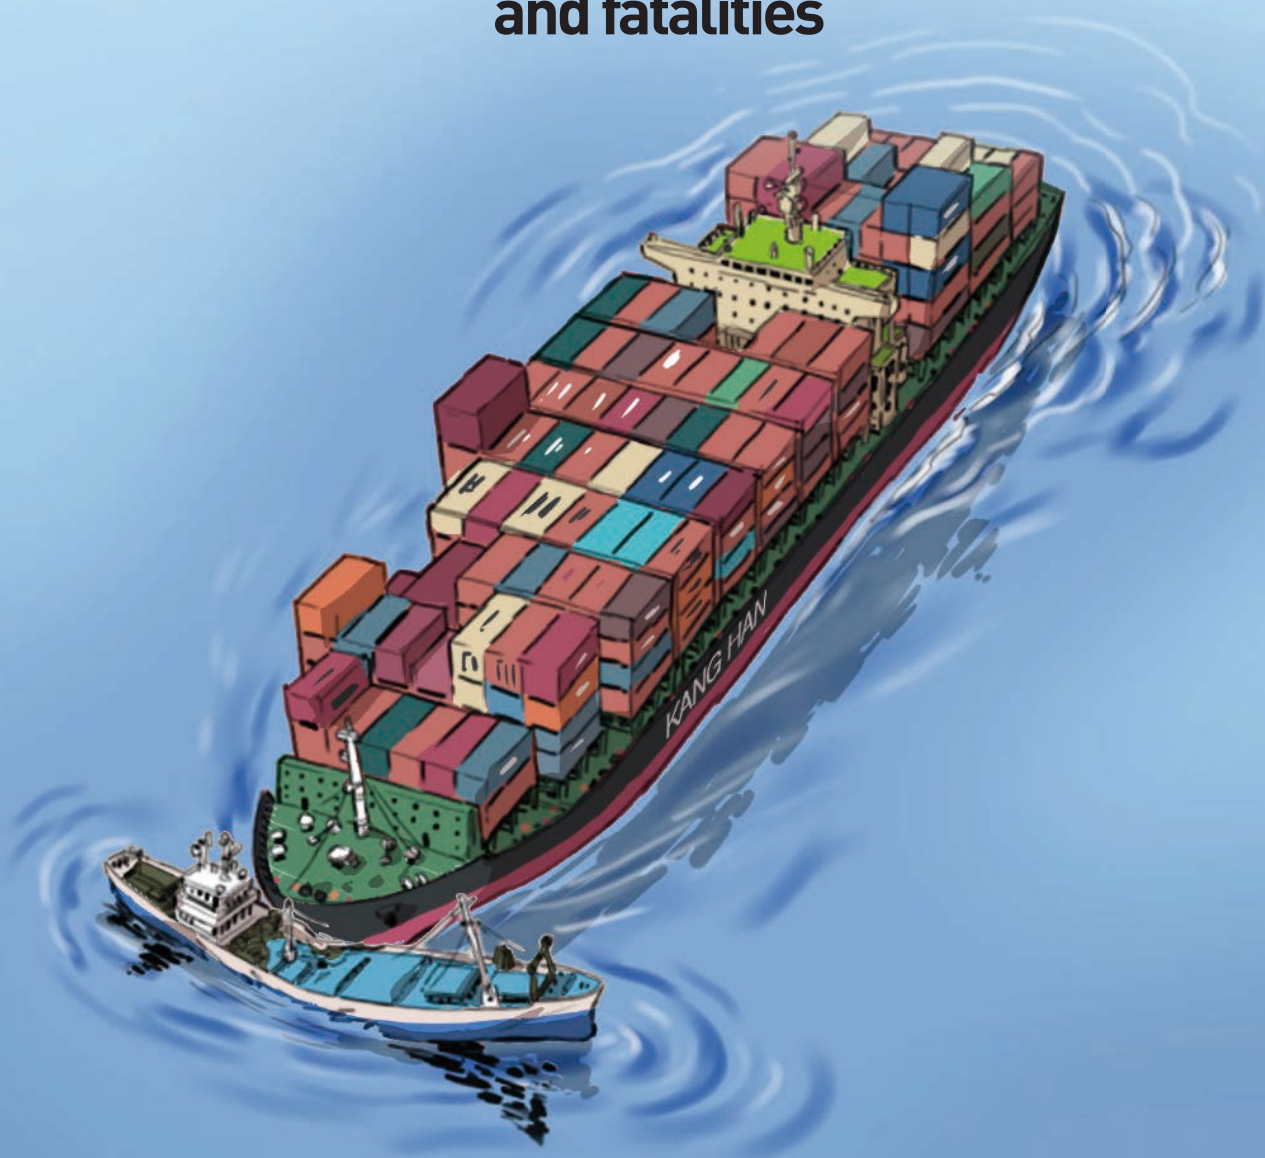
[12. COLLISION WITH FISHING VESSELS]

Collision between merchant ships and fishing vessels resulting foundering and fatalities

- In two cases, the officer of the watch of the merchant ship did not identify they were on a collision course with the fishing vessel while in the other four cases vessels were identified visually, by radar or using AIS, but sufficient action was not taken to avoid a collision. Bad weather and darkness were contributing factors in half of the cases. Inadequate use of electronic navigation aids was also evident in some cases.

- ✓ It is vital officers of the watch maintain a proper lookout using all available means to identify other vessels and determine if they may be on a collision course. Officers must be familiar with their bridge equipment and employ sensible CPA limits.
- ✓ Where a vessel is detected, sufficient early action should be taken when the vessel is the give way vessel. If determined to be the stand-on vessel officers of the watch must remain ready to take avoiding action to prevent a collision as required under the COLREGS. If in doubt, never hesitate to call the master.
- ✓ If an officer of the watch suspects a collision may have occurred, every effort must be made to establish all vessels are safe and render any assistance that may be required.
