# 2017년도 주요 해외 해양사고 교훈사례집

해양수산부  
중앙해양안전심판원

## 2017년도 주요 해외 해양사고 교훈사례

IMO 협약이행 전문위원회  
4차, 2017년

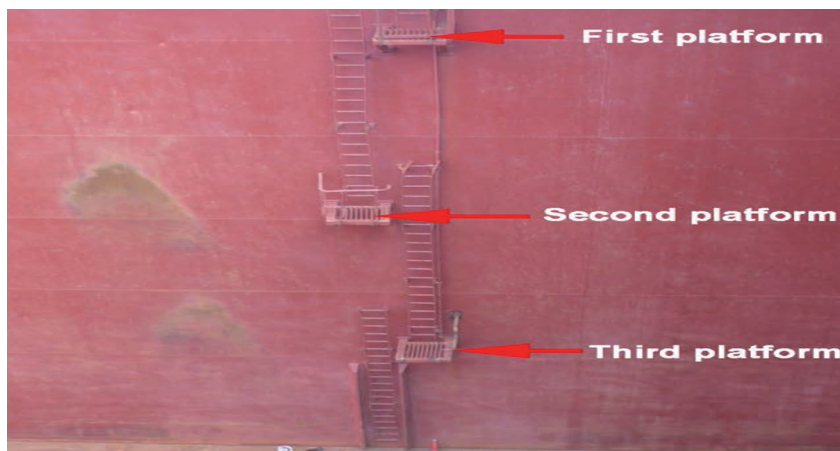
- 보호난간이 없는 상태이었기에 선원을 보호할 수 없었고 플랫폼에는 수리용 장비들이 어지럽게 널려 있어 선원이 작업하기에 복잡하고 위험한 장소였다.
- 플랫폼 위쪽의 약 1미터 지점에 할로겐 등이 설치되어 있었다. 이 등 역시 선원이 작업하는 데 장애물로 작용했다.
- 선내작업절차에 따라 이 선원은 작업 시 안전장비를 사용해야 했으나 사고 당시 장비를 착용하고 있지 않았다. 안전장비를 착용하고 이 장비를 안전한 지점에 연결했더라면 추락을 방지할 수 있었을 것이다.

Figure 1.2 Number five cargo hold ladder : note that the handrails have been removed from around the third platform 출처 Investigation report(ATSB)

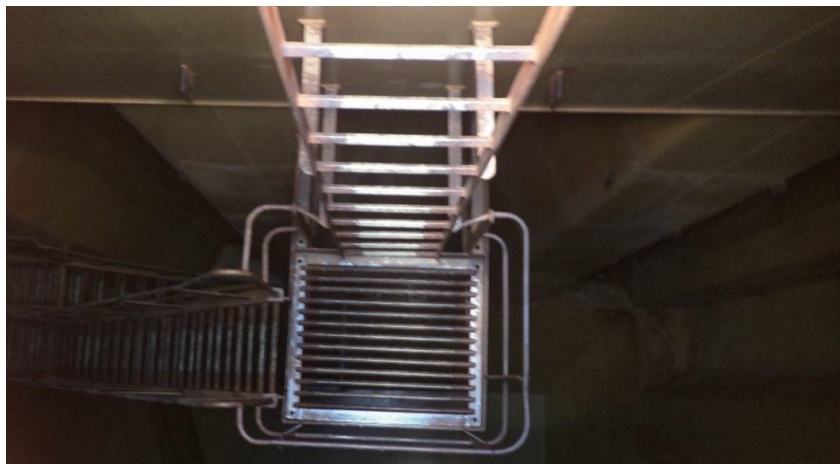
- 사고 당시, 갑판과 화물유탱크 내부의 주위 온도가 각각 33도, 37도 정도 되었다. 공무감독은 오후에 기온이 상승한 상황에서 4번 우현 측 화물유탱크에 진입하는 동안 일사병으로 인해 수직사다리를 놓쳤을 가능성이 있다.
- 수직사다리에 가드링(guard rings)이 없어 사다리를 놓친 후 옆으로 추락하는 것을 막지 못했다.

Figure 3.2 Access ladder inside 4S COT 출처 Investigation report(HKSAR, The Hong Kong Special Administrative Region)

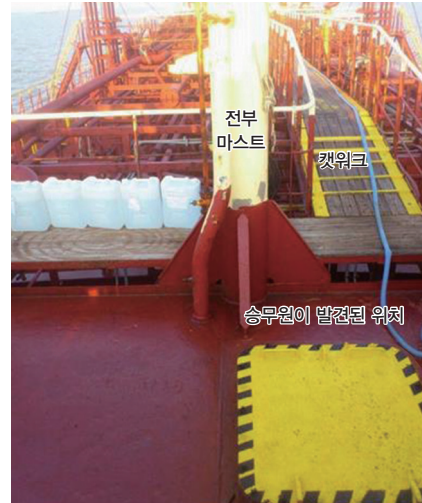
Figure 4.3 Location where the crew member was found 출처 Investigation report(HKSAR)

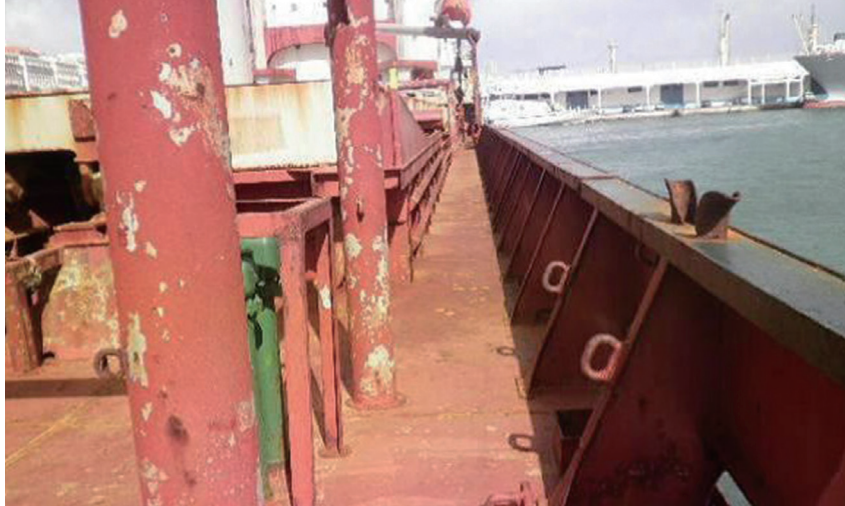
- 악천후 상황에서 폭풍우를 피해 히브투 항법으로 항해하거나 안전수역으로 대피하지 않고 선박을 정박시켰다.
- 악천후 상황에서 선원들을 갑판에 내보냈다.
- 선장뿐만 아니라 갑판에 나간 1등항해사 및 다른 선원들도 악천후 상황에서 갑판에 나가는 것이 얼마나 위험한 것인지에 대해 충분히 생각하지 않았다.

Figure 5.2 View on main deck in way of the hold No.2 출처 Investigation report(Panama Maritime Authority)

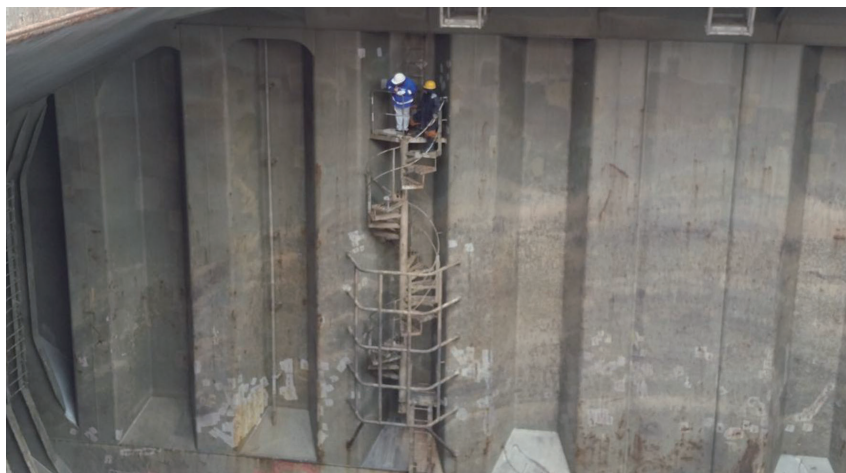
Figure 7.2 Inside 3-cargo hold 출처 Investigation report(Panama Maritime Authority)

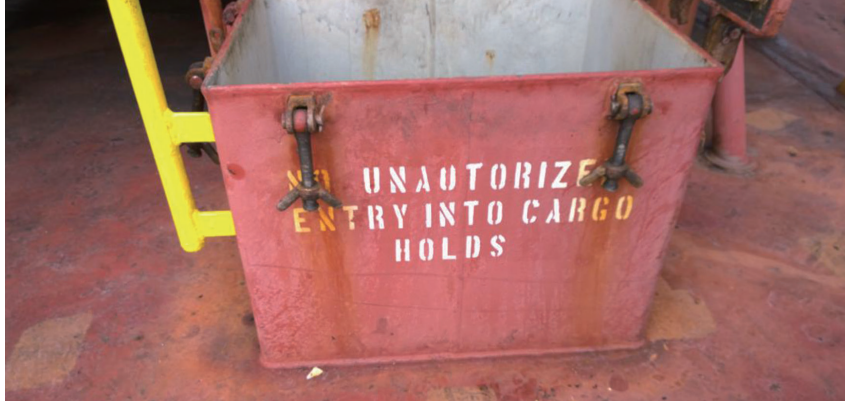
- 화물창 진입 덮개에 “No Unauthorized entry into cargo hold” 표시가 되어 있음에도 갑판장은 조타수에게 화물창에 들어가라는 지시를 했고, 선원들 중 항해사에게 동일한 지시를 받은 사람은 없었다.
- 조타수는 화물창에 들어가라는 지시를 받았을 때 안전한 진입을 위한 어떠한 의무적인 안전조치도 취하지 않았다.
- 갑판장, 조타수(AB2) 및 갑판원(OS1) 세 사람 모두 우선적으로 어떠한 안전조치도 취하지 않고 의식을 잃고 쓰러져있는 조타수를 도와주기 위해 화물창에 진입했다.

Figure 7.3 Manway Access to Cargo Hold No.3 출처 Investigation report(Panama Maritime Authority)

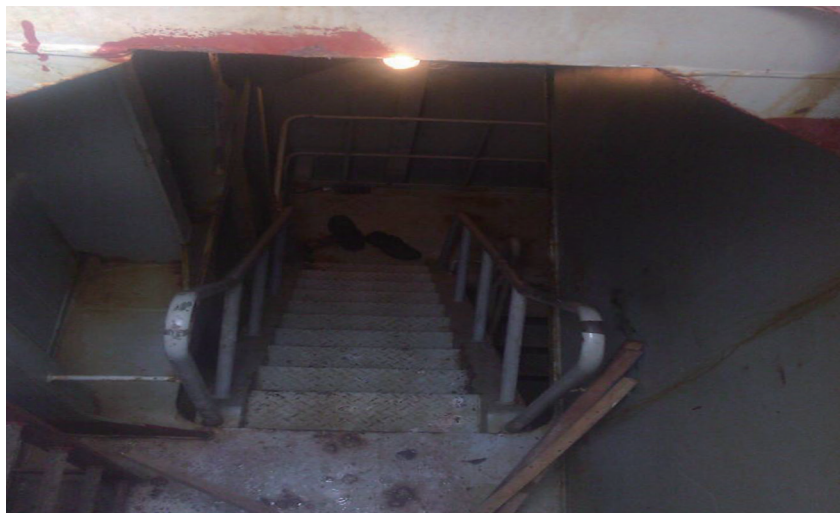
- 기존에 마련되어 있던 운항절차서에는 목재화물 운반과 산소결핍으로 인한 위험에 관한 사항이 포함되어 있지 않았다.
- 화물창접근 덮개 내·외부 어디에도 경고문이 게시되어 있지 않았다.
- 안전관리시스템상 필수적인 선박 업무인 밀폐구역 진입절차가 상세히 명시되어 있지 않았다.
- 동료를 구하고자 하는 본능 때문에 기관장과 2등항해사는 본인들의 안전을 위한 적절한 예방조치 없이 위험한 공간에 들어갔다.

Figure 8.2 No.3 Cargo Hatch View from top looking down onto platform 2 at base of stairway  
출처 Investigation report(Isle of Man Ship Registry)

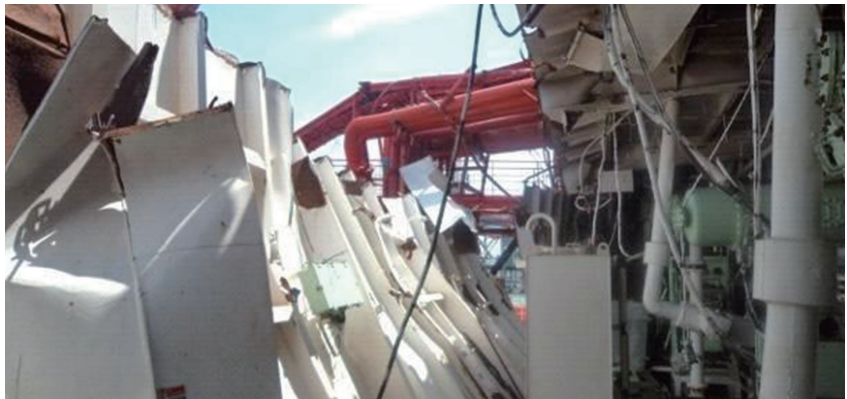
Figure 9.2 Out Side cargo compressor Room 출처 Investigation report(Panama Maritime Authority)

- 어떠한 상황에서도 선원들은 수리작업을 진행하기 위해 화물가스를 배출하려고 해서는 안 된다. 화물 라인을 변경할 경우에는 언제든지 관련 행정기관과 선급협회의 승인을 받아야 한다.
- 이번 인명사고를 초래한 관행은 어떠한 상황에서도 용인되어서는 안되며, 산소아세틸렌 등의 재래식 방법의 불꽃절단 방식은 보편적이지만 항상 능숙한 작업자가 진행하고 “작업허가”를 받아야 한다. 그렇게 해도 역화의 위험은 항상 존재한다. 영국 보건 안전청(Health and Safety Executive)은 발행물 INDG297(개정 1판)에서 다음과 같이 조언하고 있다. “역화는 보통 산소가 연료가스 호스로(또는 연료가 산소호스로) 거꾸로 흘러 들어가 호스 내부에 폭발성 혼합물이 생성되어 발생한다. 그러면 불꽃이 토치를 통해 호스 안으로 연소되어 들어가고, 심지어 조절기와 실린더에까지 이를 수 있다. 역화로 장비가 손상되거나 부서질 수 있고, 심지어 실린더가 폭발할 수도 있다.
- 올바른 점화절차를 사용한다. 혹시라도 있을 수 있는 폭발성 가스혼합물을 제거하기 위해 토치에 점화하기 전에 호스를 퍼지(purge) 시킨다.
- 분출관(blowpipe)은 스프링이 달린 역류방지 밸브가 있는 것을 사용한다.
- 작업에 맞는 가스압력과 노즐 크기를 사용한다.
- 이러한 조치를 통해 역화의 위험을 줄일 수는 있지만 완전히 제거할 수는 없다. 역화가 일단 발생하면 역류방지 밸브로 중단시킬 수 없다.

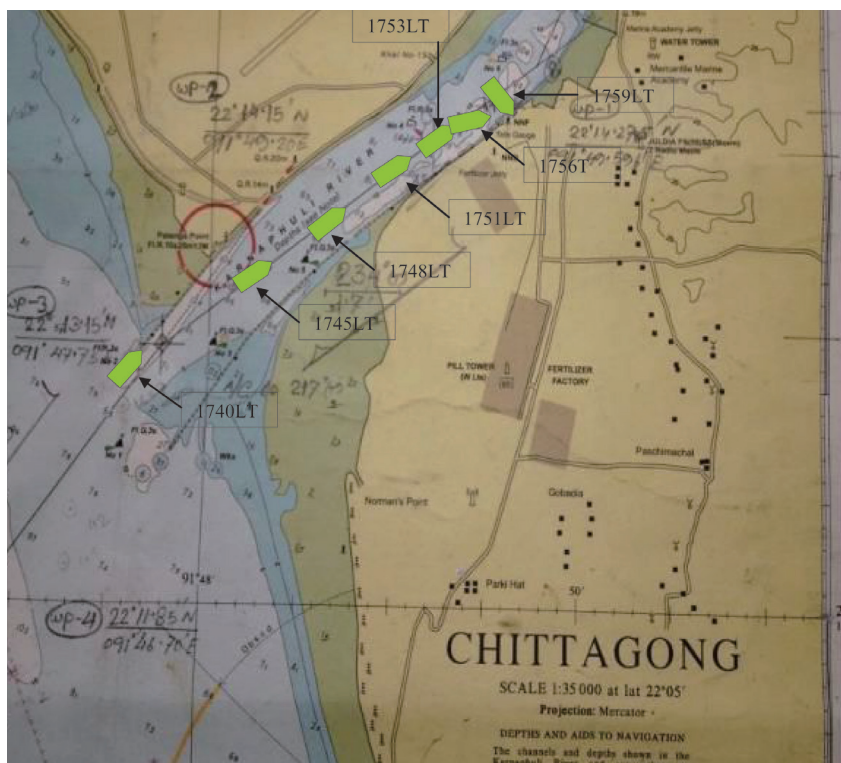
- 벌크선이 선회장에서 방향을 돌리기에는 선속이 너무 빨랐다.
- 기관이 정지된 후, 선속을 줄이기 위해 기관을 후진상태로 두는 것이 지연되었다.
- 선장과 도선사가 선박의 항해계획에 대해 자세히 논의하지 않았고, 선장은 도선사의 의도를 이해하지 못했다.
- 부두에 접안하기 위한 선박의 항해 계획 상 선회장에서의 우회 선회에 대해 고려하지 않았다.
- 도선사가 피로를 느꼈고 건강상태가 좋지 않았다. 피로가 도선사의 업무 능력에 부정적인 영향을 미쳤을 가능성이 있다.

Figure 12.3 Positions of ship and her approximate heading during transit(Collision 1759LT)  
출처 Investigation report(Panama Maritime Authority)

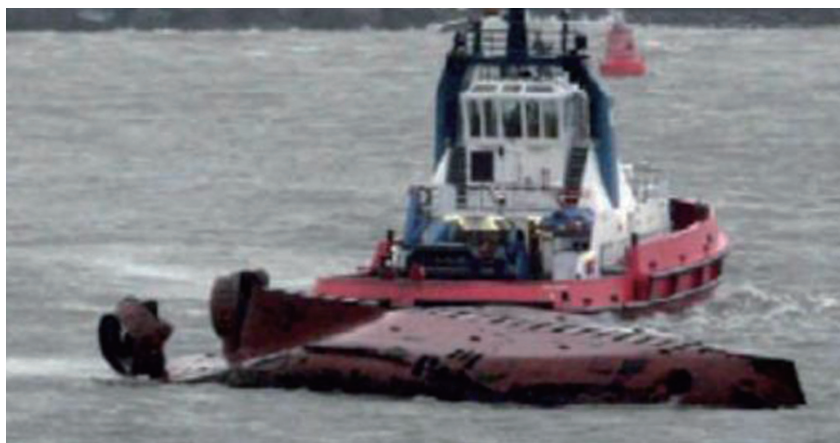
Figure 13.2 The capsized tug 출처 www.tugspotters.com, Investigation report(The Dutch Safety Board)

- 예선은 예선작업을 위해 어쩔 수 없이 “안전지대”를 떠나 선박의 선수 가까이 조종해 가야 했고, 그로 인해 선박과 예선의 선체 사이에 유체역학적 상호작용이 발생하면서 예선이 안쪽으로 끌려와 선박의 구상선수와 충돌했다.
- 사고 당시 안전한 예선작업을 하기에는 선박(여객선)의 선속이 너무 빨랐다. 선속이 상대적으로 빨랐다는 것은 예선이 머물러 있어야 하는 “안전지대”가 선박에서 멀어져 예선작업이 더 어려워졌다는 것을 의미했다.
- 선속이 상대적으로 빨랐다는 것은 또한 예선이 여객선의 선속에 맞추기 위해 사용 가능한 기관 동력의 많은 부분을 사용해야 해서 예선을 조종하기에 필요한 최소한의 동력만 남았다는 것을 의미했다.
- 도선면제선박의 선장은 예선지원 등과 관련하여 추가로 교육을 받을 의무가 없었다. 예선지원은 보통 기상상태가 좋지 않을 때 요청되었다.
- 예선이 심하게 흔들리면서 좌현으로 기울었을 때 열려져 있던 도어와 기관실 통풍구를 통해 물이 들어왔다. 이로 인해 침수가 발생하여 예선의 복원성이 더욱 악화되어 결국 전복되었다.
- 예선의 기관에 충분한 공기를 공급하기 위해 항해 중에는 의무적으로 기관실 통풍구를 열어두어야 했기 때문에 예선 선원들이 항해 중에는 기관실 통풍구를 닫을 수 없었다.
- 예선은 복원성 기준을 만족하지 않아 침수 시 더욱 심하게 기울어졌다.

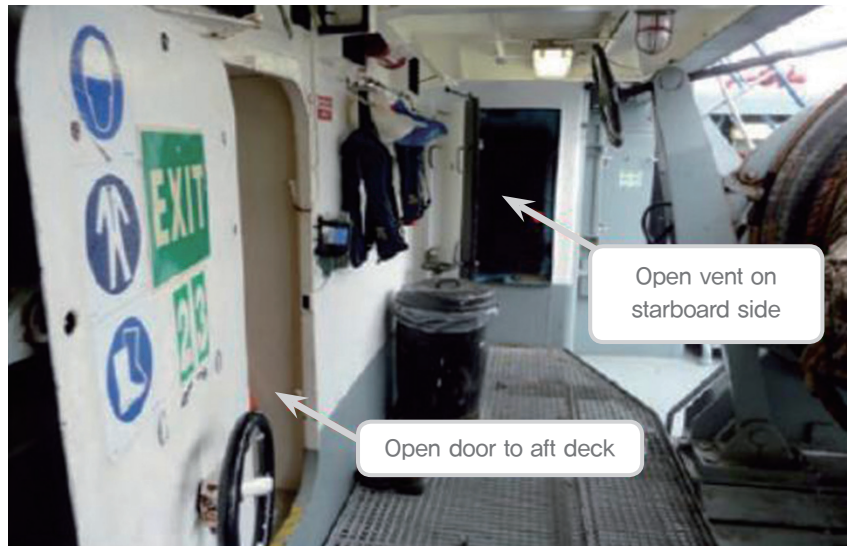
Figure 13.3 The door leading to the after deck on the tug(sister ship)  
출처 Investigation report(The Dutch Safety Board)

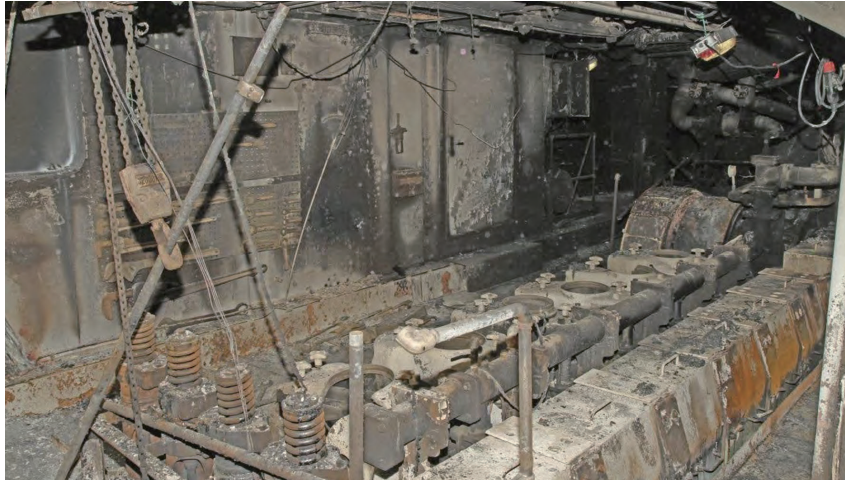
- 연료분사펌프용 체결볼트 4개가 전부 헐거워서 펌프하우징이 움직일 수 있었던 것으로 나타났다. 파손된 표면에 대해 이후 진행된 조사 결과, 펌프 몸체가 움직이면서 주기적으로 발생한 수직하중 때문에 노후로 인한 파손이 발생하여 연료유 리턴파이프가 손상되었을 가능성이 가장 높았다. 펌프몸체가 움직인 것은 12일 전 펌프를 교체한 후 체결볼트가 제대로 고정되지 않았기 때문이었다. 화재는 중요한 제어장비로 번졌다. 원래 엔진제조업체가 각 연료펌프 앞에 비산방지장치(spray shields)를 설치했었으나 화재 당시에는 설치되어 있지 않았다. 비산방지장치가 설치되어 있었다면 연료와 불꽃이 제어장비에 영향을 미치는 것을 방지했을 수도 있다.

Figure 14.2 Starboard side of the main engine room 출처 The police, Investigation report(AIBN)

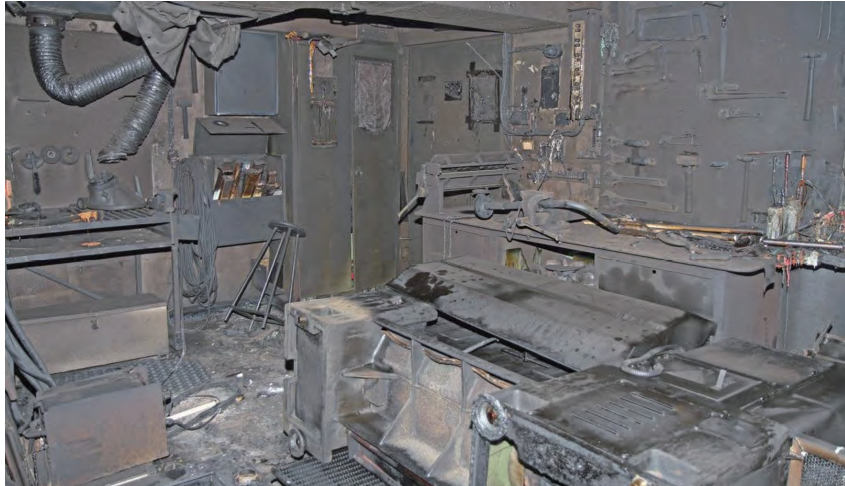
Figure 14.3 The interior of the workshop on the starboard side 출처 The police, Investigation report(AIBN)

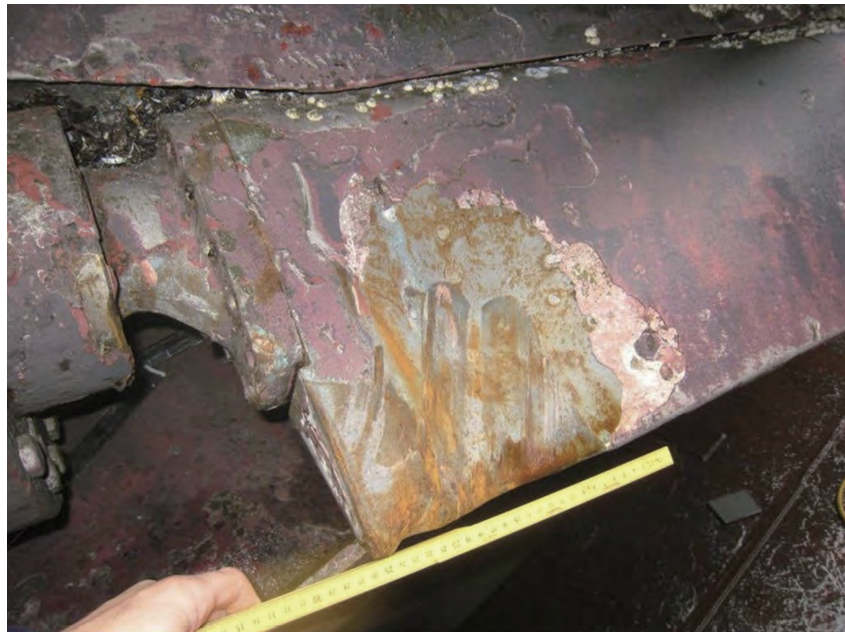
심각한 기관실 화재로 로로여객선이 주전원과 보조전원을 모두 잃고 인근 부두로 예인되어야 했다. 핀안정기(stabilizer fin)가 계속 떨어져 있는 상태였고, 선박이 부두에 닿으면서 선박 측면으로 우현 핀이 뚫고 들어왔다. 선체가 손상되면서 2번 화물창에 침수가 발생했고, 화물창 사이의 수밀문을 통해 1번 화물창에도 물이 들어왔다. 수밀문 아래쪽의 밀봉장치가 마모되어 완전히 빈틈없는 상태가 아니었다. 선체 손상된 위치를 파악하여 임시로 수리하고 충분한 펌핑 용량을 확보하는 데까지 상당한 시간이 걸렸다. 상황이 악화되어 선박이 부두를 따라 거의 전복될 정도의 심각한 상황에 이르렀다.

Figure 16.1 damage sustained on the starboard stabiliser fin 출처 DNV, Investigation report(AIBN)

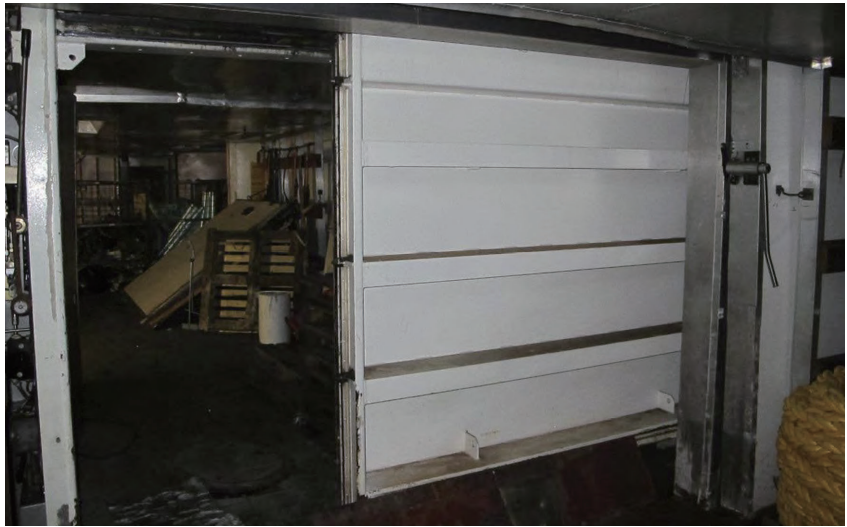
- 통상적으로 바우스러스터가 작동하면 핀안정기는 자동으로 들어간다. 이 사고에서는 전력이 중단되어 바우스러스터를 사용할 수 없었기에 핀안정기가 자동으로 들어가지 않았다.
- 항만에 입항할 때 사용하는 체크리스트가 마련되어 있었고, 여기에 핀을 선내로 접어 넣는 것에 관한 내용이 포함되어 있었다. 수동유압펌프 등을 포함하여 핀을 선체 안으로 접어 넣기 위한 여러 가지 수단이 있었으나, 그중 어떤 장치도 사용되지 않았다. 사고보고서상으로는 접안 시 이 체크리스트를 참고했는지, 또는 비상수동펌프를 사용해 핀을 넣으려고 시도했는지 여부는 확인할 수 없다. 1번 화물창과 2번 화물창 사이의 수밀문 아래쪽 밀봉장치가 심하게 마모되어, 수밀문의 가로 방향으로 8~10mm의 공간과 200cm<sup>2</sup> 가량의 공간이 생겨 있었다.

Figure 16.2 The watertight sliding door between cargo hold no 1 and cargo hold no 2  
출처 Investigation report(AIBN)

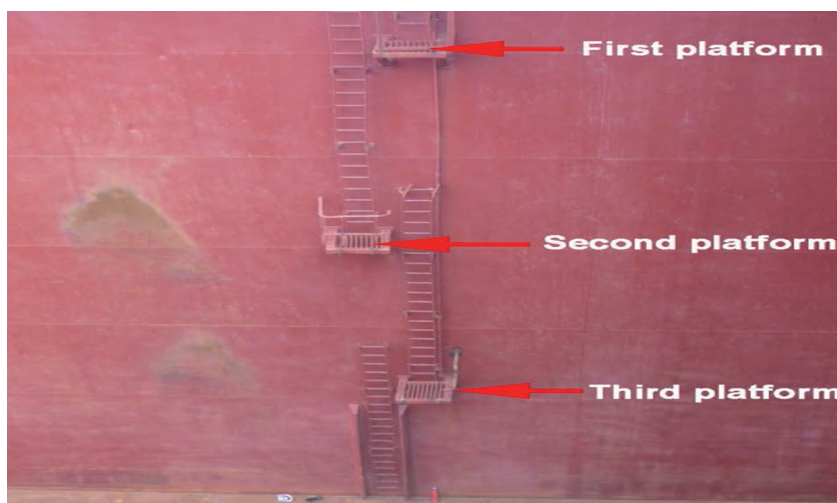
- The platform was cluttered with equipment that the crew member was using to effect the repairs and was not guarded by hand rails, making the platform a congested and dangerous place to work.
- A single halogen light had been rigged about one metre above the platform. The light was another obstacle that the crew member had to work around.
- Although shipboard procedures required the crew member to use a safety harness for the task, he was not wearing one at the time. Wearing a safety harness and connecting it to a secure point would have arrested his fall.

Figure 1.2 Number five cargo hold ladder: note that the handrails have been removed from around the third platform SOURCE Investigation report(ATSB)

- Working at height without the protection of hand rails is a hazardous situation. It is important that seafarers follow industry best practice of using a safety harness when working at height.
- It is important when working in dark spaces that sufficient lighting is used to illuminate the immediate and general working area without obstructing the workers.

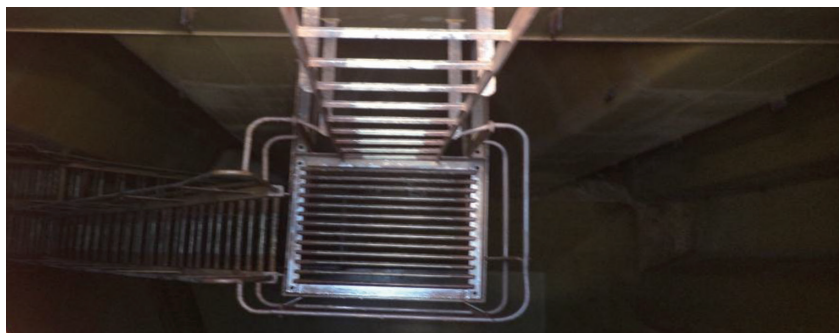
- At the time of the accident, the ambient temperatures on deck and inside the cargo oil tanks were about 33°C and 37°C respectively. The superintendent might have suffered from heat exhaustion that caused him to lose his grasp of the vertical ladder while he was entering 4S cargo oil tank in the afternoon under high ambient temperature.
- The vertical ladder had no guard rings, which could have prevented him from falling sideways after he lost his grasp of the ladder.

Figure 3.2 Access ladder inside 4S COT SOURCE Investigation report(HKSAR, The Hong Kong Special Administrative Region)

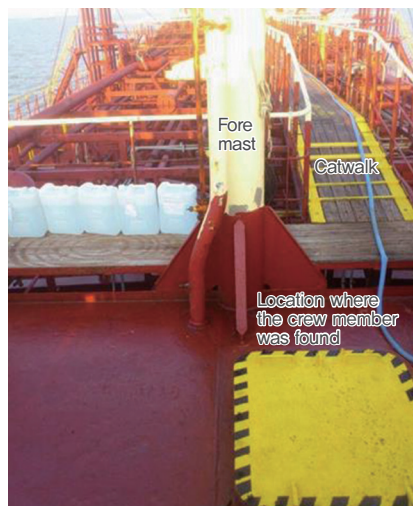
Figure 4.3 Location where the crew member was found SOURCE Investigation report(HKSAR)

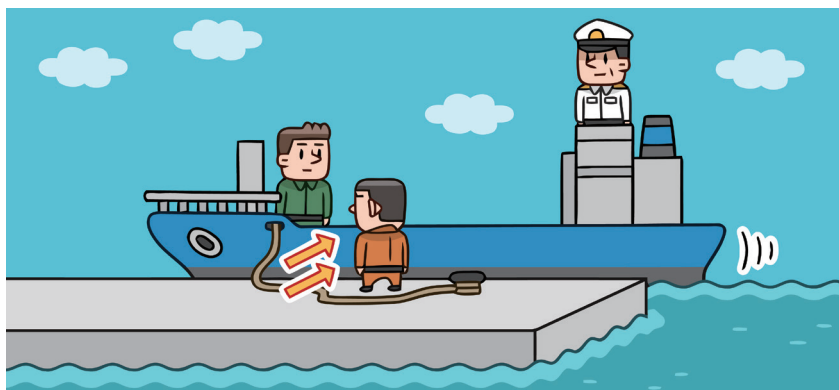
- The stevedore moved into a hazardous area, where mooring operations were still underway. The ship's crew on deck could not see him or the mooring line on the wharf from their positions, and no one on the bridge noticed him.
- The shore mooring linesmen did not prevent the stevedore from entering the hazardous area where they were still conducting mooring operations. The mooring gang company's safety management system did not have adequate procedures to prevent unauthorized entry to prohibited areas. There were neither warning signs for such areas nor other physical measures to prevent entry to them. The safety oversight of the company managing the wharf (with respect to supervision of the mooring gang company) was also inadequate.

Figure 6.1 The Scene of the casualty SOURCE Investigation report(China MSA)

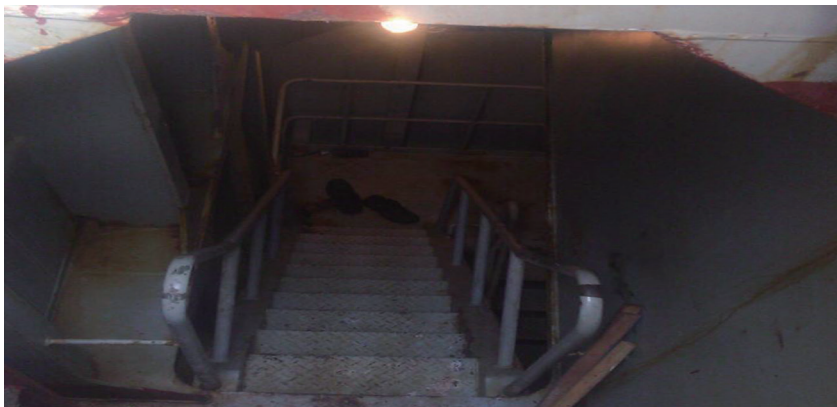
- The existing shipboard operational procedures did not take account of the carriage of timber cargoes and the danger posed by oxygen depletion.
- There were no warning notices at the point of entry to the cargo hold, on either the outside or inside of the access hatch cover.
- An enclosed space entry procedure had not been detailed as a key shipboard operation in the Safety Management System(SMS).
- The human instinct of wanting to save a colleague resulted in the Chief Engineer and second Officer entering an unsafe space without suitable precautions for their own individual safety.

Figure 8.2 No.3 Cargo Hatch View from top looking down onto platform 2 at base of stairway  
SOURCE Investigation report(Isle of Man Ship Registry)

- There are inherent dangers associated with entry of enclosed spaces, particularly cargo holds, no matter what type of cargo they may contain, including those posed by oxygen depletion from the timber cargo.
- There is a need to ensure that all persons who are required to enter an enclosed space positively identify the atmospheric condition against parameters, which should be stated in the SMS together with procedures for safe entry.
- Effective enclosed space entry training and drills should take into account the instinctive reaction of seafarers to provide assistance and highlight that doing so without appropriate safety equipment is hazardous and can result in additional casualties.

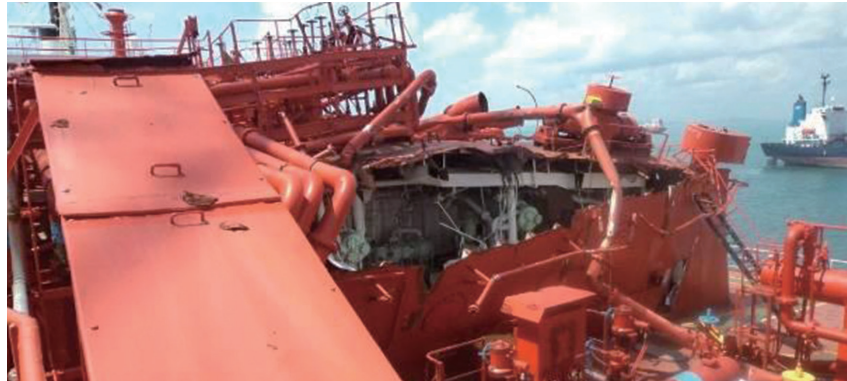
Figure 9.1 Photo of the accident(Fwd cargo compressor Room) SOURCE Investigation report(Panama Maritime Authority)

- The ship's managers had not made arrangements for the work to be done while the ship was at a repair facility; instead, they allowed it to be carried out during a laden voyage. The facilities and equipment on board were not suitable for the work. No permit to work was issued; risks were not properly assessed and no specific safety precautions were planned. No officer had been assigned to supervise the work.

- The source of ignition was not established but it is believed to have caused a flashback from the cutting torch along the hose connecting it to a cargo compressor.

- Whenever possible, hot work within the cargo area of a vessel carrying flammable cargoes should be carried out in a repair yard after all gas-freeing processes have been carried out and the area declared safe.

- If it is imperative that hot work has to be undertaken during the voyage, it should only be undertaken after a detailed risk assessment has identified ALL significant risks arising out of the work activity – including an evaluation of the suitability of the tools to be used – and suitable mitigation measures have been put in place. This should include procedures for any repairs or maintenance pertaining to any kind of hot work, particularly in areas exposed to hydrocarbons which would cause a serious accident, threatening life and property. The assessment should also take into account any existing precautions to control the risk, such as permits to work, agreed procedures as per SMS, use of personal protective equipment, use of safe tools, and a "Stop Work Policy."

- Under no circumstances should attempts be made by the crew to tap-off cargo gas to progress repair work. Any modification to cargo lines should be approved by the Administration and the vessel's classification society.

- While the practice leading to this unfortunate casualty cannot under any circumstances be condoned, flame-cutting using conventional set-ups such as oxy-acetylene, while commonplace, should always be carried out by competent operators and subject to a "permit-to-work." The danger of a flashback is nevertheless always present. The UK's Health and Safety Executive advises in its publication INDG297(rev1). "Flashbacks are commonly caused by a reverse flow of oxygen into the fuel gas hose(or fuel into the oxygen hose), producing an explosive mixture within the hose. The flame can then burn back through the torch, into the hose and may even reach the regulator and the cylinder. Flashbacks can result in damage or destruction of equipment, and could even cause the cylinder to explode.

- Make sure the blowpipe is fitted with spring-loaded non-return valves.
- Use the correct gas pressures and nozzle size for the job.
- Maintain the equipment in good condition.

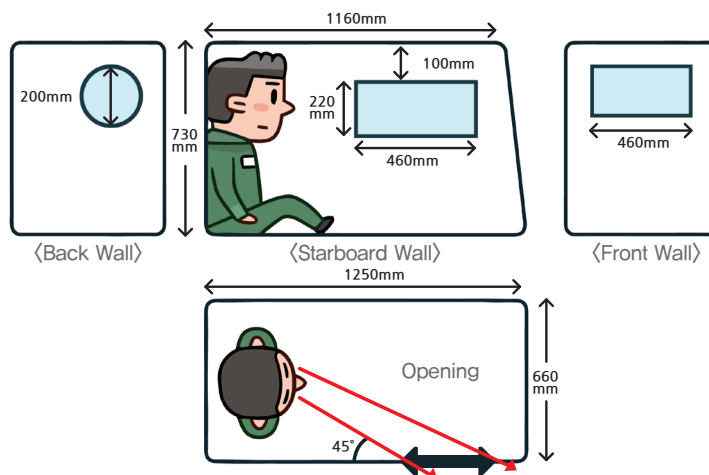
Figure 10.3 Watch room Dimensions Diagram SOURCE Investigation report(JTSB)

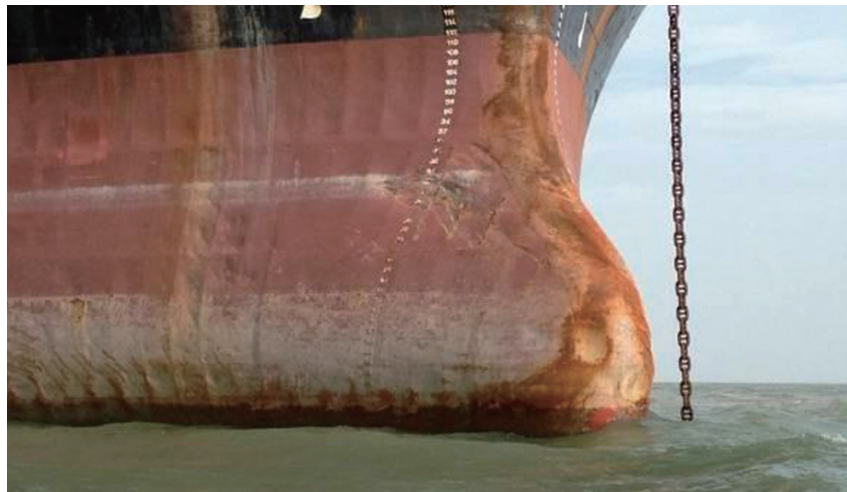
Figure 12.1 Photo of the ship after collision(Bulk Carrier) SOURCE Investigation reportInvestigation report (Panama Maritime Authority)

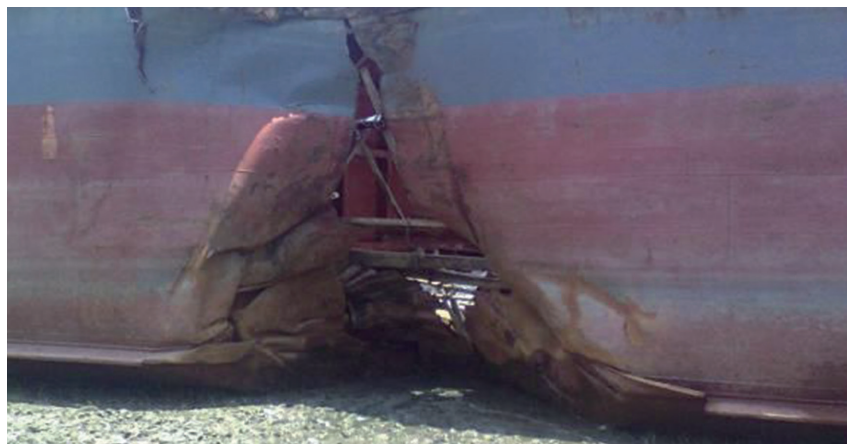
Figure 12.2 Photo of the ship after collision(Coaster Barge) SOURCE Investigation report (Panama Maritime Authority)

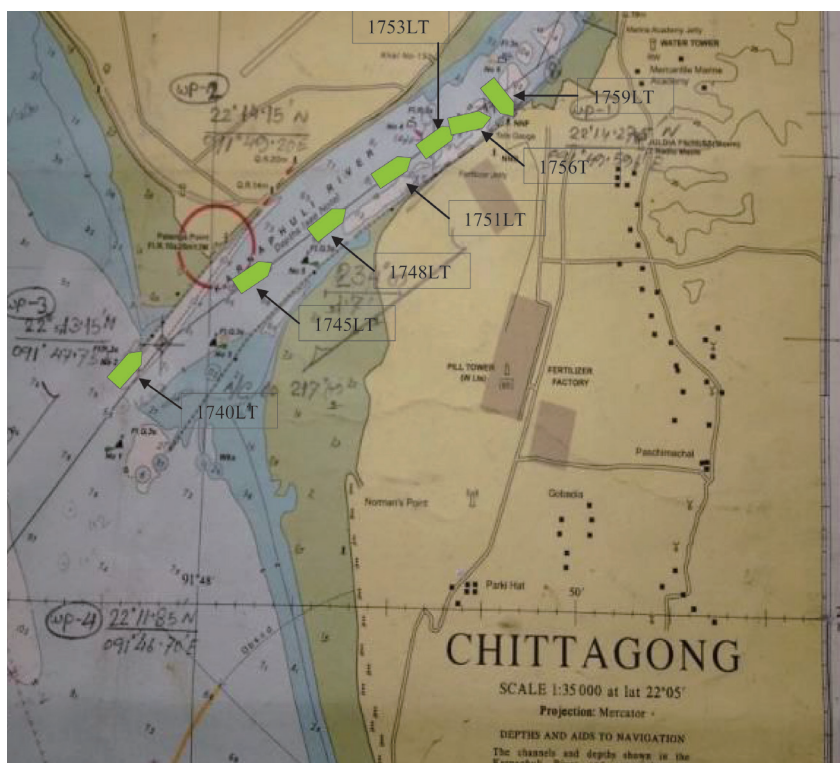
Figure 12.3 Positions of ship and her approximate heading during transit(Collision 1759LT)  
SOURCE Investigation report(Panama Maritime Authority)

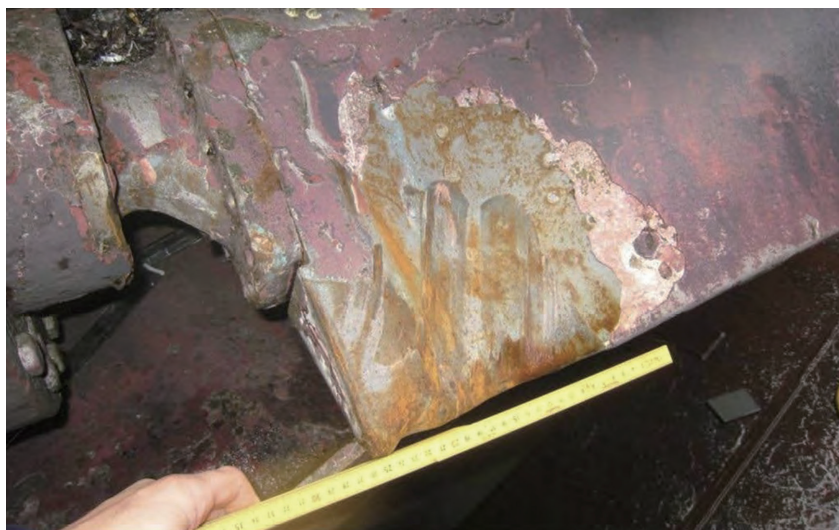
Figure 16.1 damage sustained on the starboard stabiliser fin SOURCE DNV, Investigation report(AIBN)

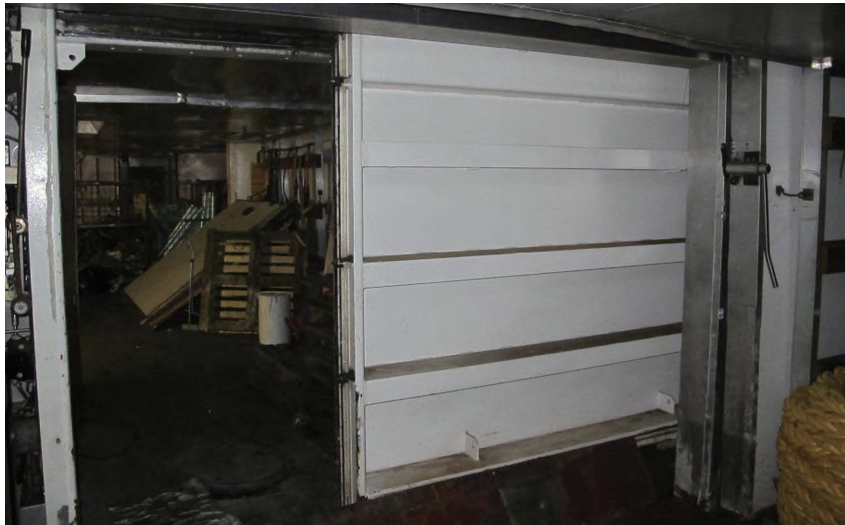
Figure 16.2 The watertight sliding door between cargo hold no 1 and cargo hold no.2  
SOURCE Investigation report(AIBN)
