해양사고 특별조사보고서

- 자동차운반선 골든레이호 전도사고 -

사고일자 : 2019.09.08.

해양사고보고서

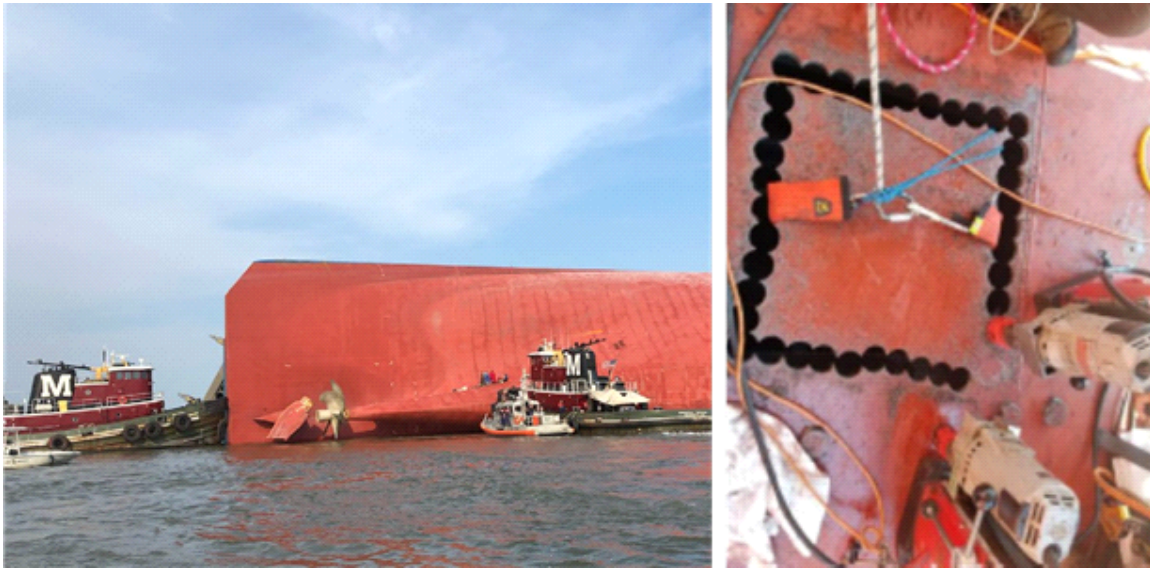
사고가 발생한지 약 16시간이 경과한 9월 8일 18시 12분경 구조대원들은 선내에서 두드리는 소리를 들었다고 보고하였다. 다음날 USCG는 돈존-SMIT와 디파이안트 마린(Donjon-SMIT, Defiant Marine, 모두 인양 및 구조선사), 엘리베이티드 세이프티(Elevated Safety, 밀폐공간 구조전문), 구난업체 뿐만 아니라 글린 카운티의 긴급구조 8팀(Heavy Rescue-8)과 조지아주 천연자원부와 긴밀하게 협업하여 기관사들을 가장 안전하게 구조할 계획을 수립하였다. 여기에는 냉각절단장비를 조달하여 선체에 탈출구를 만드는 것이 포함되었다. 이 장비를 현장에 수배하는 데는 약 14시간이 걸릴 것으로 예상되었다. 구조대원들은 약 13시 00분경 선체에 2.5인치 크기의 구멍을 뚫고 고립된 기관사들에게 접촉을 시도하였다(그림 7 참고). 기관실 내부 온도는 화씨 155도만큼 높았다. 내부 온도가 기관사들에게 극도로 위험하다는 것을 깨달은 구조대원들은 요청한 냉각절단장비가 도착하기를 기다리지 않고 선체에 사각형 모양의 출입구를 만들기 위해 파공작업을 계속하였다.

[그림 7] 고립된 기관사 및 실습 기관사 구조를 위한 구조대원들의 시도(왼쪽).
기관사들에게 접근하기 위한 파공작업(오른쪽).

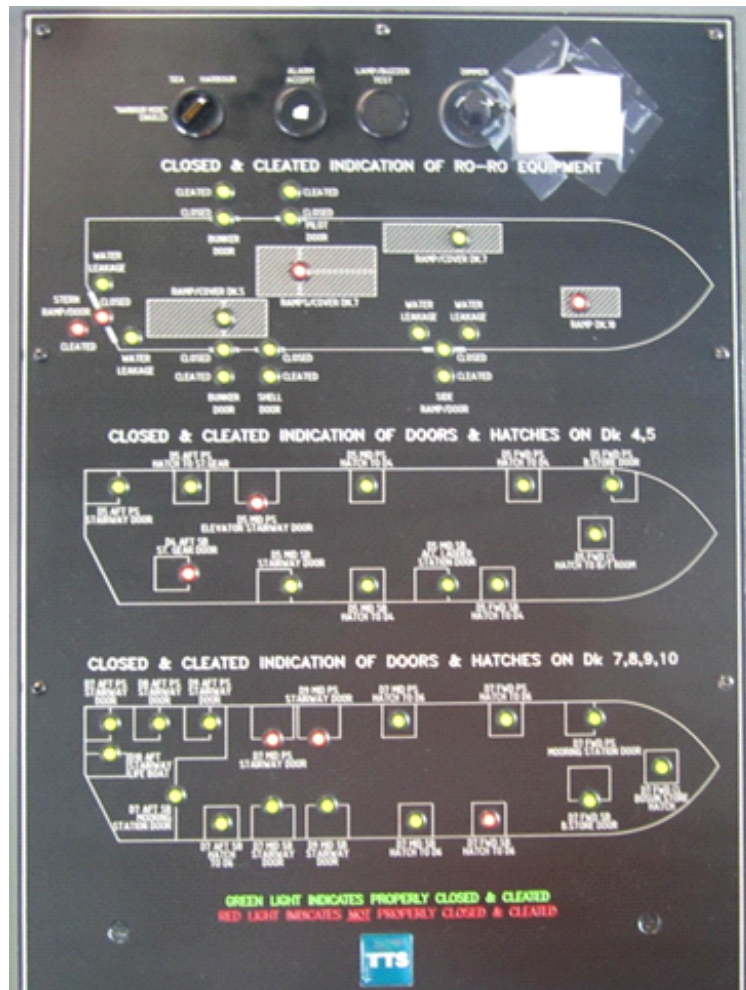
수밀문. 골든레이호에는 도선사 출입문과 선미램프, 현측램프, 그리고 램프커버 4개에 더하여 폐쇄 시 선박의 수밀성을 유지시키는 수밀문 17개와 수밀해치13개가 있다. 선교에는 수밀문과 해치가 열렸는지(빨간불), 닫혔는지(녹색불) 알려주는 수밀문 개폐 표시반이 있다(그림 10 참조).

[그림 10] 골든레이호의 동형선, 실버레이호 선교에 위치한 수밀문 개폐 표시반

IMACS 데이터에 따르면 사고 당시 좌현측 도선사 출입문 뿐만 아니라 5번 갑판 선미 계단통로와 좌현 중앙부 계단통로로 연결되는 수밀문은 모두 개방되어 있었고, 선박이 콜로넬스 아일랜드 터미널을 출발하기 전인 9월 7일 23시 41분부터 계속 열려 있었다. 도선사 출입문에서 선미 방향으로 약 75피트(22.9미터) 떨어진 좌현 중앙부 계단통로는 4번 갑판의 기관실과 기관제어실로 접근할 수 있는 주요 출입구였다. 더 아래층 기관실로 연결되는 탈출 통로 계단으로 이동하면 4번 갑판에 있는 이 계단통로로 나가게 된다(그림 11 참고).

- ① 복원성 계산과정에서 발생할 수 있는 오류를 바로 잡을 수 있도록 선장과 회사 담당자가 담당사관의 복원성 계산결과를 검증하는 절차를 마련할 필요가 있다.
- ② 복원성 계산 담당사관이 복원성 계산능력을 충분히 갖출 수 있도록 복원성에 대한 교육 및 훈련을 강화할 필요가 있다.
- ③ 선원이 다른 선박에 승선하더라도 복원성 계산 컴퓨터를 쉽게 사용할 수 있도록 선대 전체에 유사한 형식의 복원성 계산 컴퓨터를 사용하는 것이 바람직하다.
- ④ 출항 전 수밀문 폐쇄여부 확인 절차(체크리스트)가 제대로 이행되도록 하여야 한다.

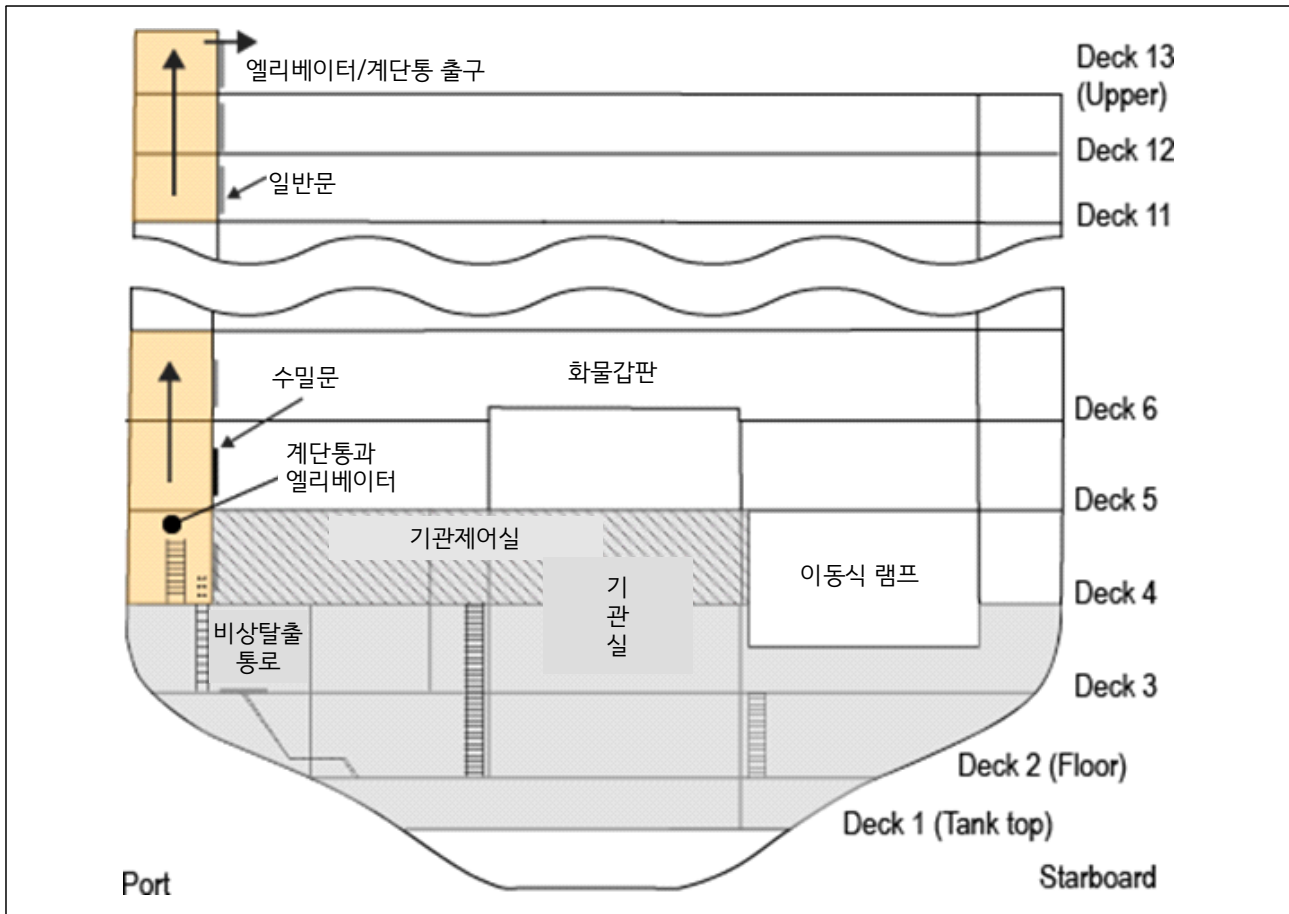
[그림 12] 기관실 및 기관제어실에서 밖으로 나가는 탈출 통로와 좌현 중앙부 계단통로의 간략도

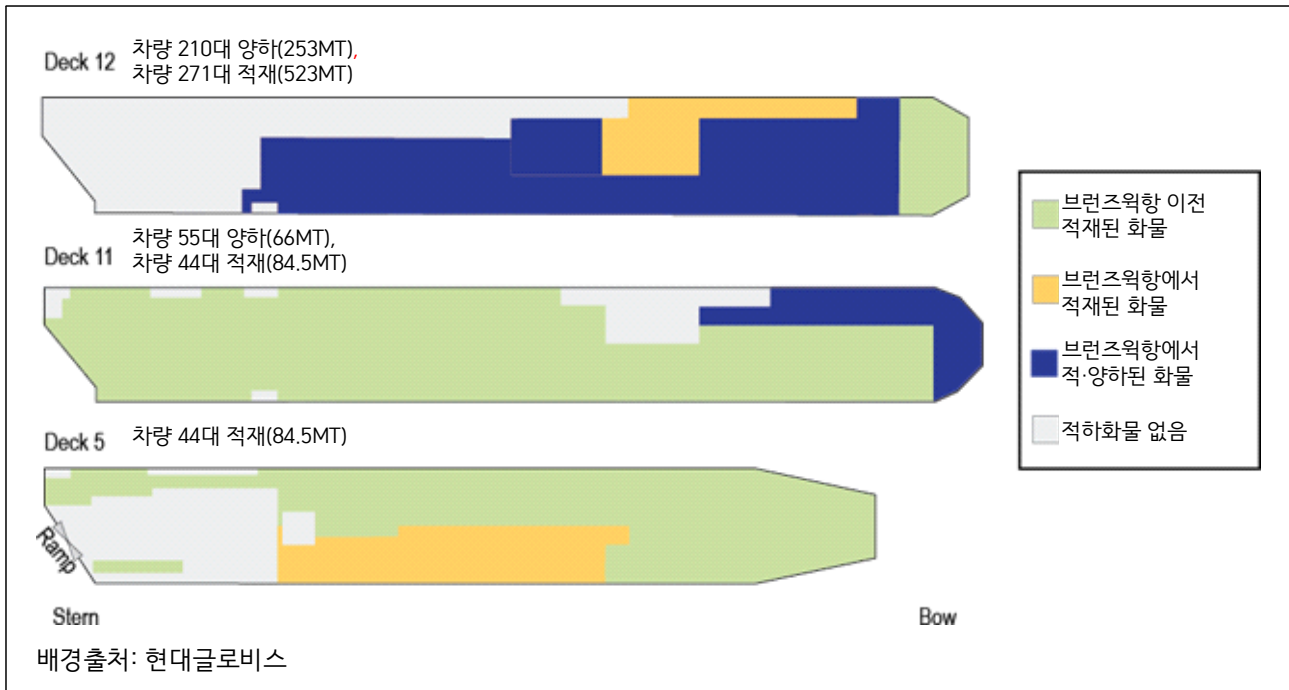
[그림 13] 골든레이호의 콜로넬스 아일랜드 터미널 사전적부계획(5번, 12번, 13번 갑판의 평면도)

일항사는 자신이 받은 사전적부계획서에는 차량 대수와 차종만 포함되어 있었으며 차종별 무게는 없었다고 진술하였다(사후 본 계획서를 검토한 결과 계획서에는 차량 대수와 각 선적지 별 적재될 차량의 총 무게만 포함되어 있음). 그는 과거 경험으로 미루어 양하할 각 소형차의 무게를 1.3톤, 적재할 각 중형차의 무게를 2톤으로 추산하였으며 “주어진 차량 대수의 평균 무게에 기초”하여 차량 전체의 무게를 판단하였다. 일항사는 변경된 화물이 선박 복원성에 미칠 영향을 판단하기 위해 사전적부계획서에 기재된 화물의 적재위치와 그가 계산한 예상 무게를 바탕으로 복원성 계산 컴퓨터를 사용하여 복원성을 계산하였다. 그는 골든레이호가 차량을 수용할 수 있고 복원성 요건을 충족시킬 수 있을 것으로 판단하였다. 그는 선박이 브룬즈윅항에 도착하기 전 사전적부계획을 승인하기 위해 선박대리점에 메일을 보냈다.

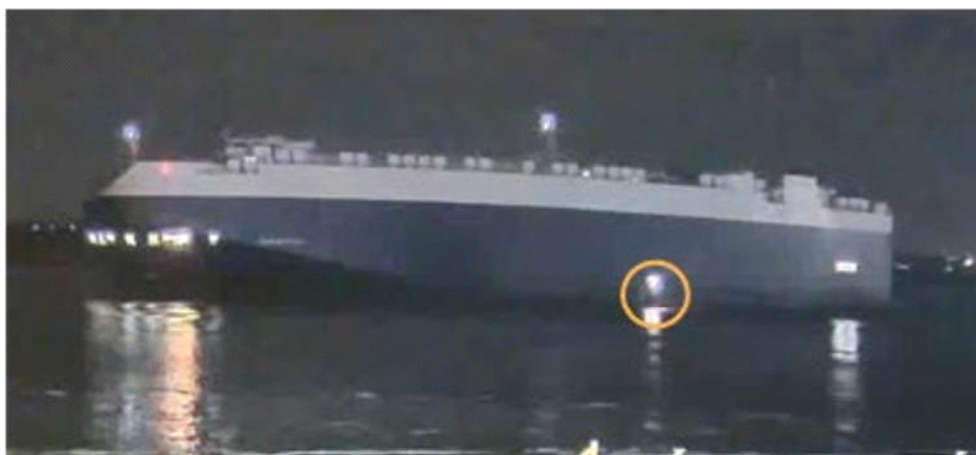
About the same time, the master ordered the crew to open the portside pilot door (side port), located on deck 5, in preparation for the pilot's planned departure just outside of the Port of Brunswick at the sea buoy (see figure 3). The pilot door was a watertight hatch in the side shell that opened and closed locally by an electronic/hydraulic system; the door was 7 feet (2.1 meters) high and 7 feet (2.1 meters) wide. After supervising the opening of the portside pilot door, the chief officer went to his stateroom. The crewmembers left to conduct other duties, and no one remained at the open door as the vessel proceeded outbound.

Figure 3. The *Golden Ray* departing Jacksonville, Florida, about 0130 on September 7. The light amidship is the open portside pilot door. (The lights on the blue hull at the bow and stern are mooring line stations.)

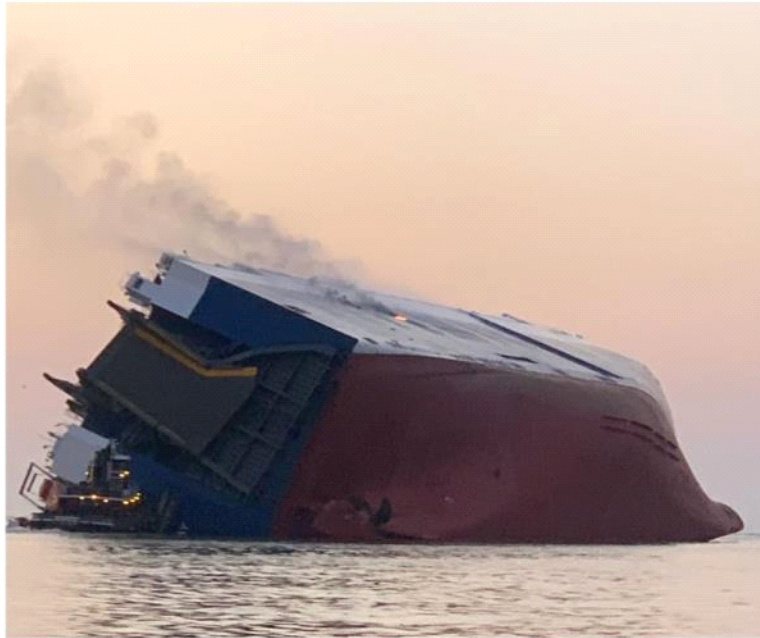
About 0430, first responders noticed smoke and flames on the starboard side of the *Golden Ray* in the area of the vehicle decks (see figure 5). The cargo hold contained combustible materials, including tires and plastic components in the vehicles. Because of the reported thick, black smoke

Figure 5. Stern view of the grounded *Golden Ray* after the heeling event. Flame and smoke emanate from the starboard side in the area of the cargo decks. Photo taken 6 hours after the heeling event.

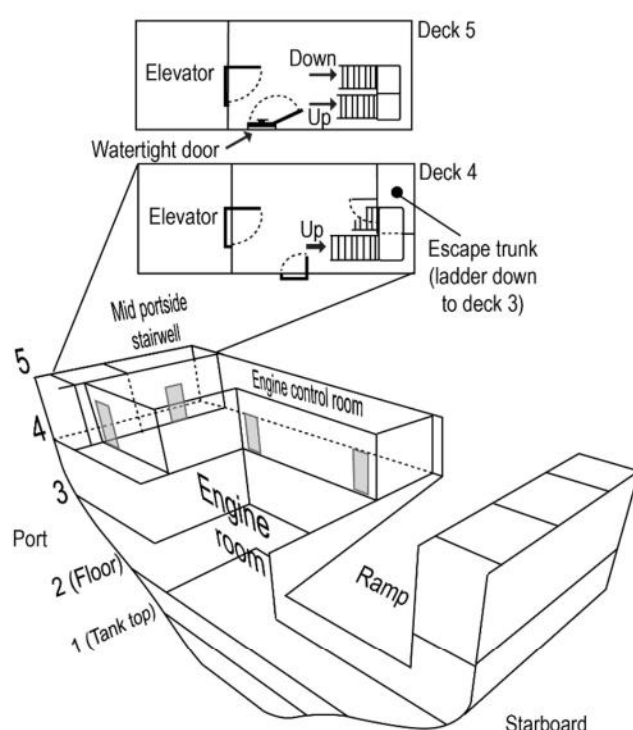
Figure 6. Simplified diagram showing a portion of the engine room and engine control room exits. Doors shaded gray.

the mid-portside stairwell—the primary stairwell serving the engine control room and engine room—but were blocked by incoming water, which was entering the stairwell from an open watertight door on deck 5. The engine control room also had three other doors facing aft that accessed the engine room directly (see figure 6).

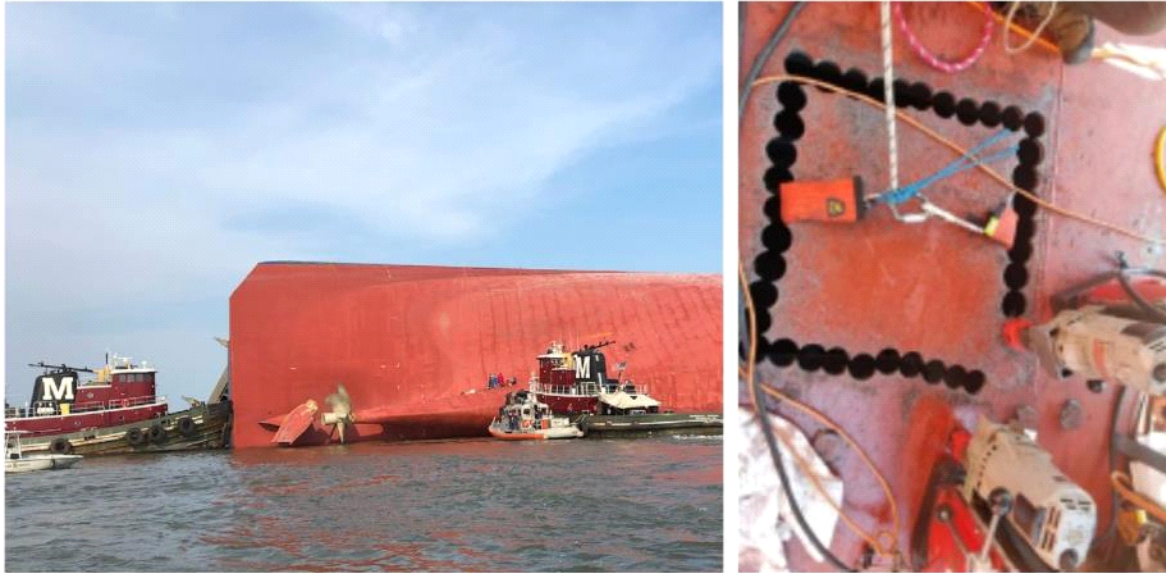
contact with the engineers (see figure 7). An atmosphere reading of the engine room showed its temperature was as high as 155°F. Realizing that the internal atmosphere was extremely hazardous to the engineers, the rescuers continued drilling holes to create a square access opening into the hull rather than wait for the requested cold cutting equipment to arrive.

Figure 7. Emergency responders attempt to rescue the trapped engineers and cadet (left). Responders drilled holes into the hull to access the engineers (right).

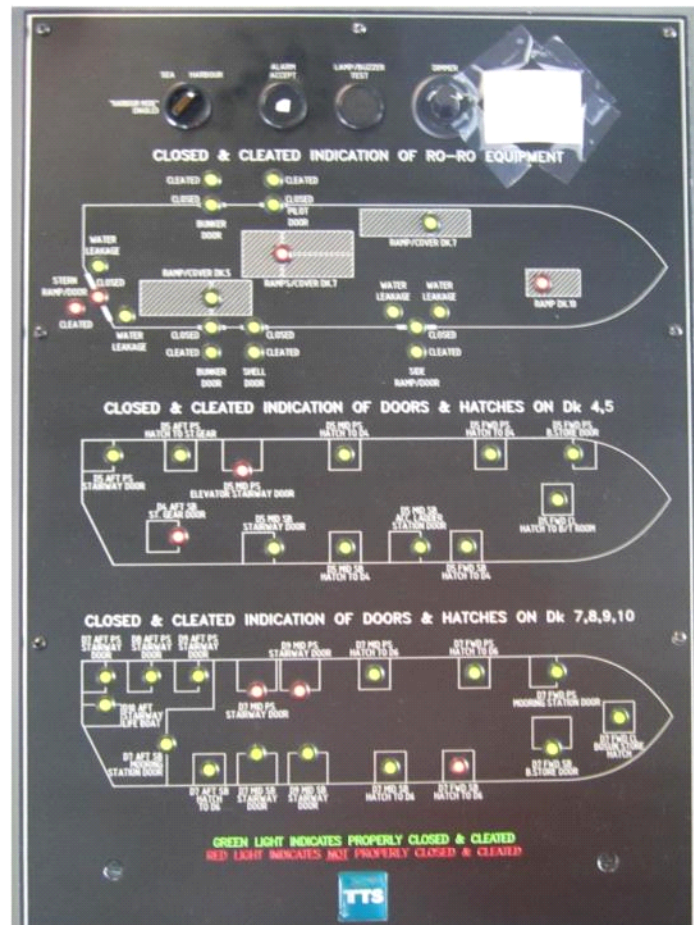
Watertight Doors. In addition to the pilot door, stern ramp, side ramp, and four ramp covers, the *Golden Ray* had 17 watertight doors and 13 watertight hatches that, when shut, maintained the vessel's watertight integrity. On the vessel's bridge, there was a watertight door indicator panel that showed whether the watertight doors and hatches were open (red light) or closed (green light) (see figure 10).

Figure 10. Watertight door indicator panel located on the bridge of the *Silver Ray*, a vessel of the same class as the *Golden Ray*.

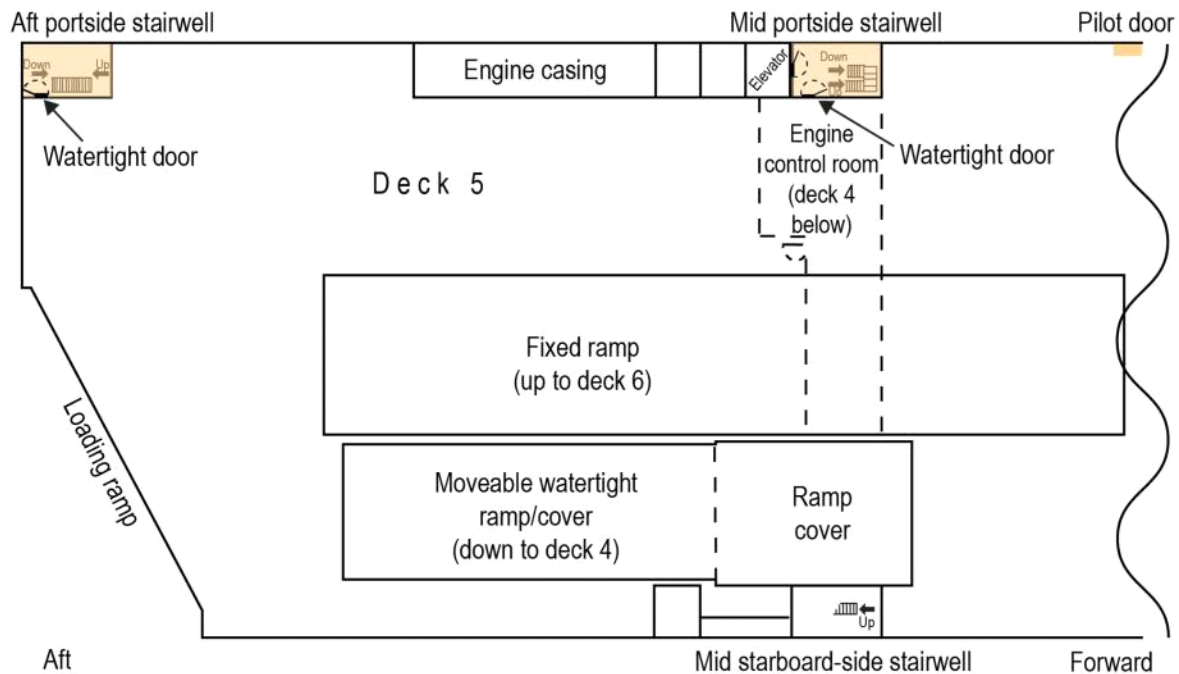
Figure 11. Simplified overhead plan of the aft portion of deck 5. The stairwells with open watertight doors and the pilot door are highlighted. Dashed lines indicate spaces on deck 4 below.

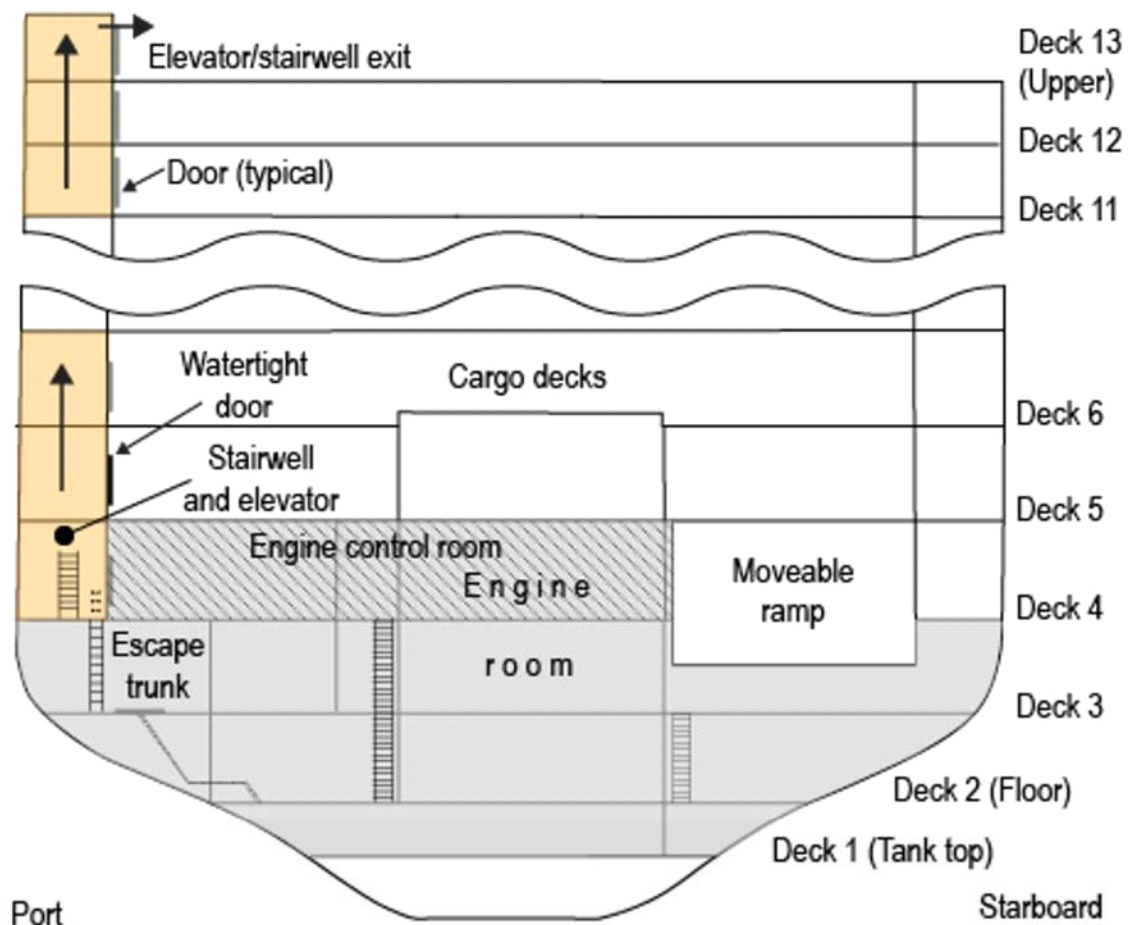
Figure 12. Simplified section view of the escape trunk and mid portside stairwell exit from the engine room and engine control room.

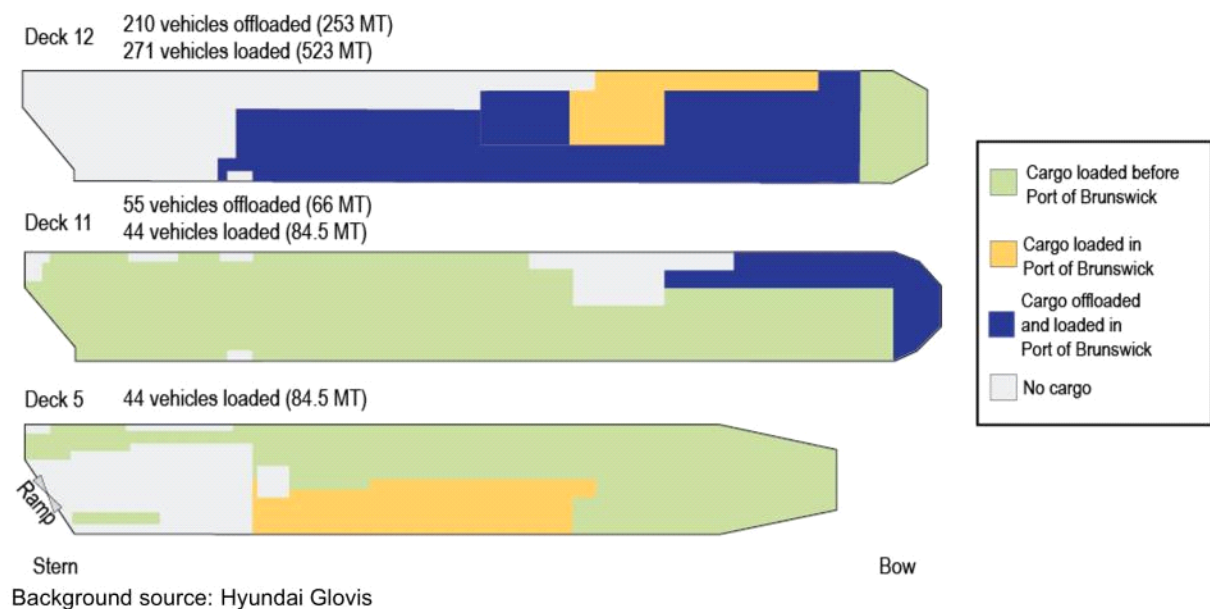
Figure 13. Preload plan (top view of decks 5, 12, and 13) for the *Golden Ray* at the Colonel's Island Terminal.

The chief officer stated that the preload plan that he received only contained the number and type of vehicles but did not contain the weight of each type of vehicle. (A postaccident review of the plan confirmed that the plan contained the number of vehicles and the total weight to be loaded in each loading location). Based on his experience, he estimated that each small vehicle being offloaded weighed 1.3 MT and each mid-sized vehicle being loaded weighed 2 MT, and he determined the total weight of the vehicles “based on the average weight of the given number of cars.” Using the stowage locations of the cargo provided in the preload plan and the estimated weight based on his calculations, the chief officer used the LOADCOM stability calculation program to determine the effect the cargo change would have on the vessel’s stability. He concluded that the vessel would be able to accommodate the vehicles and meet stability requirements. He emailed the ship’s agent to accept the preload plan before the vessel’s arrival at the Port of Brunswick.

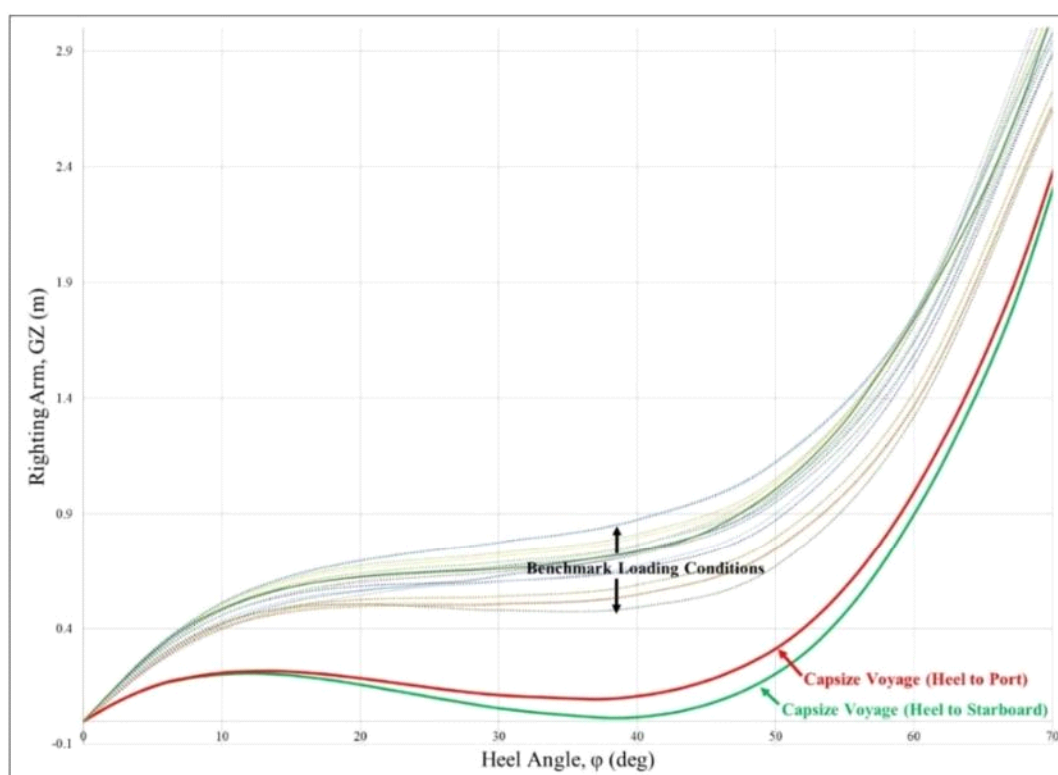
IS Code criteria were applied to these righting arm curves, the MSC found that with the vessel's loading condition, the area under the vessel's righting arm curve between 30° and 40° was particularly limited, and it failed to meet the 2008 IS Code (see figure 16). Because there was limited area under the righting arm curve, the MSC determined that the vessel did not meet the area ratio criteria of the 2008 IS Code's severe wind and rolling criteria. The MSC concluded that the vessel, as loaded, had an extremely low righting energy, which prevented it from withstanding further adverse static or dynamic heeling effects and enabled the vessel to capsize due to the centrifugal force experienced by the vessel throughout the starboard turn.

Figure 16. Righting arm curves generated from the MSC analysis of the *Golden Ray* during the accident voyage compared with benchmark righting arm curves chosen from the vessel's T&S Booklet loading conditions.

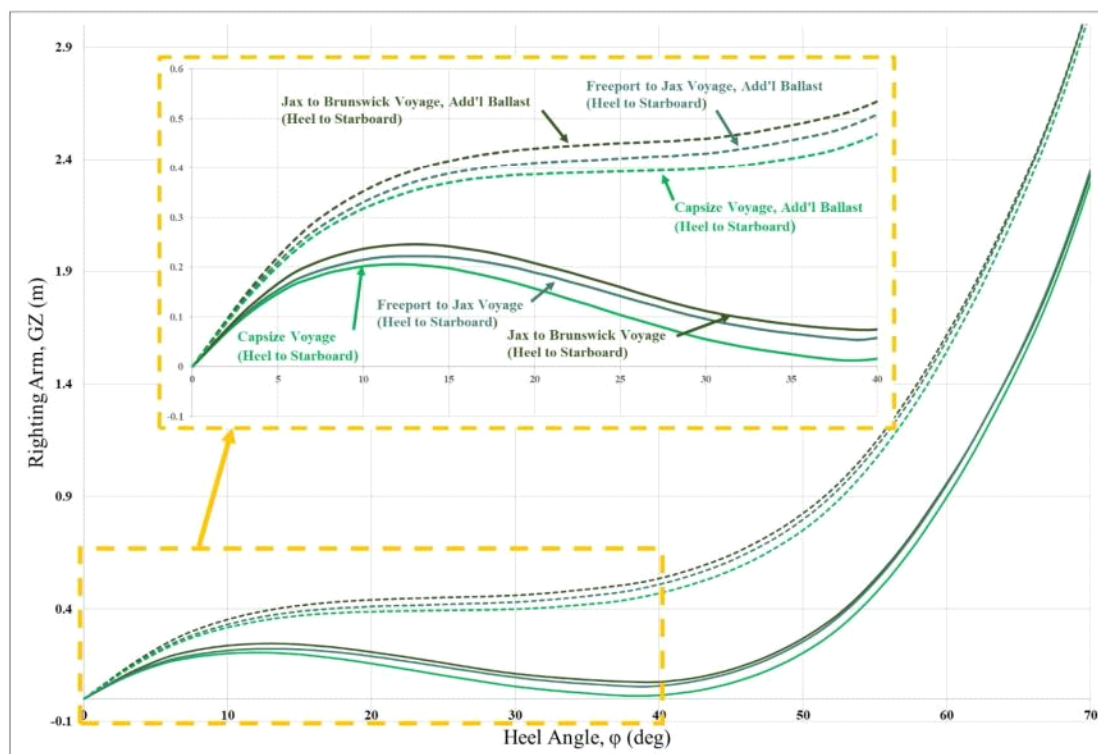
또한, MSC 보고서에서는 만일 골든레이호가 1,492톤의 평형수(프리포트에서 출항 후 1,500톤의 평형수를 주입하였고 잭슨빌에 입항하기 전 항만의 흡수요건을 충족하기 위해 배출하였다)를 추가로 적재했다면 선박은 이전 두 항차와 사고항차 모두에서 IS 코드를 준수했을 것이라고 설명하였다(그림 17 참고). 또한, MSC는 추가 평형수를 적재하였을 때를 가정하여 계산한 골든레이호의 이론상 초기 GM값은 사고항차의 경우 2.25미터(7.4피트), 프리포트 출항 항차에는 2.4미터(7.9피트), 그리고 잭슨빌 출항 항차에는 2.47미터(8.1피트)였을 것으로 기술하였다(비교를 위해 MSC는 당시 선적 상태에 대한 초기 GM값은 사고항차의 경우 1.76미터(5.8피트), 프리포트 출항 항차는 1.84미터(6피트), 그리고 잭슨빌 출항 항차는 1.91미터(6.3피트)로 산출하였음).

The MSC analysis also found that, although the vessel had more righting energy for the two preceding voyages than during the planned accident voyage, it was not in compliance with all of the minimum righting arm requirements of the 2008 IS Code during either because the area under the vessel's righting arm curve between 30° and 40° was insufficient. The MSC report stated that "failure of the IS Code criteria...is an indicator that the vessel poses a higher risk of capsize given exposure to certain dynamic conditions such as severe wind, waves and faster speed/tighter radius turns," and it was possible that the *Golden Ray* "could have capsized on a previous voyage if it had been exposed to more severe adverse conditions."

The MSC report also stated that if the *Golden Ray* had maintained an additional 1,492 MT of ballast (1,500 MT was loaded after departure from Freeport and then discharged before the vessel arrived in Jacksonville in order to meet the port's draft requirements), the vessel would have been in compliance with the 2008 IS Code during both previous voyages and the accident voyage (see figure 17). The MSC also noted that, with the additional ballast, the vessel's theoretical initial GM for those voyages would have been 2.25 meters (7.4 feet) for the accident voyage, 2.4 meters (7.9 feet) for the voyage from Freeport, and 2.47 meters (8.1 feet) for the voyage from Jacksonville. (For comparison, the MSC calculated the initial GM for the representative loading condition to be 1.76 meters (5.8 feet) for the accident voyage, 1.84 meters (6 feet) for the voyage from Freeport, and 1.91 meters (6.3 feet) for the voyage from Jacksonville.)

Figure 17. Theoretical righting arm curves (dashed green lines) generated from the MSC analysis of the *Golden Ray* during the accident voyage and previous two voyages with an additional 1,492 MT of ballast. The righting arm curves (solid green lines) generated from the MSC analysis for the vessel in the representative loading condition for each voyage are shown for comparison.

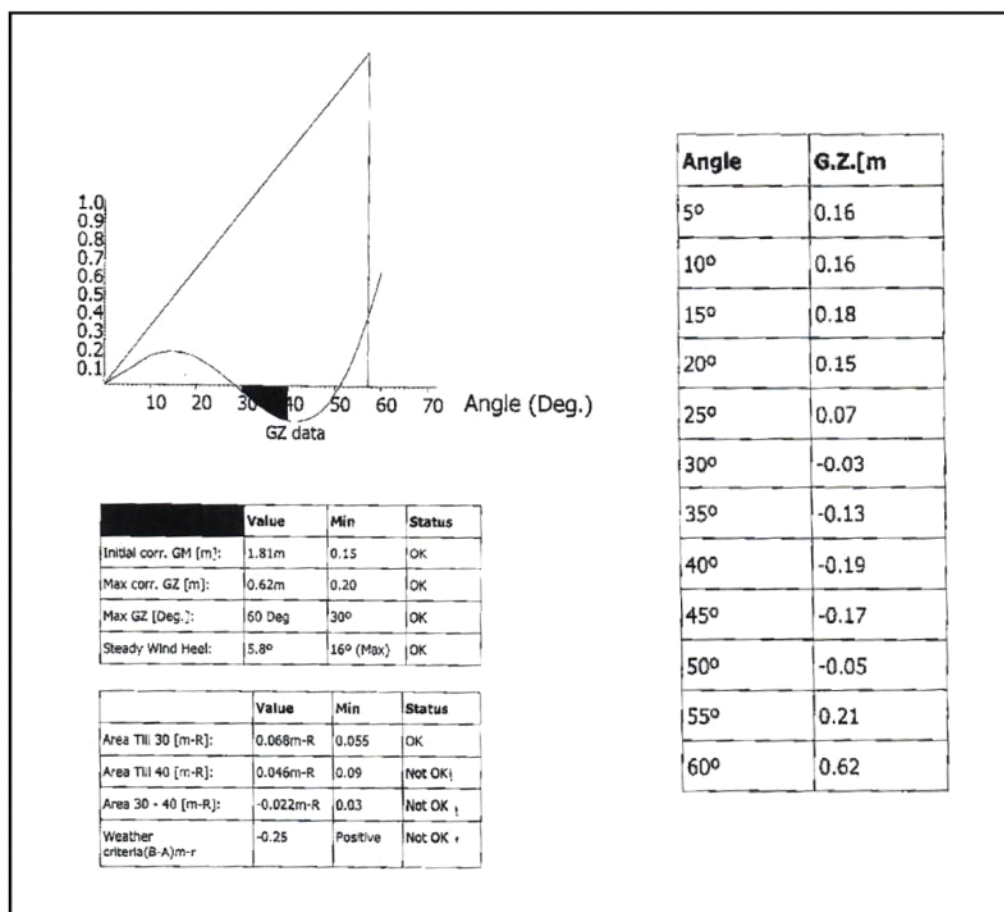
현대글로벌비스(Hyundai Glovis). 이 용선자는 골든레이호와 동급 선박인 실버레이호에 설치된 복원성 계산 컴퓨터를 사용하여 골든레이호의 복원성을 분석하였다(현대글로벌비스, 2020년). 용선자는 본 시뮬레이션에서 자체 수집한 선박 데이터와 상태자료를 활용하였으며 USCG나 NTSB는 참관하지 않았다. 해당 시뮬레이션에서 골든레이호의 GM값은 1.8미터(5.9피트)로 계산되었으며 사고 당시 골든레이호의 복원정곡선은 극도로 낮았고 3건의 복원성 요건에 대해 복원성 계산 컴퓨터에서는 “불량(Not OK)”으로 나타났다(그림 18 참고). 또한, 횡경사각이 약 25도가 되자 복원정곡선은 음(-)의 복원성을 보였다.

Hyundai Glovis. The charterer conducted a simulated stability analysis of the *Golden Ray* using the LOADCOM computer on board the *Silver Ray*, a vessel of the same class as the *Golden Ray* (Hyundai Glovis Co. Ltd. 2020). This simulation used vessel data and conditions collected by the charterer and was not observed by the Coast Guard or the NTSB. The simulation calculated that the GM of the *Golden Ray* was 1.8 meters (5.9 feet), indicated that the righting arm curve for the *Golden Ray* at the time of the accident was extremely low, and showed a LOADCOM status of “Not OK” for three stability requirements (see figure 18). Additionally, the righting arm curve showed negative stability after a heel of about 25°.

Figure 18. Righting arm curve calculated on the *Silver Ray*'s LOADCOM stability computer based on the *Golden Ray*'s vessel data from the accident. Note that three of the stability requirements have a status of "Not OK" and the righting arm (GZ) is negative beyond 25°.
