[MSI Report 2022-002]

Marine Safety Investigation Report on Containership Sawasdee Bangkok – Fatality of a crew member –

Date of Accident: 31 December 2017

**Korea Maritime Safety Tribunal
Marine Safety Investigation Team**

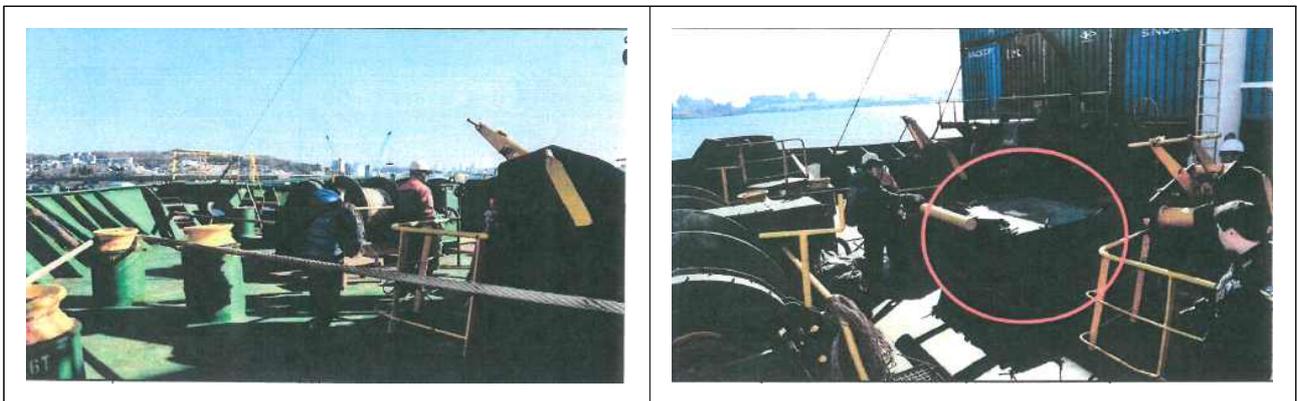
<Figure 4> Photo of the forecastle deck and the bosun store

2.5.2 The forecastle deck of Sawasdee Bangkok is equipped with a windlass, winch, and other machinery. The bosun store is located under the forecastle deck. Crew have to lift the small hatch to open and enter the bosun store.
