[MSI Report 2022-001]

Marine Safety Investigation Report

– Sinking of VLOC, Stellar Daisy –

Korea Maritime Safety Tribunal
Marine Safety Investigation Team

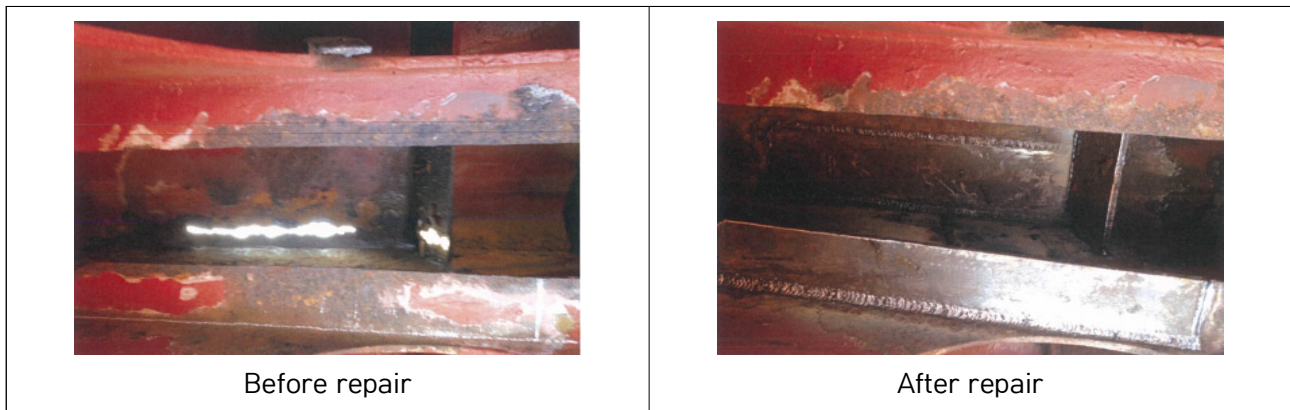
[Figure 16] Holes in the shell plate on the bow upper deck (3Q2015 Hull Inspection Report)

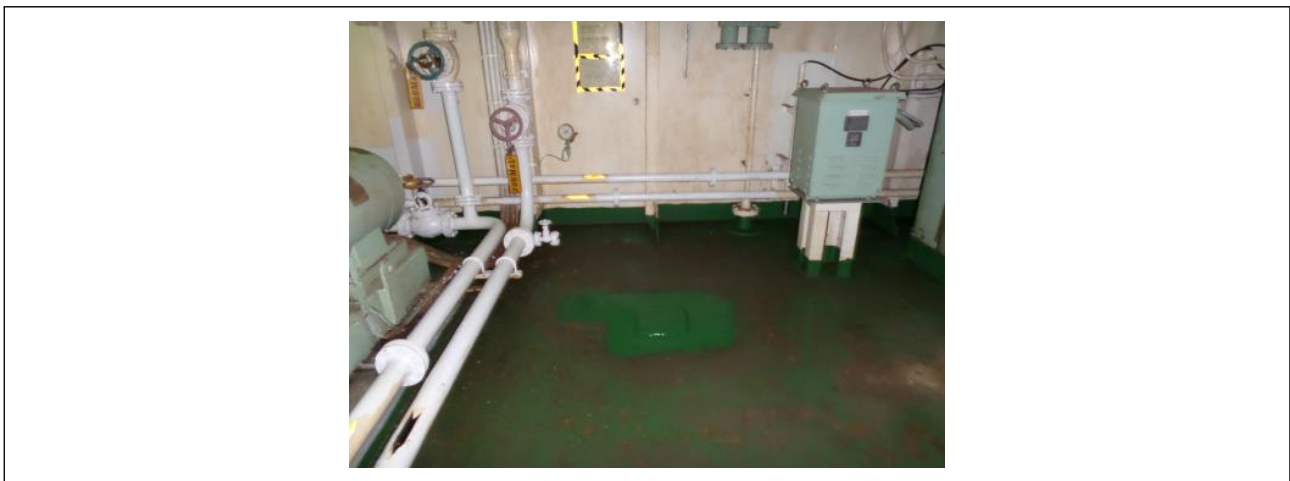
26) The 3Q2015 Hull Inspection Report specifies that the bottom of the deck store was doubled as it was holed and became thinner broadly.

[Figure 17] Doubling the floor plate of the deck store on the bow (3Q2015 Hull Inspection Report)

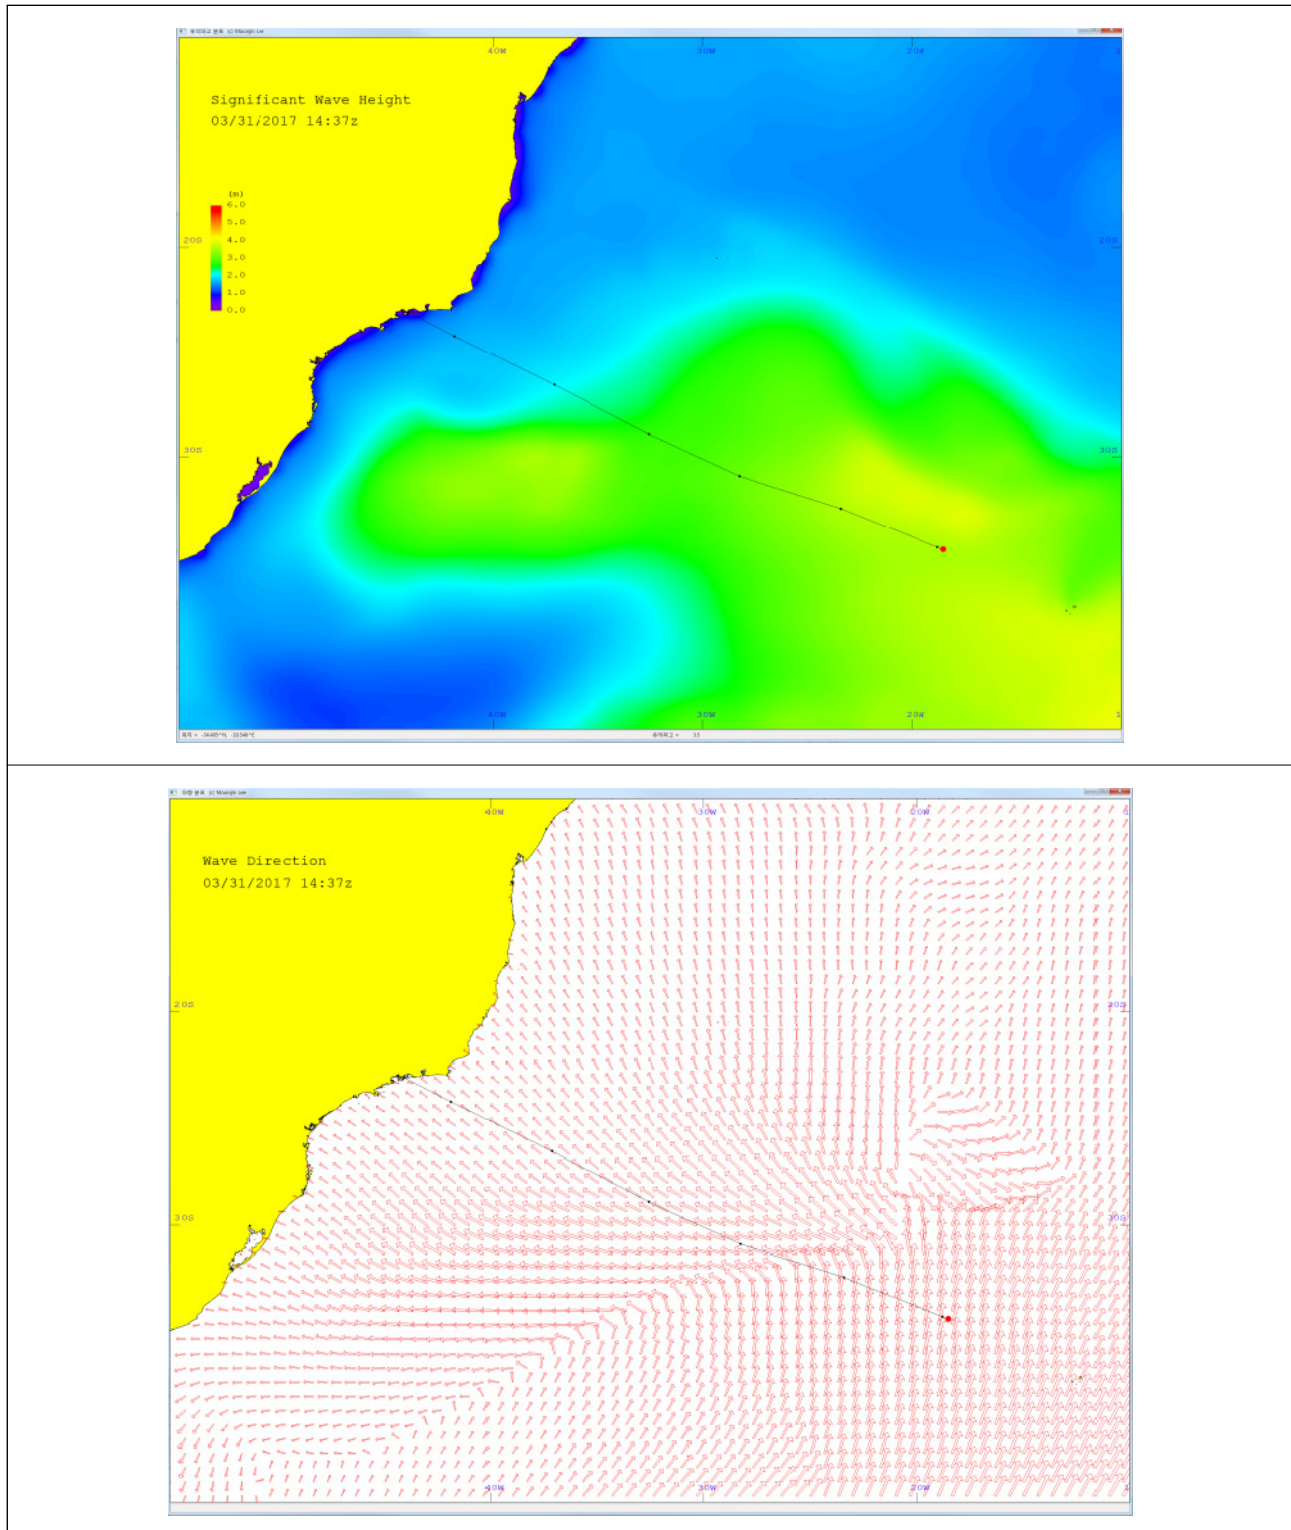
[Figure 31] Distribution of H_s and wave directions at the time of the accident

4.1.1.4 The significant wave height (H_s) and wave direction distribution at the time of the accident are visualized in [Figure 31].

4.1.1.10 Therefore, it is determined that such sea states, including waves at the time of the accident, are less likely to have increased the ship's motion excessively and caused significant damage to the hull or capsized the ship.

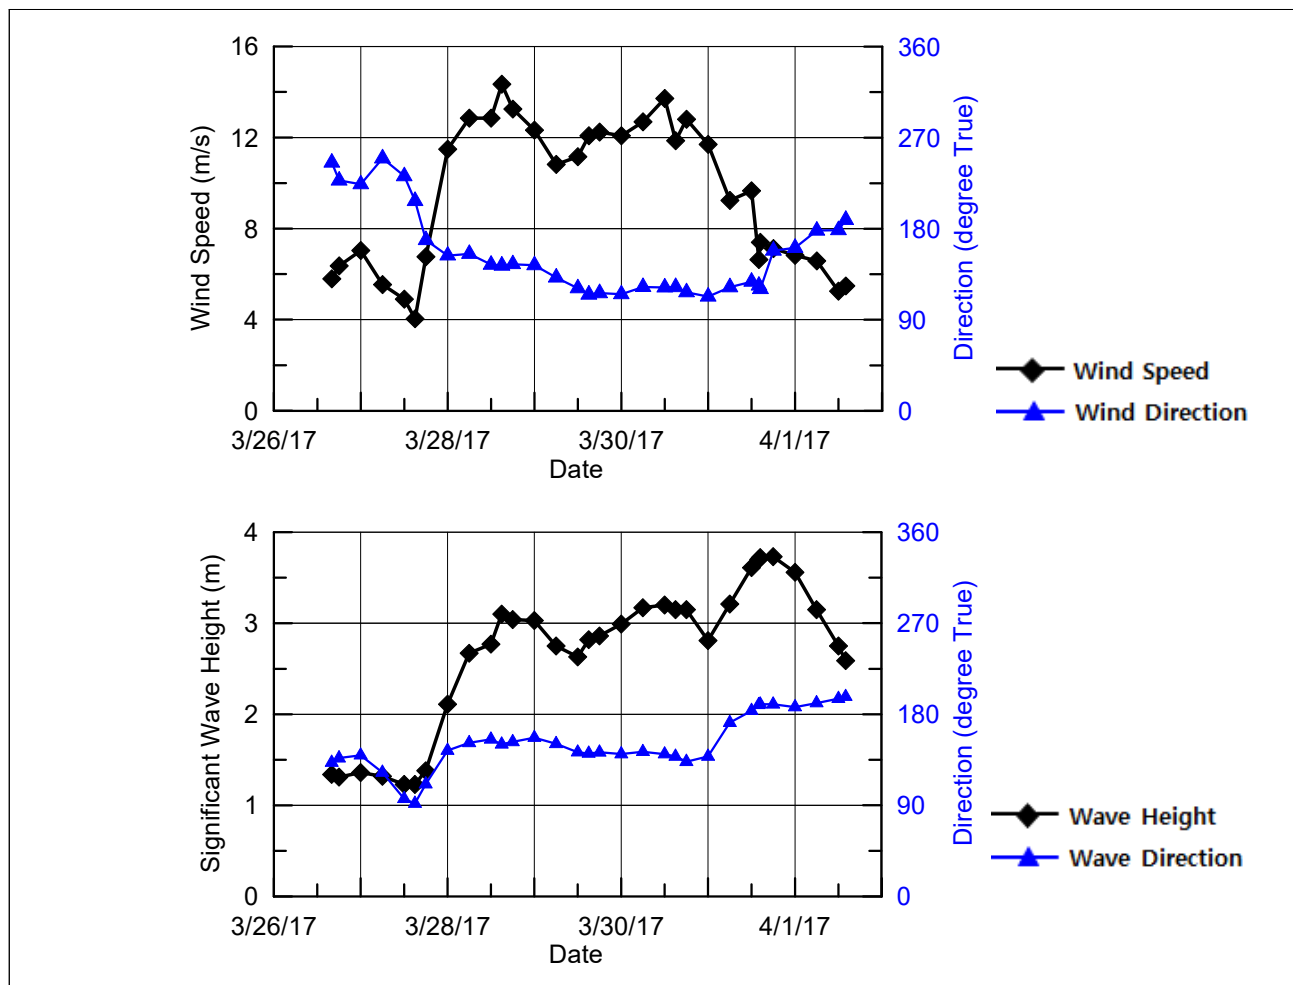
[Figure 32] Sea states of the accident voyage by time

4.1.1.6 Analysis also shows that Stellar Daisy sailed at 11.5 knots on average for about 129 hours from the time her departure on 25 March 2017 to the moment of the accident. Meanwhile, she encountered winds mainly coming from the southeast at a speed of 6-14 m/sec and waves with Hs of 1.2-3.7 meters, but the waves direction shifted from the east to the south, as demonstrated on the graphs in [Figure 32].

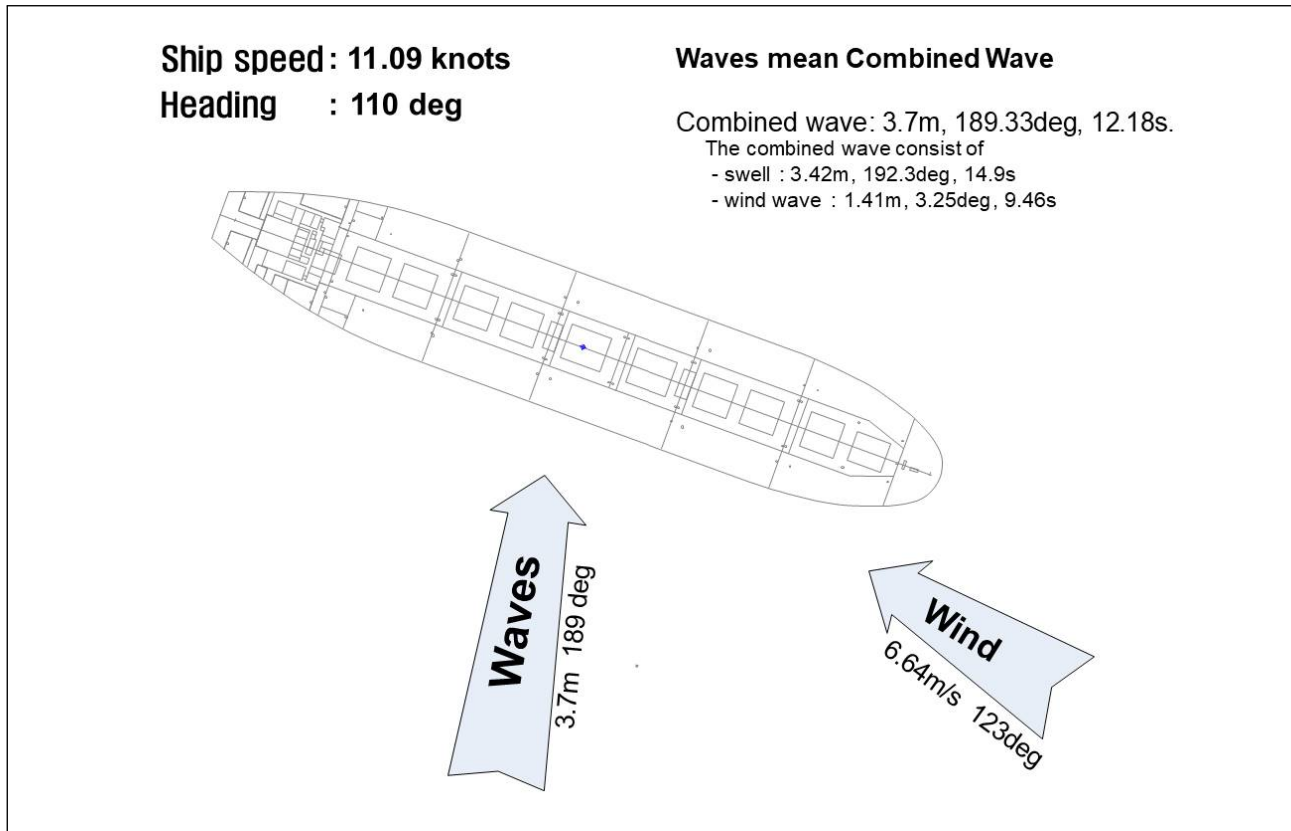
[Figure 33] Wind and wave at the time of the accident

4.1.1.7 At the moment of the accident, the wind was coming from the starboard bow of Stellar Daisy at about 6.6 m/sec, while a 3.7-meter-high wave was coming from the ship's starboard beam.

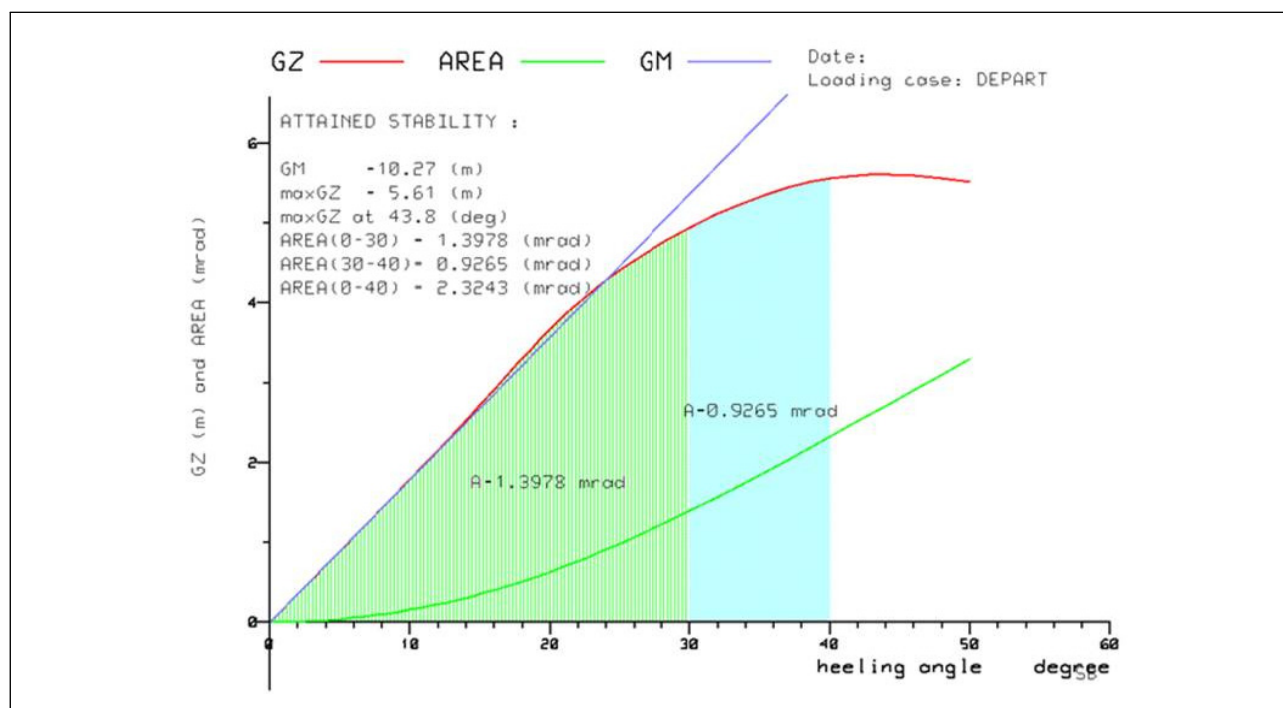
[Figure 34] Righting lever curve

4.1.2.2 The righting lever curve of Stellar Daisy resulting from the stability calculation is demonstrated in [Figure 34].

4.1.2.3 Stellar Daisy satisfied the required intact stability criteria⁴⁵⁾, such as the initial metacentric height and maximum righting lever, at the time of her departure as shown in [Table 18].

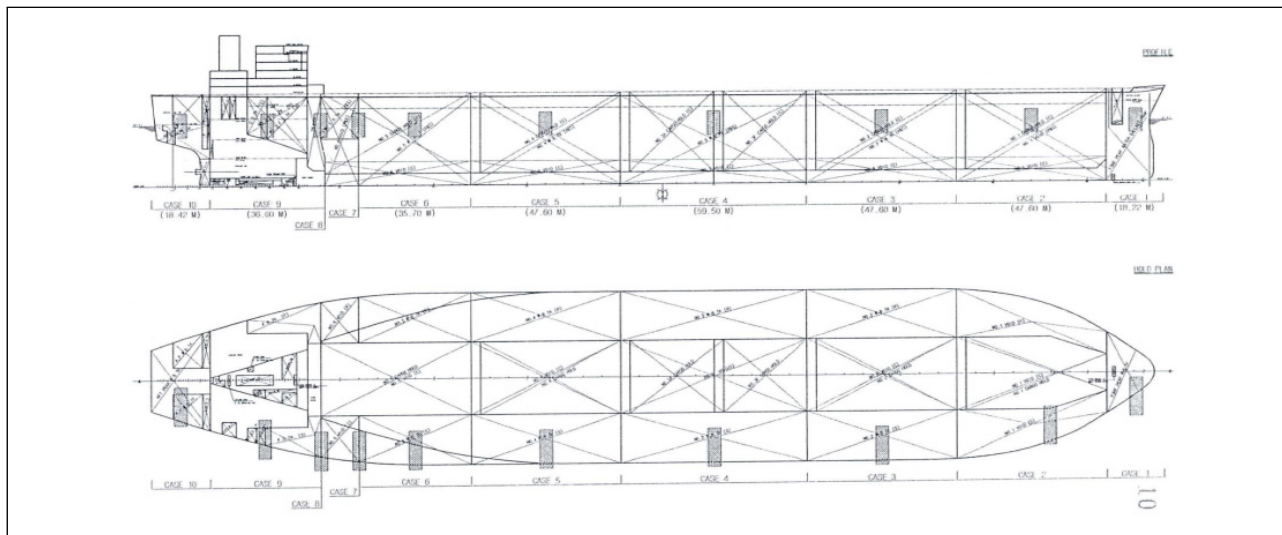
[Figure 35] Damage cases

4.1.3.3 The ship's damage stability book reviewed a total of 10 damage cases. The stability calculations of each case are presented in [Figure 35] and [Table 20].

4.1.3.4 Among the ten damage cases, seven (Case Nos. 2–8) are related to the flooding of the wing tanks inside adjacent to the cargo hold. Moreover, the damage stability criteria required in SOLAS Regulation XII 4.2 (Damage stability requirements applicable to bulk carriers) are applicable for case No. 2 where cargo hold No. 1 is damaged. In that case, calculations showed that the heel angle was 9.82° , which is less than the threshold of 15° , while the GM was 7.021 m, which is 0.763 m higher than the threshold of 6.258 m. Such results indicate that the damage stability of Stellar Daisy met the requirements specified in Regulation XII/4⁴⁹⁾.

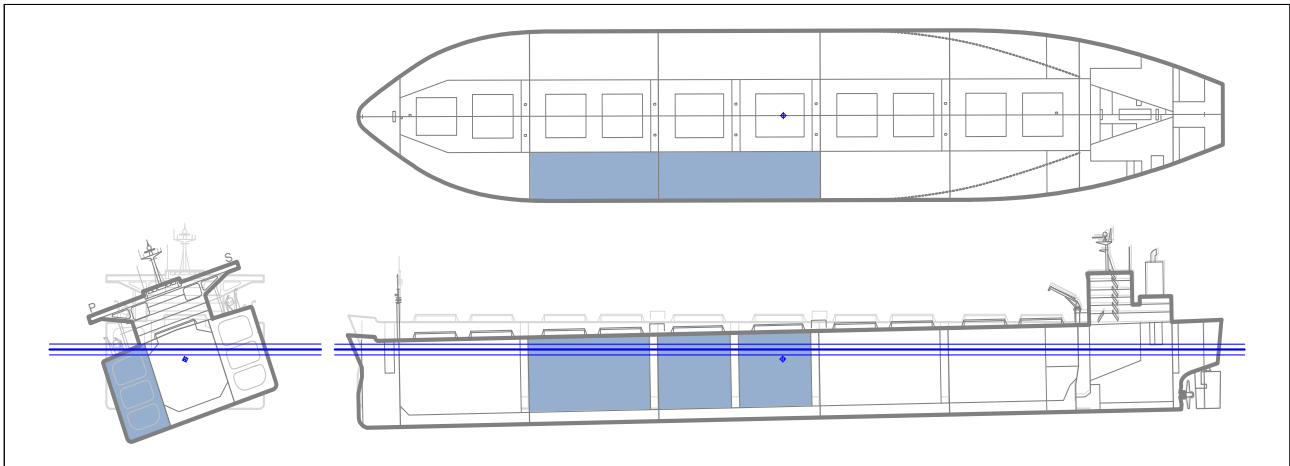
[Figure 37] The hull's immersion and posture if WBT Nos. 2 & 3 (P) were damaged⁵²⁾

- 4.1.3.9 In addition, the calculations showed that when both WBT Nos. 2 and 3 (P) were simultaneously flooded under the loading condition at the time of the accident, which is not the required criteria of the damage stability calculation, the heel angle would be about 19° , the ship would go under about 3.3 m, and thereby the upper deck of the ship would start submerging. Despite the significant wave height at the time of the accident, the hatch covers of the cargo holds were estimated to remain afloat as in [Figure 37].

4.1.3.10 In conclusion, the loading conditions of Stellar Daisy had satisfied the damage stability criteria required in the international conventions at the time of the accident. Even if WBT Nos. 2 and 3 (P) were both damaged, it seemed difficult to determine that such stability had caused the ship to sink in the sea.

52) In a scenario where damage was made to an 1 m x 4 m area on the lower shell plate of both WBT Nos. 2 and 3 (P) under their waterlines, it took about 700 seconds to reach 90% of the ship's final state.

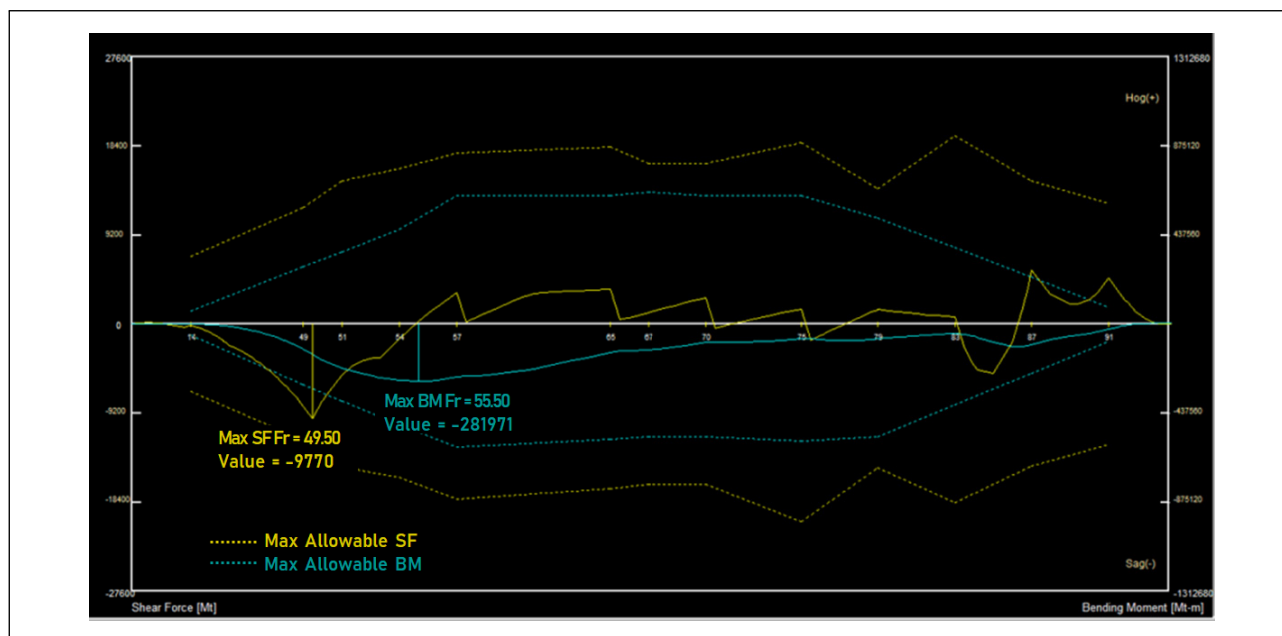
[Figure 38] Longitudinal strength calculation after completion of loading

4.1.4.3 The at-sea values of the BM and the SF when cargo loading had been completed were calculated in [Figure 38]. The maximum value of the BM was 53% at the frame No. 55.00, and that of the SF was 77% at the frame No. 49.50, meaning that both remained within their allowable limits as well.

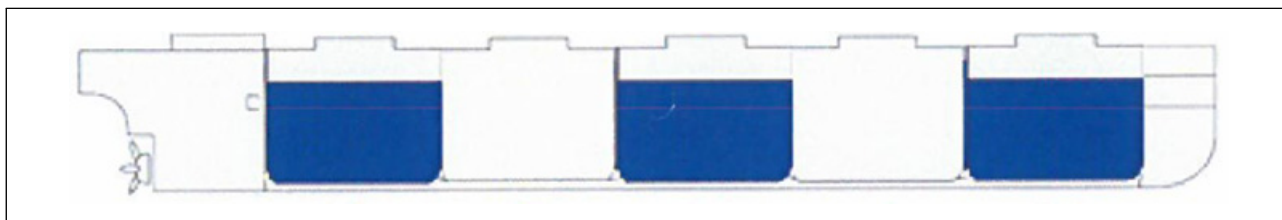
[Figure 39] Example of alternate offloading (discharging cargo from alternate holds)

4.2.2.4 It was during eight voyages, described in [Table 22], when the vessel offloaded cargo at two discharging ports among 33 voyages with a full load after the conversion. Among those, the ship offloaded the same amount of cargo from each hold at the first port of discharge and moved to the second discharge port during the four voyages. However, the ship was operated in an "alternate loading condition," meaning that the ship offloaded all of the cargo from alternate holds at the first port of discharge and then emptied out the other holds at the second discharge port over the remaining four voyages as illustrated in [Figure 39].

4.2.2.5 Even with voyage No. 40, the one just before the accident, Stellar Daisy discharged all of cargo from only cargo hold Nos. 2 and 4 and left cargo in cargo hold Nos. 1, 3, and 5 at the port of Tianjin in China and proceeded to Caofedien in China in the alternate loading condition.

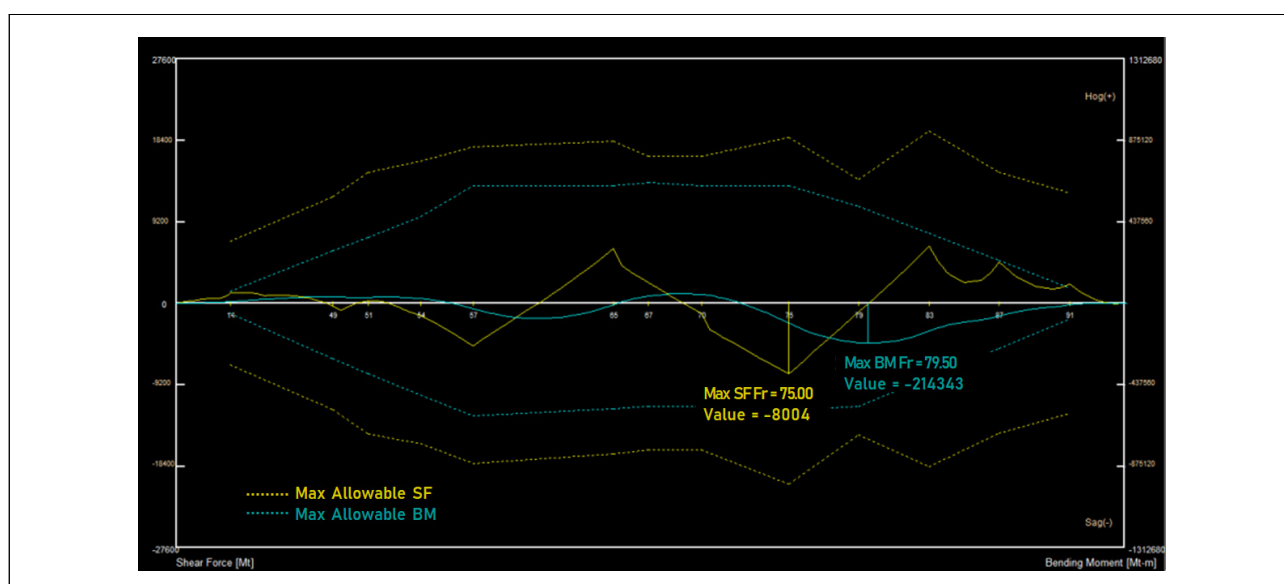
[Figure 40] Longitudinal strength calculation of the loading computer

4.2.2.6 For the ship in the alternate loading condition during voyage No. 40, the loading computer calculated the hull strength and showed that both BM and SF were within the allowable levels as frame No. 75.90 had the maximum BM, amounting to 40% of the allowable level, and frame No. 75.00 had the maximum SF, or 93% of the allowable level as in [Figure 40].

4.2.2.7 However, the computer could not be used to check the ship's local stress⁶⁸⁾ which might be generated when cargo was not evenly loaded or offloaded. That is because the computer could offer only the BM and the SF for hull strength.

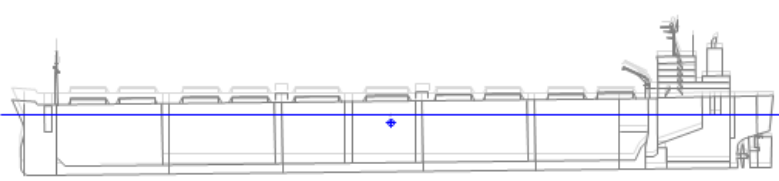
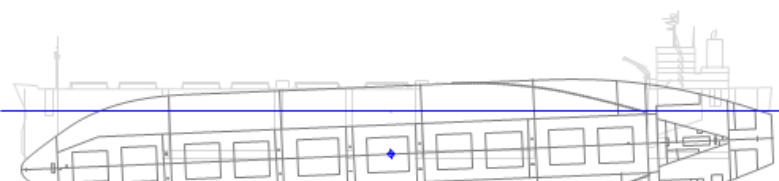
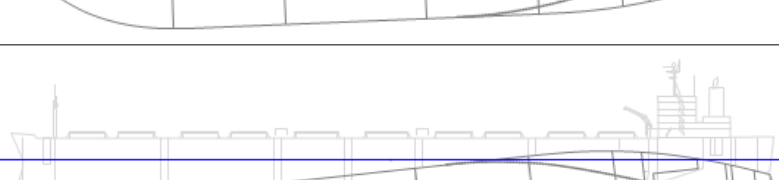
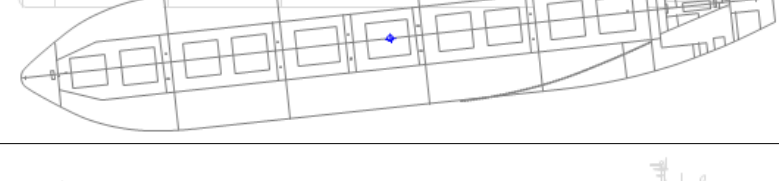
[Table 25] Scenario No. 1

- 4.3.3.1 The estimated scope of damage and the results of its simulation led to the conclusion that at least three tanks on port, including WBT No. 2 (P), would have had to be flooded in order for Stellar Daisy to sink within about five minutes.
- 4.3.3.2 In addition, the ship needs more than 170,000 tons of water flowing into the hull to lose her buoyancy. The ballast and void tanks on port are not large enough alone to store 170,000 tons of seawater, leading to a presumption⁷⁵⁾ that the double-bottom tanks were also damaged and the ballast tanks on starboard were also flooded, accordingly. Also, the cargo is presumed not to have spilled at all or just slightly.

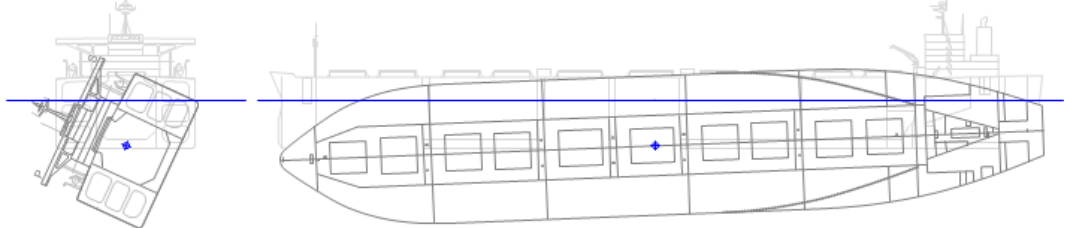
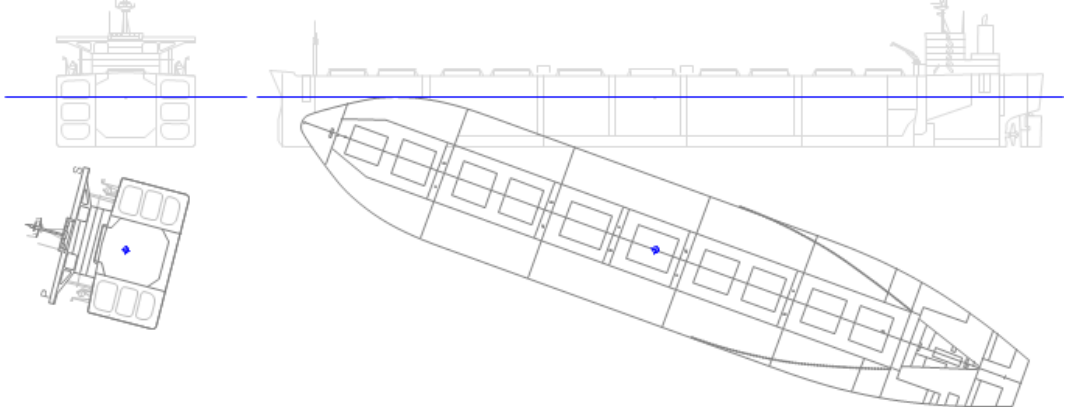
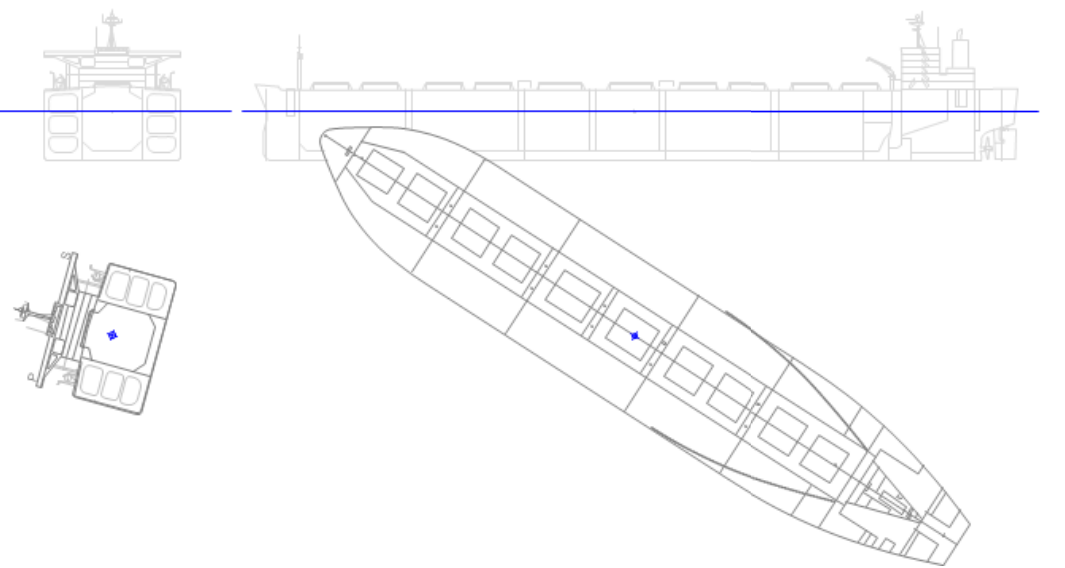
4.3.2.9 The scenario No. 2 is also consistent with the situation described by the survivors. In this case which added cargo hold No. 5 and VT No. 5 (S) to the scenario No. 1, the aft body of the ship sank first, unlike the scenario No. 1.

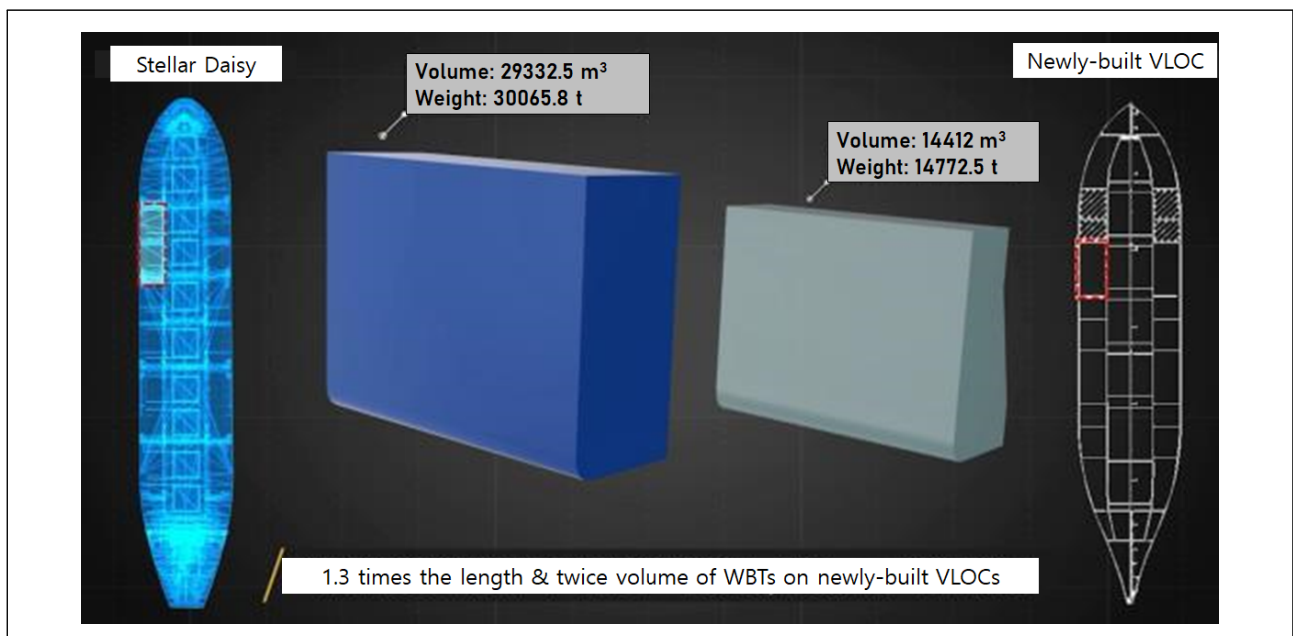
[Figure 42] Size comparison of Stellar Daisy's WBT to that of new VLCCs

4.4.2.3 Also, as an ore carrier converted from a single-hulled oil tanker, Stellar Daisy has ballast tanks on both sides that are 1.3 times the length and twice the volume of those on the recently-built ore carriers.

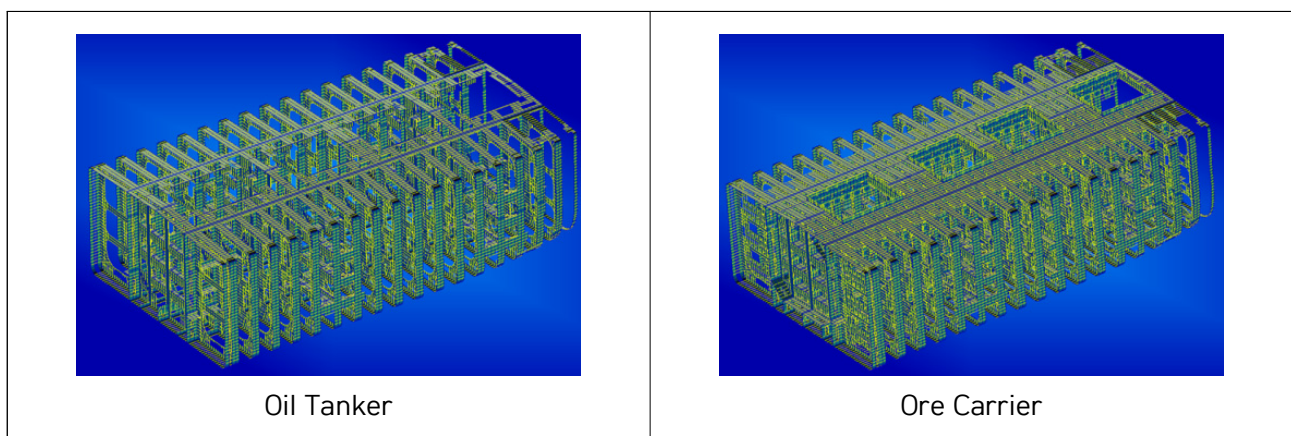
[Figure 46] Structural member for fatigue strength analysis

- 4.4.4.3 The scope of this analysis includes the rear half of cargo hold No. 1, whole of cargo hold No. 2, and the forward half of cargo hold No. 3. Fatigue strength was also analyzed for all members of those structures welded to other members.

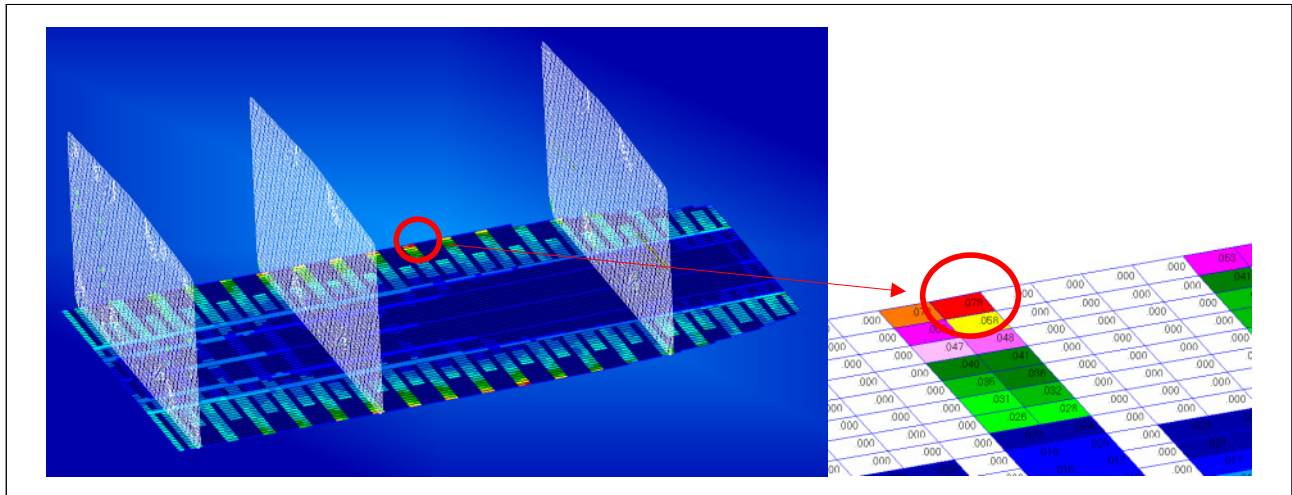
[Figure 47] Fatigue-critical areas of the bottom plate

- 4.4.4.8 The results showed that the bottom and side plates in way of the bilge area of WBT No. 2 (P/S) were more critical than any other primary members⁹²⁾ of the hull structures, as presented in [Figure 47] and [Figure 48]. Since these areas are not fitted with structures to reduce the stress concentration effect, they may show a high level of fatigue damage if the finer mesh size is applied in the analysis.

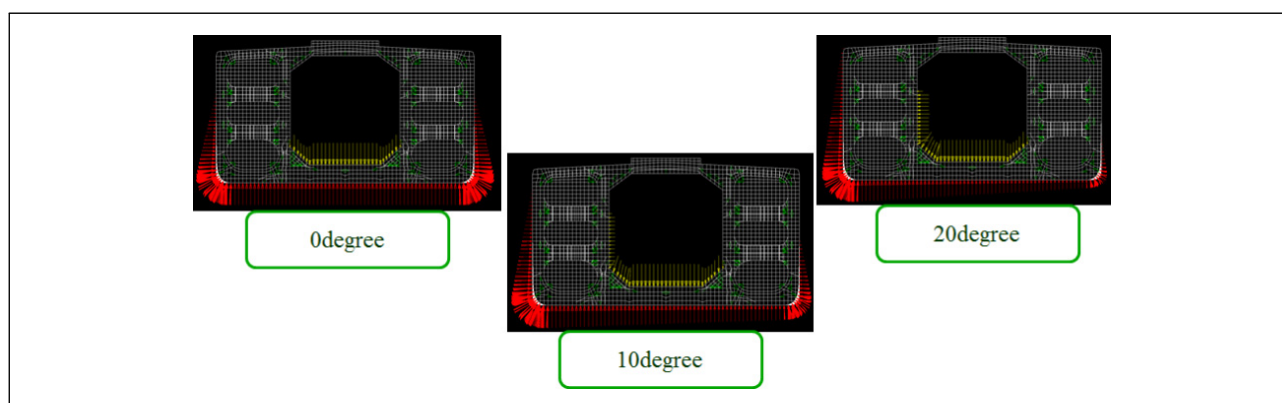
[Figure 49] Application of load at heel angles

- 4.4.5.1 The cargo hold structural analysis was conducted under the KR rules when Stellar Daisy was converted. At that time, however, the KR rules did not require asymmetric lateral load, and thereby, it was not considered in the analysis as well. Thus, cargo hold No. 4 was added to the models used in the fatigue strength analysis to assess the impact of the asymmetric lateral load. The structural strength of the members connected to cargo hold Nos. 1 to 4 was examined at each heel angle⁹⁴⁾.
- 4.4.5.2 In the analysis, a buoyancy corresponding to the draft similar to the one at sea was applied to the hull at each heel angle. Instead, loads of the cargo holds generated at each heel angle were applied in vertical and transverse directions. Therefore, structural strength was assessed at heel angles from 0° to 20° with five-degree intervals.

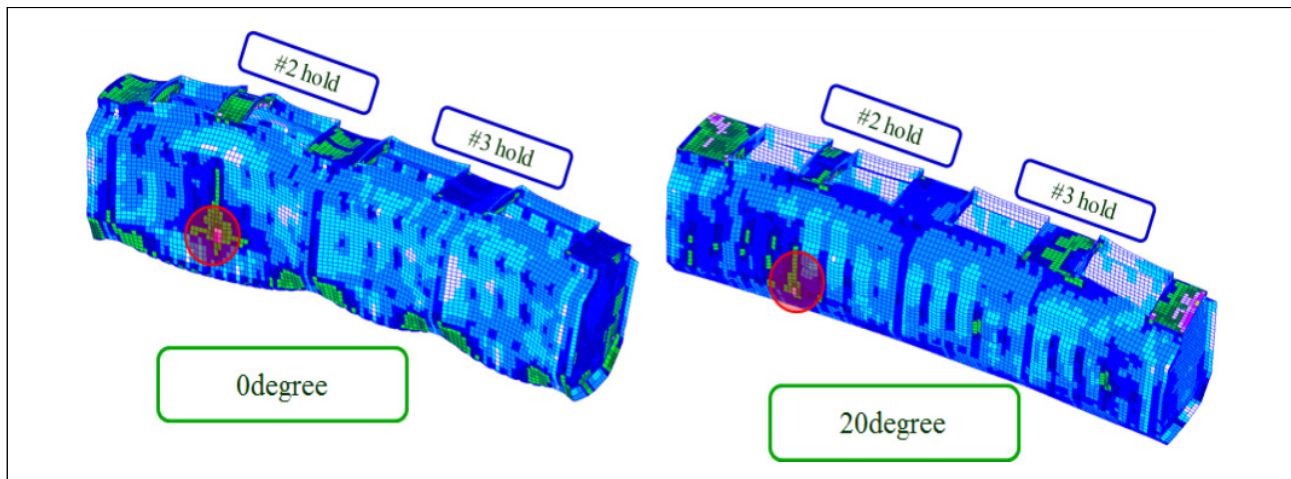
[Figure 50] Stress distribution of C/H Nos. 2 and 3

4.4.5.4 The results from the structural strength analysis of cargo hold Nos. 2 and 3 at heel angles showed that the stress was high at certain locations, including the inner longitudinal bulkheads and hoppers at frame No. 79 of cargo hold No. 2. However, these members' stress was about 53% of their yield stress (315 Mpa), lower than 80%.

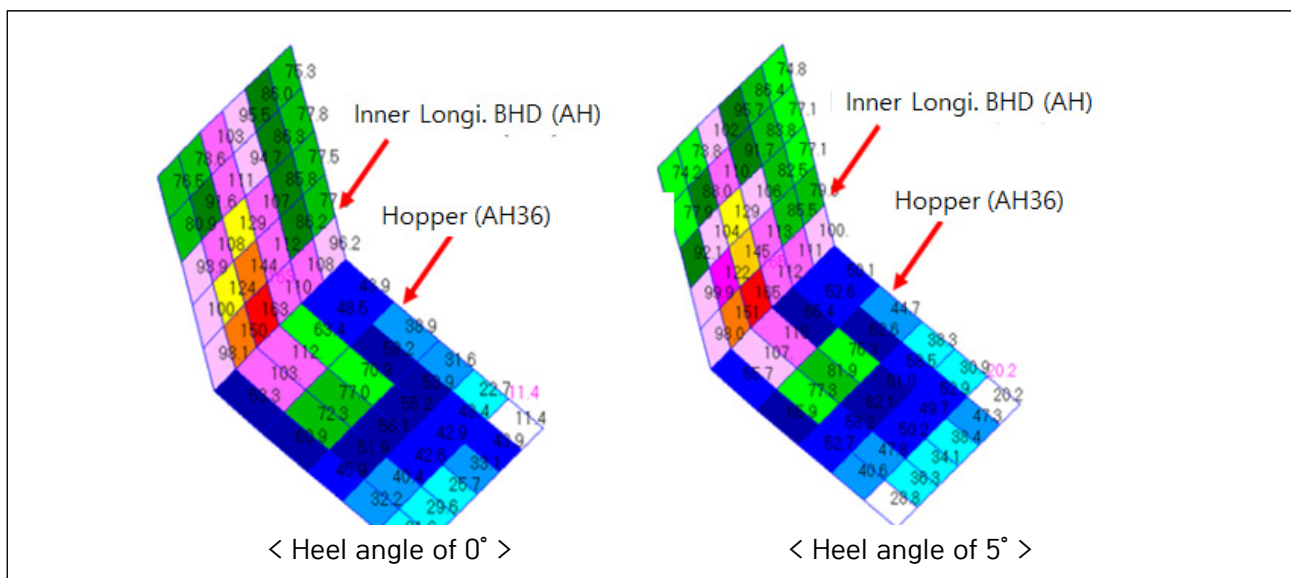
[Figure 51] Stress of FR. 79

4.4.5.5 Meanwhile, in the structural strength analysis of the members in way of the cargo holds, the stress of certain areas, such as transverse members at frame No. 79 in cargo hold No. 2 and at frame No. 72 in cargo hold No. 3, exceeded their yield stress at heel angles between 0° and 10°. When the angle was 10° or larger, several

of those transverse members in cargo holds No. 2 and 3 showed the probability of structural damage on their upper side. It is presumably because those transverse members were made of mild steel and there were weld lines going along the lower end of the high stress zones.

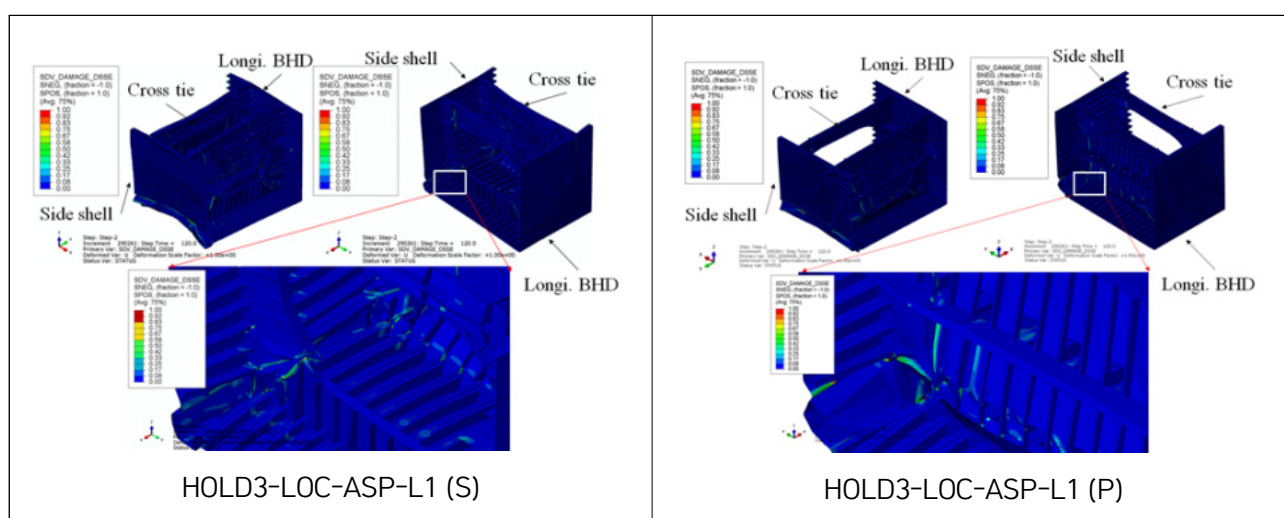
[Figure 61] Visualization of damage to L1 of C/H No. 3

4.4.7.6 In contrast, when the ASP was applied to the structures, fracture, including buckling and structural damage, were likely to occur extensively in such areas as the bilge plate, inner cross tie, and the transverse frame connections of the local model, L1. The extent of the damage to the local models (L1) of cargo hold Nos. 2 and 3 are well visualized in [Figure 60] and [Figure 61], respectively.

4.4.7.8 The results of the fracture analysis show that if a ship sails under the ASP¹⁰⁵⁾ in beam seas for a long time, she may suffer damage (fractures) on the bilge plate, the inner cross tie, and the transverse frame connections of WBT Nos. 2 and 3 (P/S). And, when such damage is accumulated, it can undermine transverse strength, thereby causing structural vulnerability to the ship.

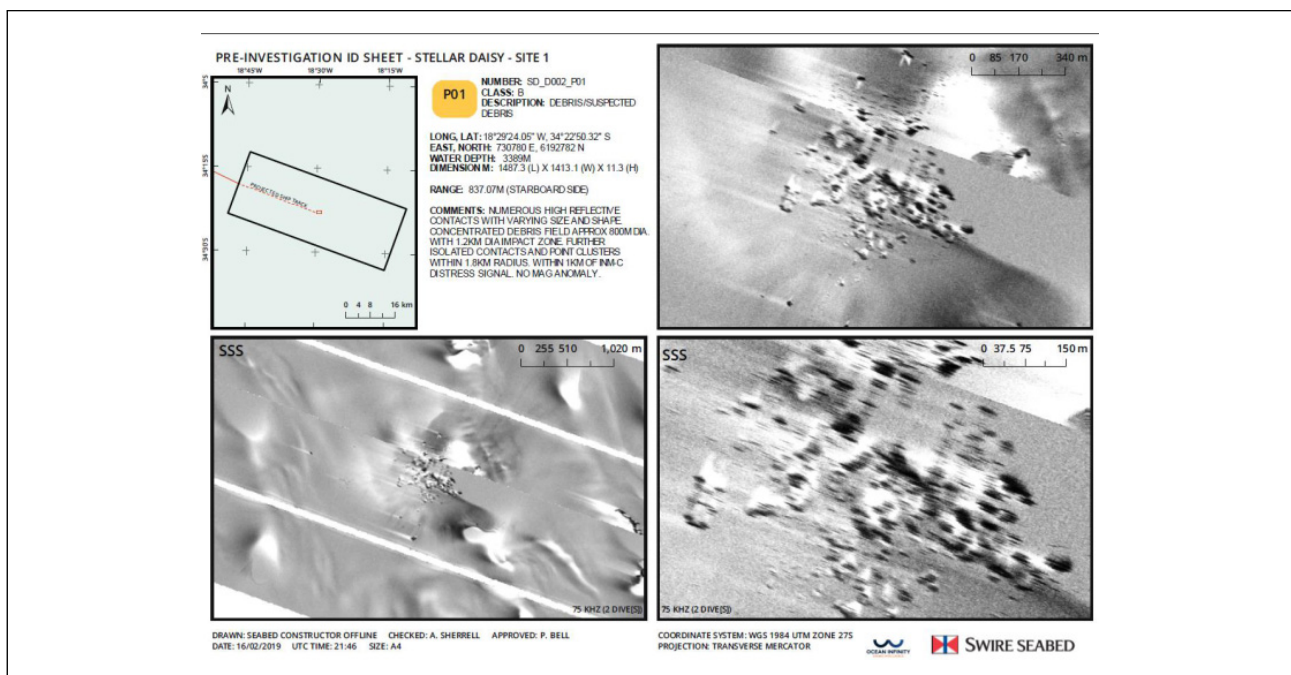
[Figure 67] Low-frequency SSS mosaic of the area presumed to have the ship's debris

5.2.3 The survey failed to identify any objects similar in size to the hull of Stellar Daisy. However, there were high reflective point contacts in various sizes and shapes, which were presumed to be the ship's debris, on an 1 km x 0.8 km seabed area in way of rock ridge about 1 km away from the EPIRB signal location.

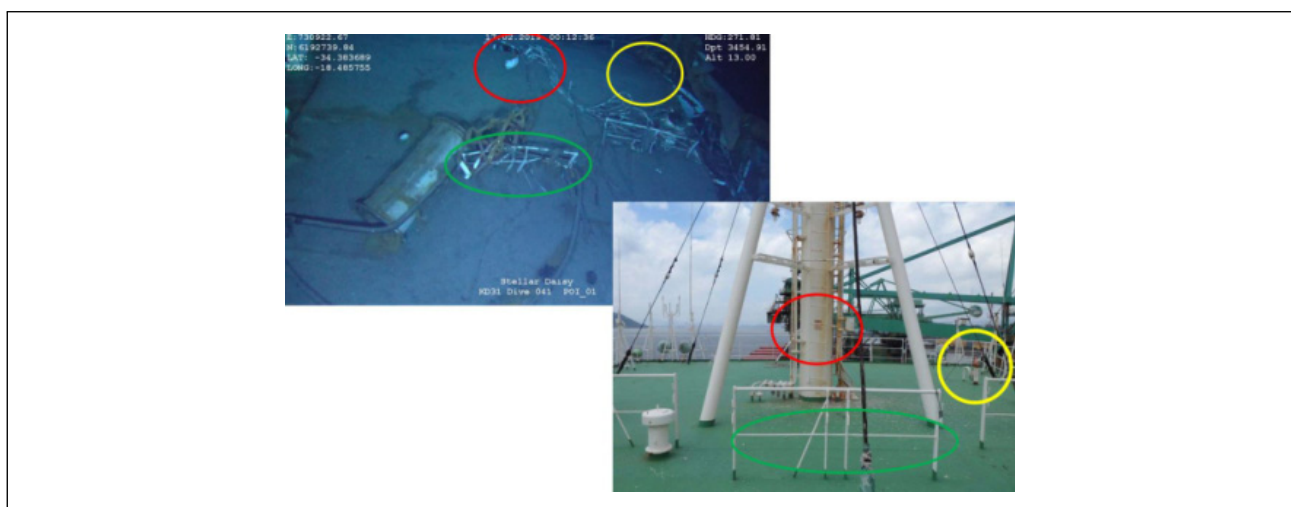
[Figure 70] Compass deck above the steering room before and after the accident

- 5.3.3 Later, the visual inspection continued to search for the VDR protective capsule of the ship.
- 5.3.4 The VDR protective capsule was originally installed on the compass deck above the wheel house. However, the compass deck was identified as detached from mast, handrails, and antenna or deformed during the visual inspection.

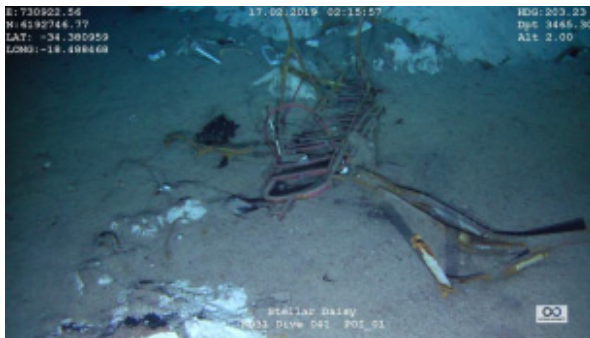
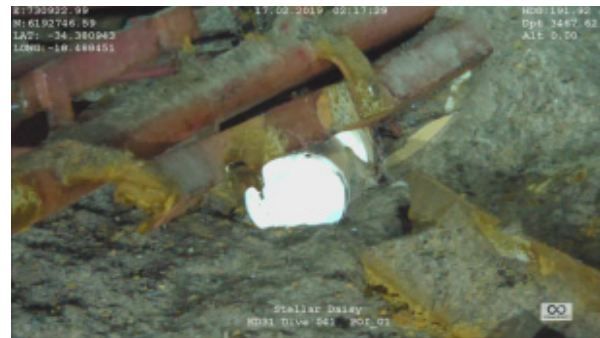
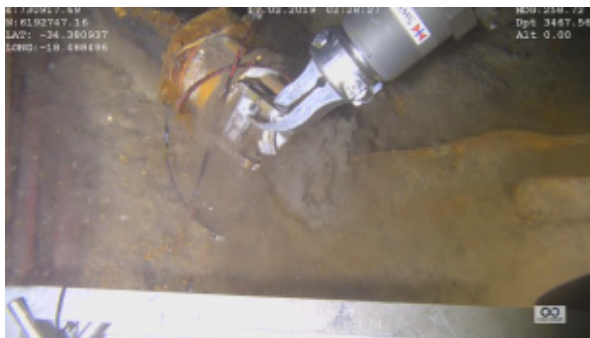
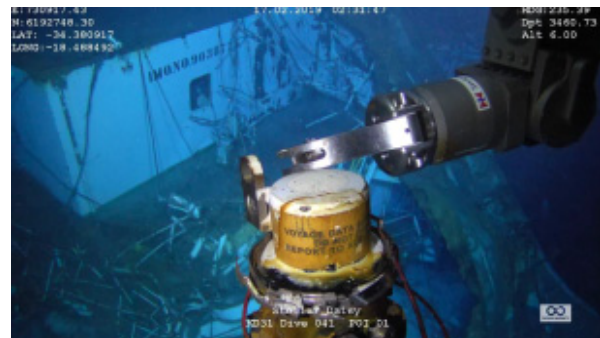
[Figure 71] Finding and retrieving the VDR

5.3.5 The protective capsule was observed under the object presumed to be a ladder on the starboard side of the bridge while conducting the visual inspection on the areas in way of the accommodation structures.

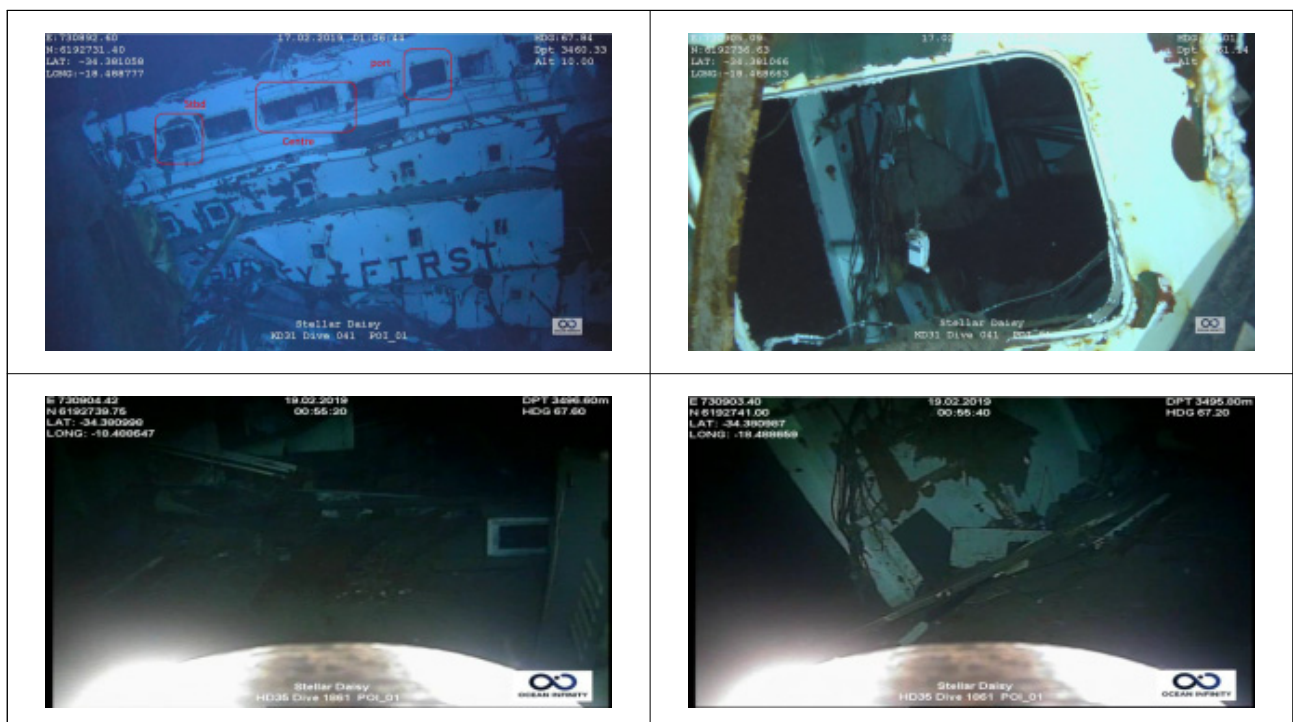
[Figure 73] Details of topside structures

5.3.7 Meanwhile, compared to the size of AUVs, the bridge access door or windows were relatively narrow, making it difficult to enter the bridge. Therefore, the AUVs checked the inside through the windows from the outside and observed widespread damage inside the bridge: the panels in the walls and ceiling were mostly broken, and cables inside the bulkheads were also exposed.
