[MSI Report 2022-001]

Marine Safety Investigation Report

– Sinking of VLOC, Stellar Daisy –

Korea Maritime Safety Tribunal
Marine Safety Investigation Team

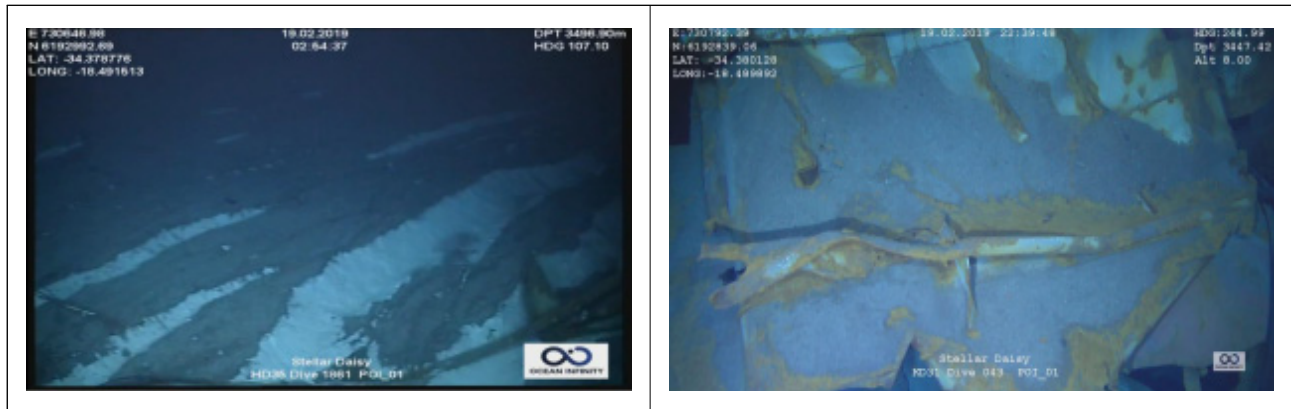
[Figure 78] Iron ore around the debris

5.5.3 The cargo of iron ore loaded on Stellar Daisy was deposited around the debris, and gray or brown metallic luster was observed.

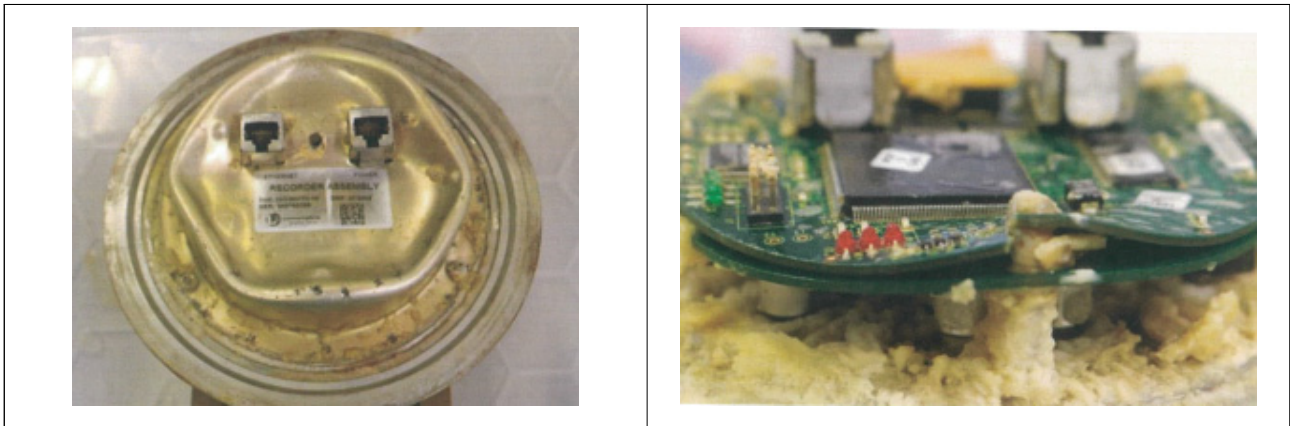
[Figure 81] Protective capsule's casing and processor board

5.8.2 The casing of the retrieved protective capsule was damaged. After removing it, the specialists found out that the processor board had been also damaged. They separated the board, took out the insulation materials inside, and ascertained that the memory module case was also deformed in many places.

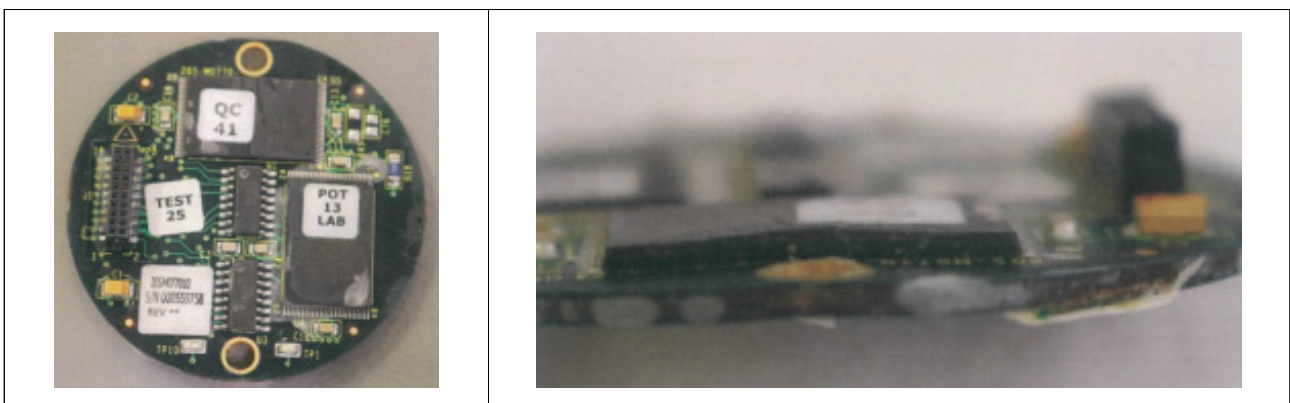
[Figure 83] Memory module

5.8.3 After opening the memory module case and examining the module's printed circuit board (PCB), they found there were two memory chips, which are the key components, and one of them was damaged. The other memory chip also indicated possible damage. The controller chip, another key component, was damaged as well.

5.8.4 The specialists recovered data from the relatively less damaged memory chip by removing it from the PCB and reading it with a chip reader. They discovered that 50 % of the data were invalid¹¹⁴⁾, 43 % were empty, and only 7 % remained valid.

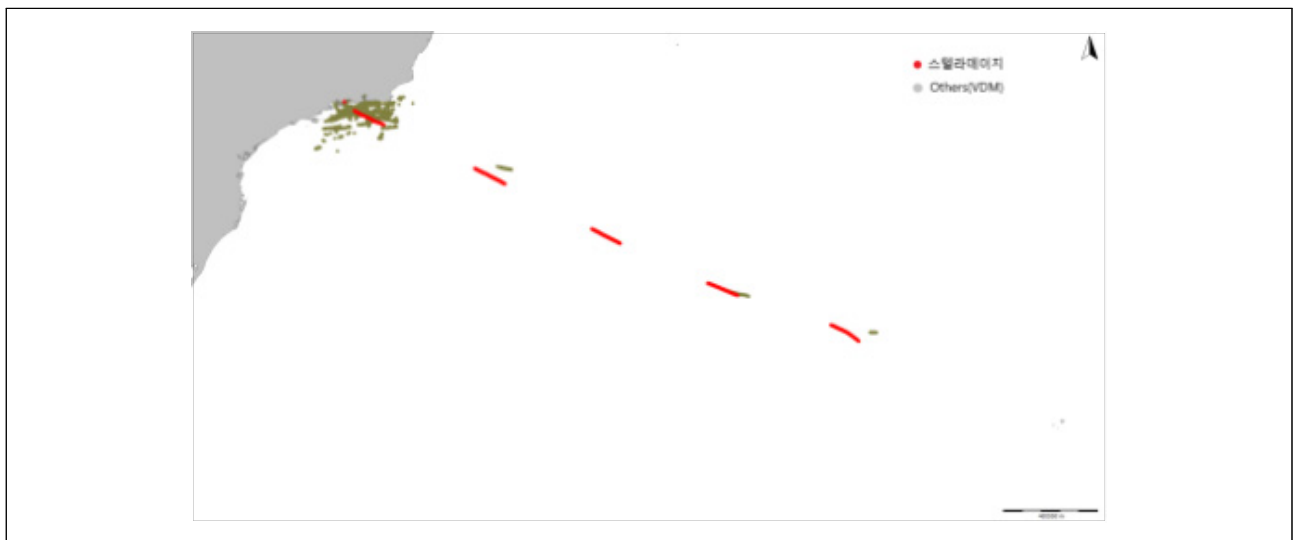
[Figure 84] Track of Stellar Daisy from the recovered data

5.8.5 The intact 7 % was processed and identified as GPS and AIS information. A total of 47 hours of information was saved as listed in [Table 32], and the data were divided into seven storage sections, which are marked on the chart as in [Figure 84].

115) The data on 24 and 25 March are the ship's location data while berthing, which indicate the positions the same as in [Figure 84].

5.8.6 The recovered data are the objective source as the tracking data confirm the sailing route of Stellar Daisy during the accident voyage. However, the data are of limited utility for analyzing causes of damage and sinking of the ship.

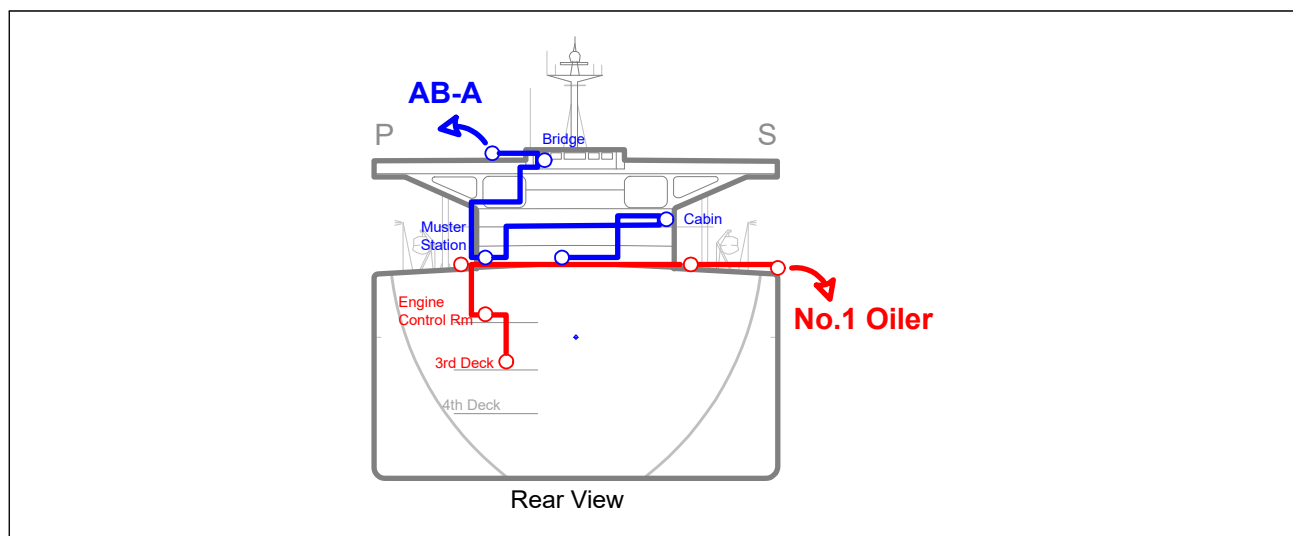
[Figure 85] Location of the surviving crewmembers at the time of the accident

- 1) The location of the surviving crewmembers, their travel routes, and other important information at the time of the accident are demonstrated in [Figure 85] and [Table 33] based on their statements, a message sent to the shipping company via a social media application, and EPIRB distress calls.

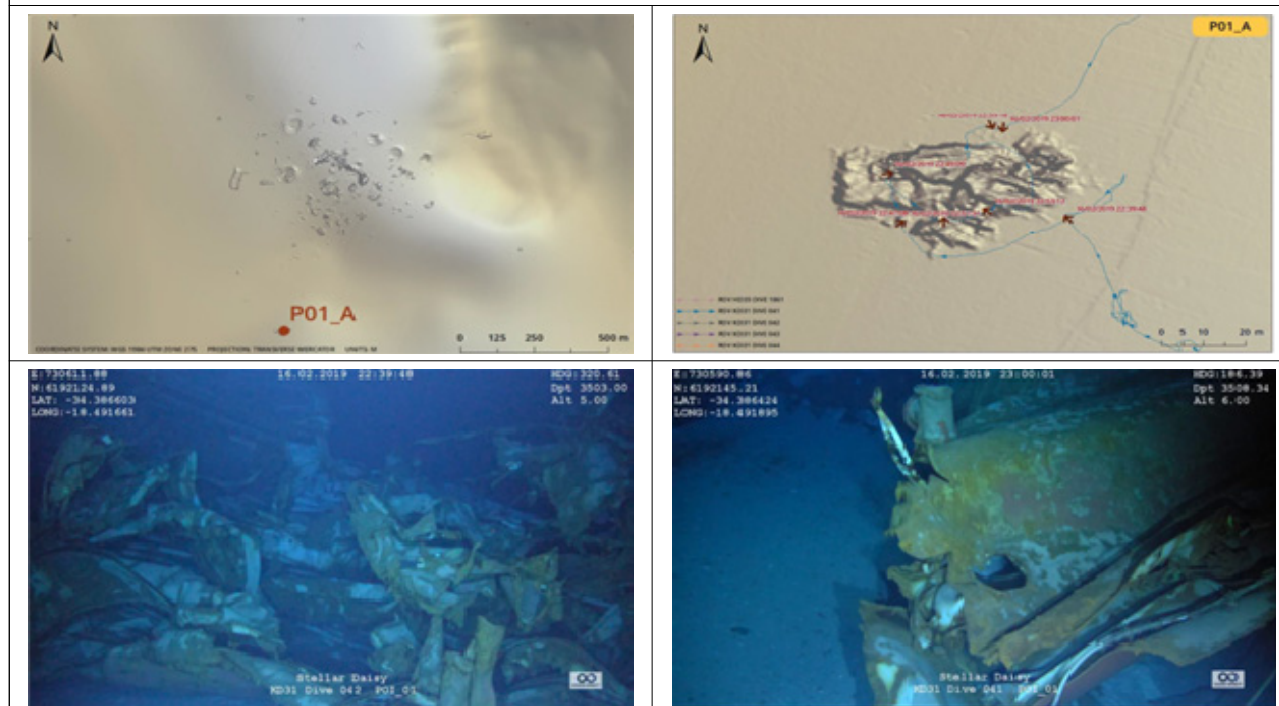
2. P01_AB01

These objects are presumed to be part of the deck structure where mooring bollards were located.

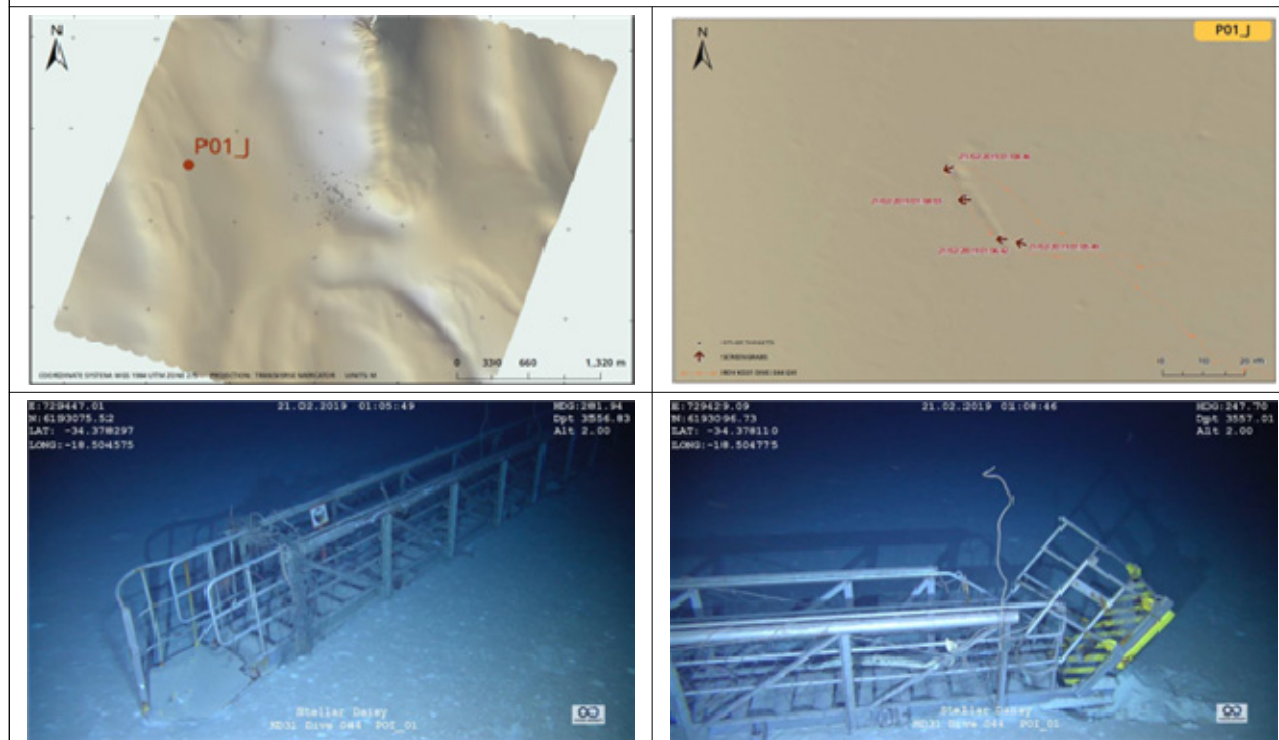
35. P01_J

The objects were identified as gangway structures.

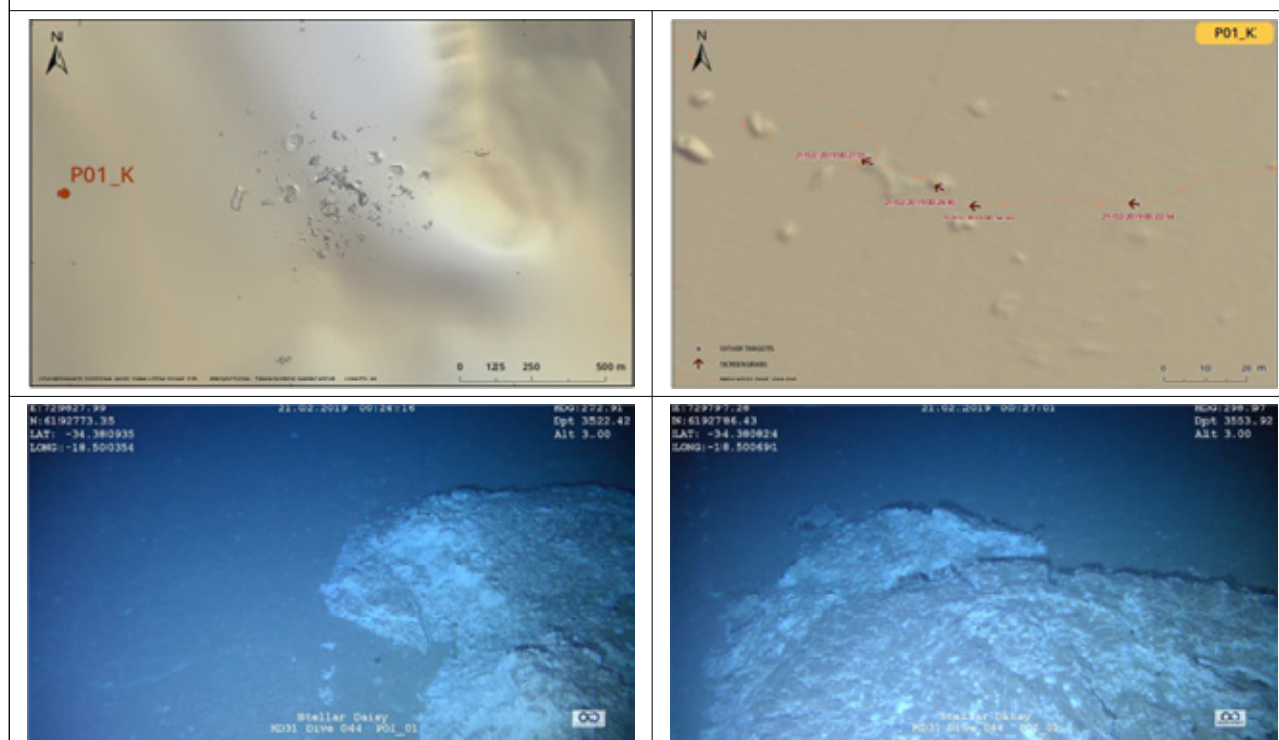
36. P01_K

There is debris scattering broadly and partly tainted with oil. But there is no debris from the hull structure. Given that, this point of interest is presumed to be where part of the fuel oil immersed.

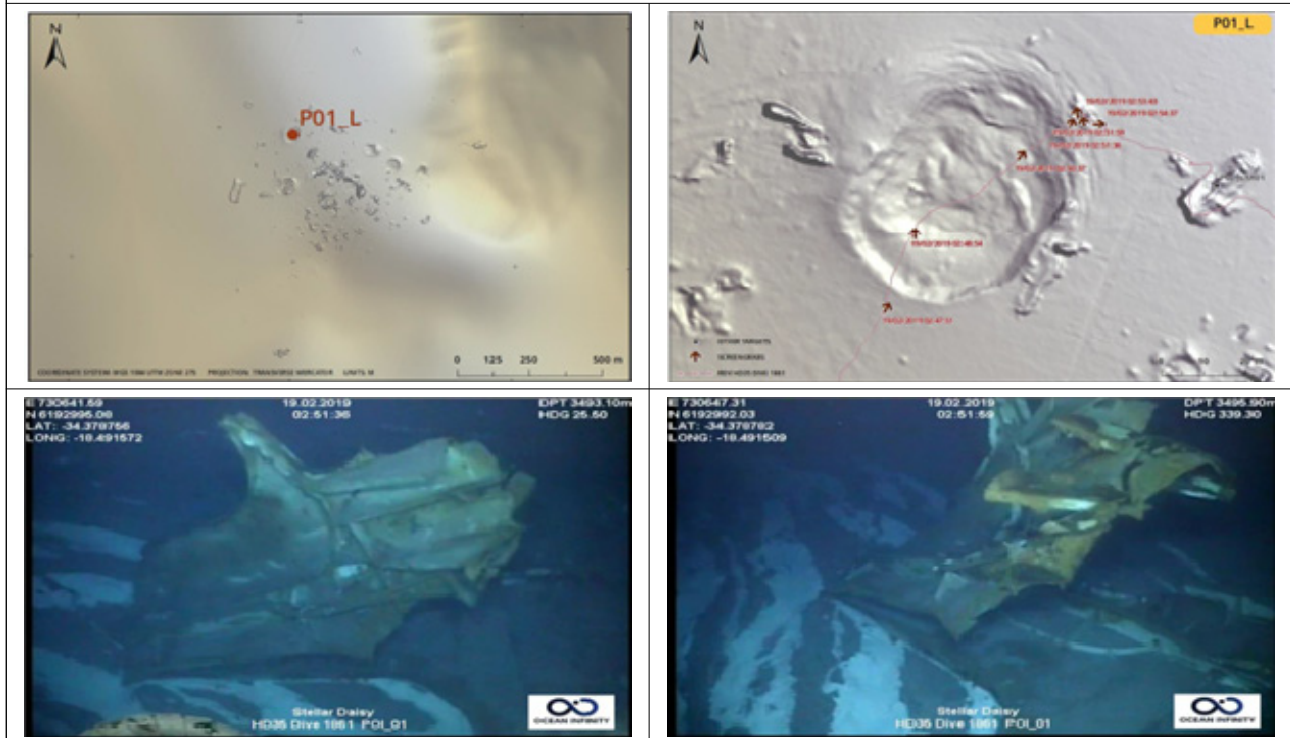
37. P01_L

There is debris identified as part of a ladder along with iron ore. The debris is difficult to determine but presumed to be part of structures inside the hull.

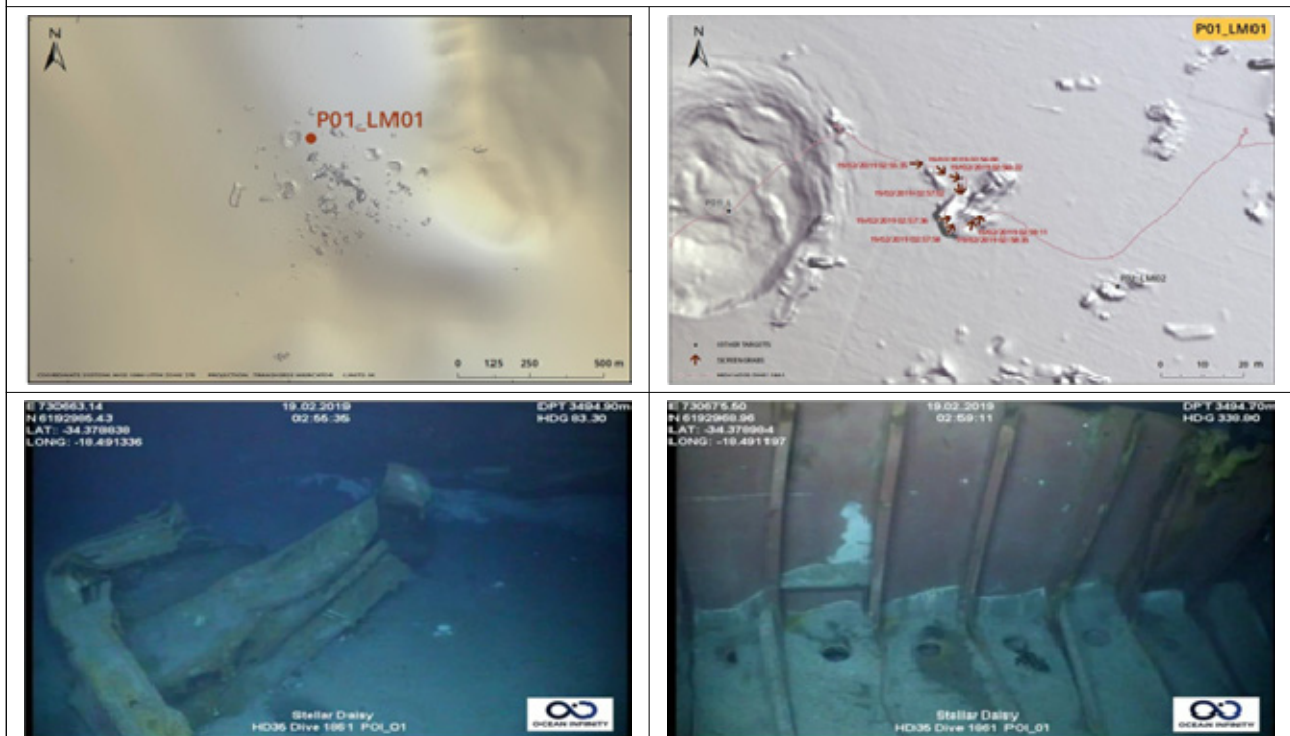
38. P01_LM01

The objects are pipe and torn and crushed stiffened plate structures with bar-type stiffeners. They are presumed to be part of the cargo hold or ballast tank structures.

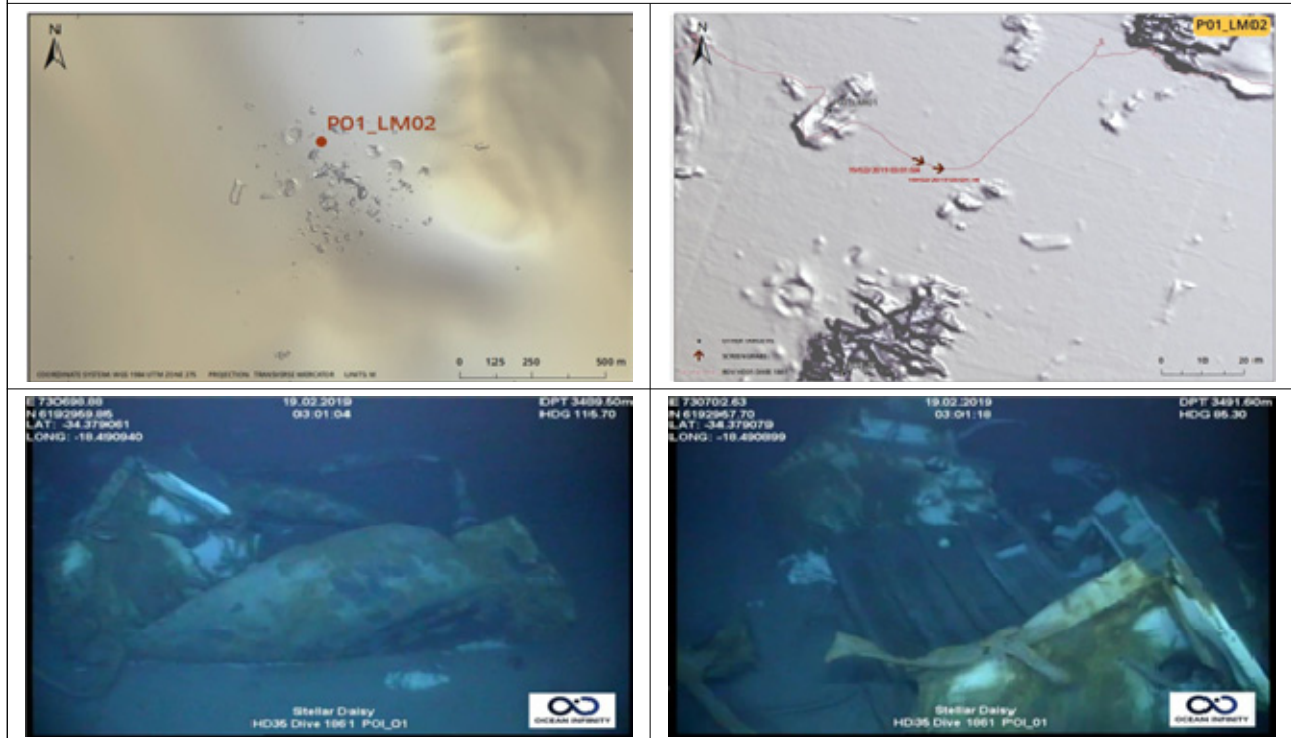
39. P01_LM02

The objects are severely torn and crushed. They are not certain but presumed to be part of the stiffened plate structures inside the hull fitted with frames.

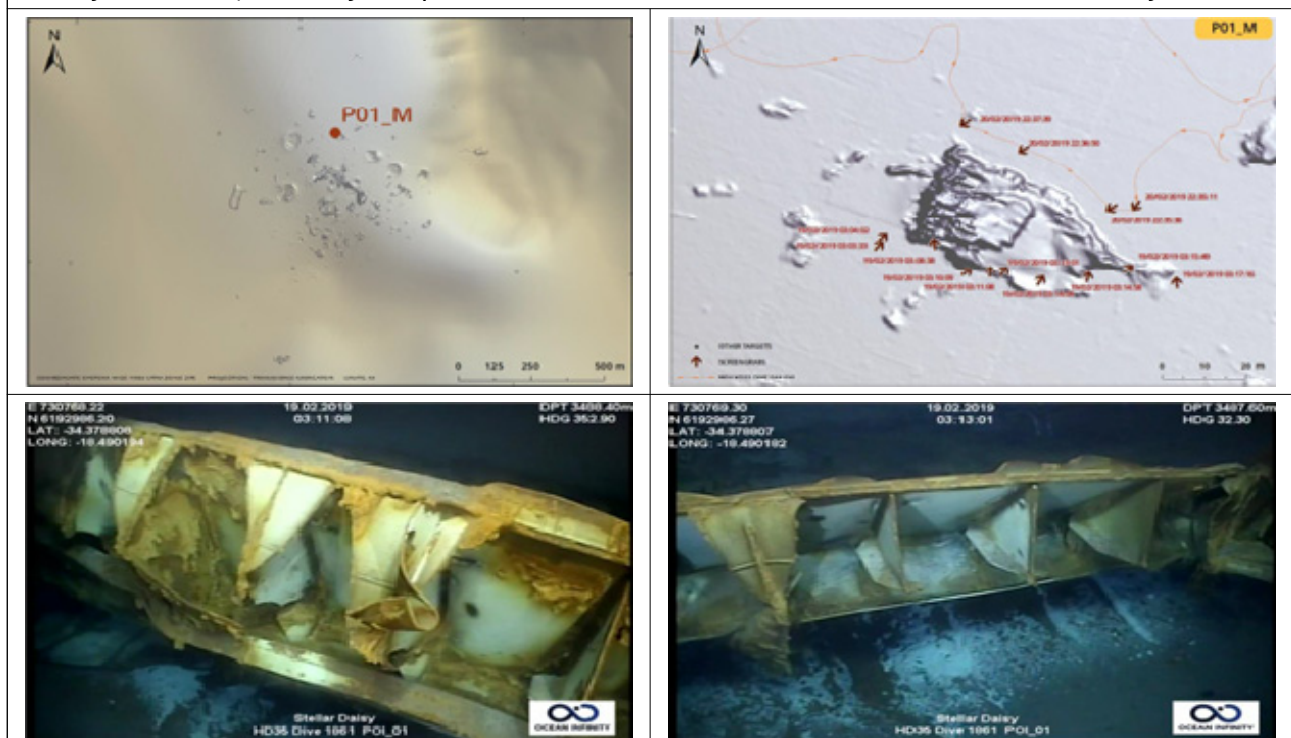
40. P01_M

The part of the hull from where these dented stiffened plate structures came cannot be easily identified, but they are presumed to be internal structures attached with many frames.

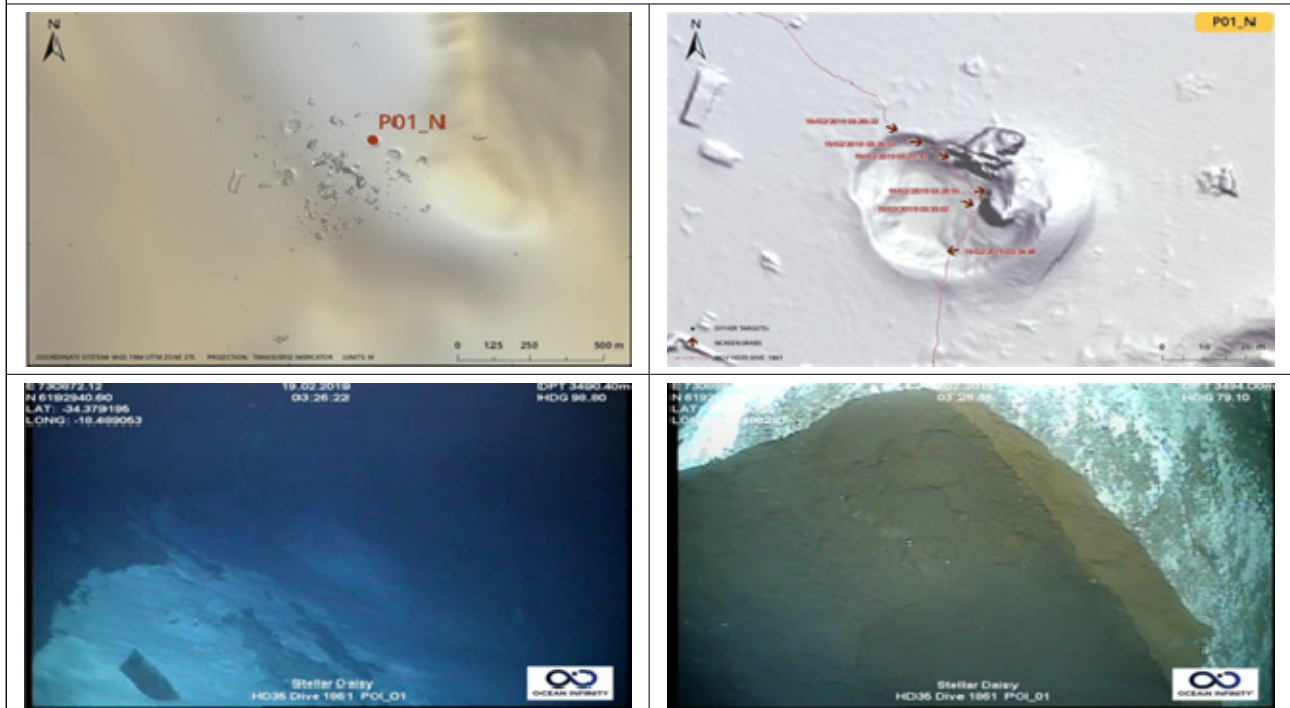
41. P01_N

Solid objects presumed to be iron ore and debris of many structures were observed. They are difficult to determine with precision but presumed to be from inside the hull in way of the cargo holds.

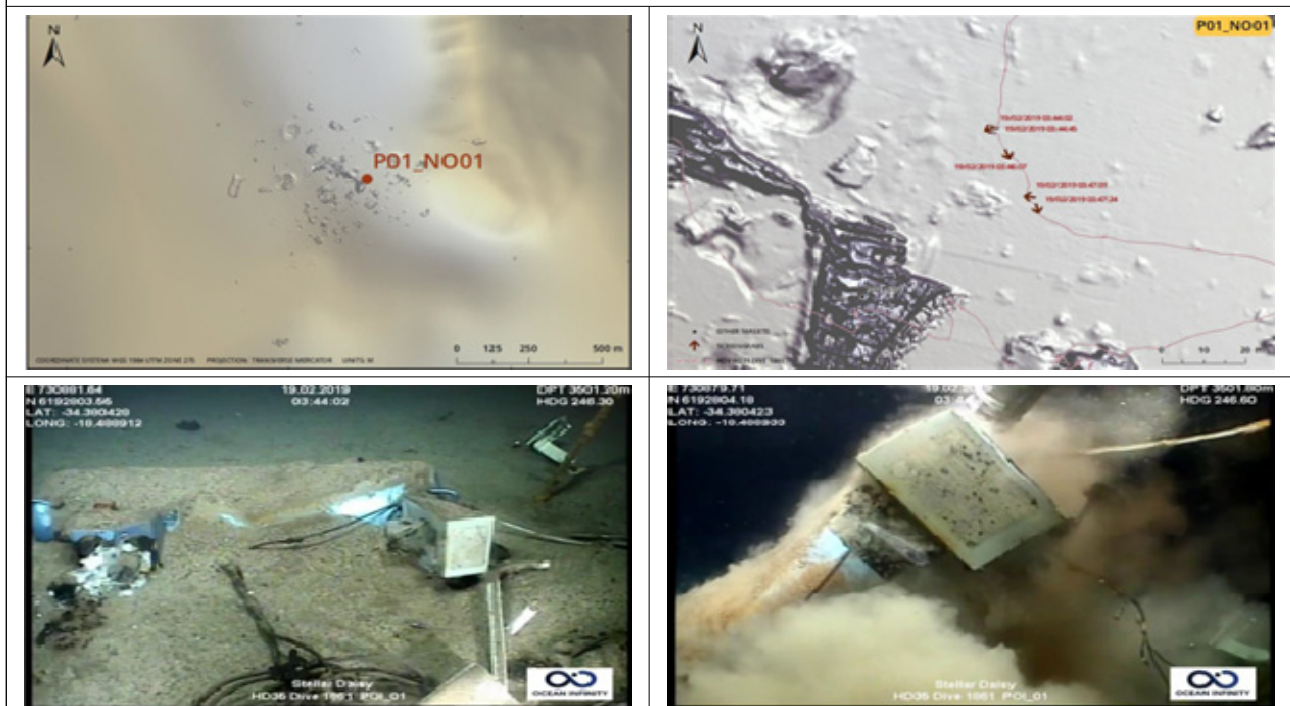
42. P01_N01

Seen here are numerous small pieces of debris presumed to be part of the bar-typed structure; cables; pipes; and other devices and torn and crushed stiffened plate structures. They are presumed to be part of the hull's internal structures.

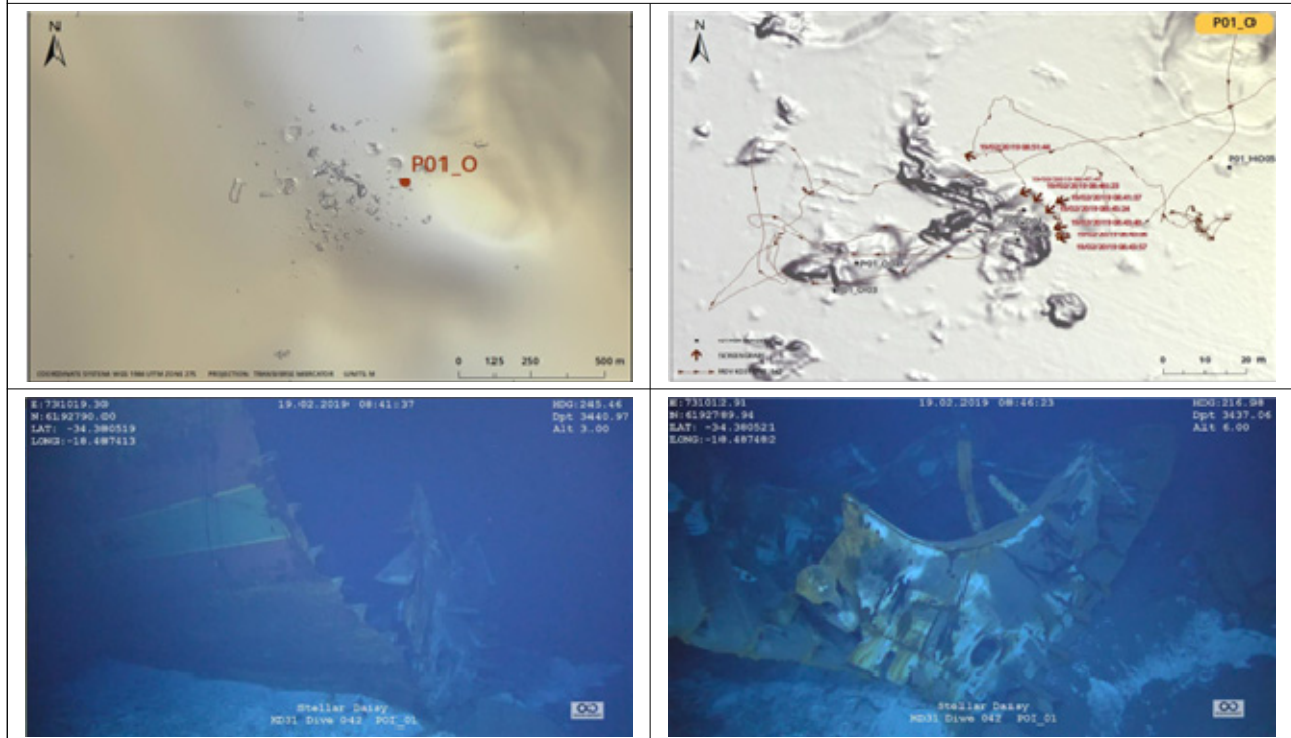
43. P01_O

Given that frames with some openings are torn and crushed, they are presumed to be the shell plating structures.

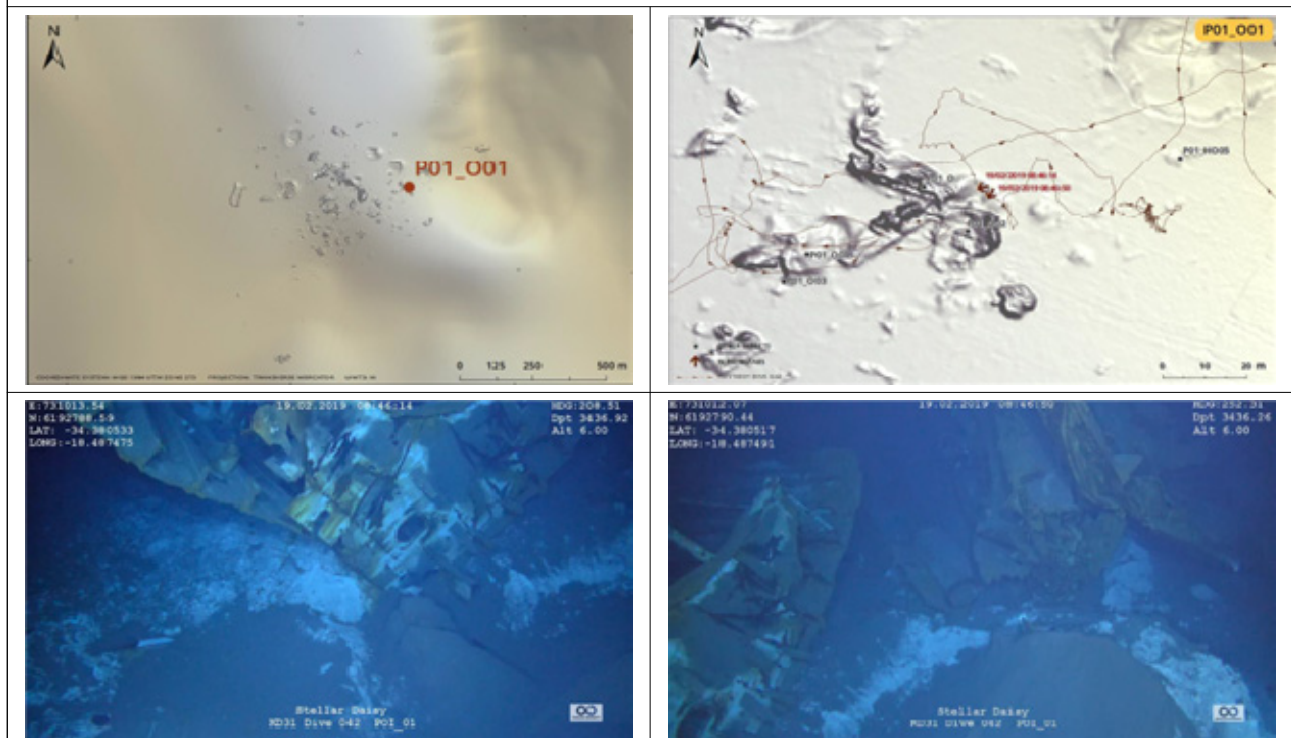
44. P01_001

The pieces of yellow debris are mostly identified as stiffened plate structures attached with stiffeners. They are uncertain but presumed to be part of the hull's internal structures.

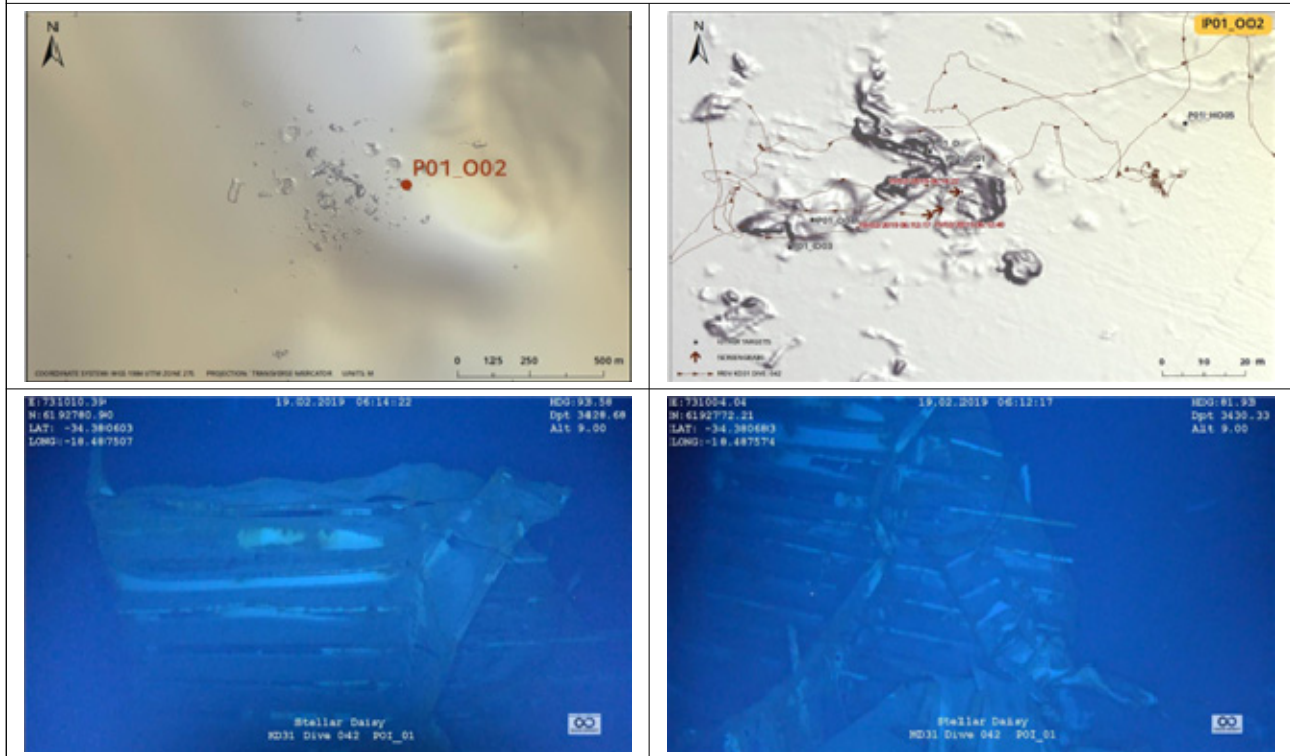
45. P01_002

The stiffened plate structures attached with stiffeners are torn and dented. They are presumed to be part of the hull's internal structures.

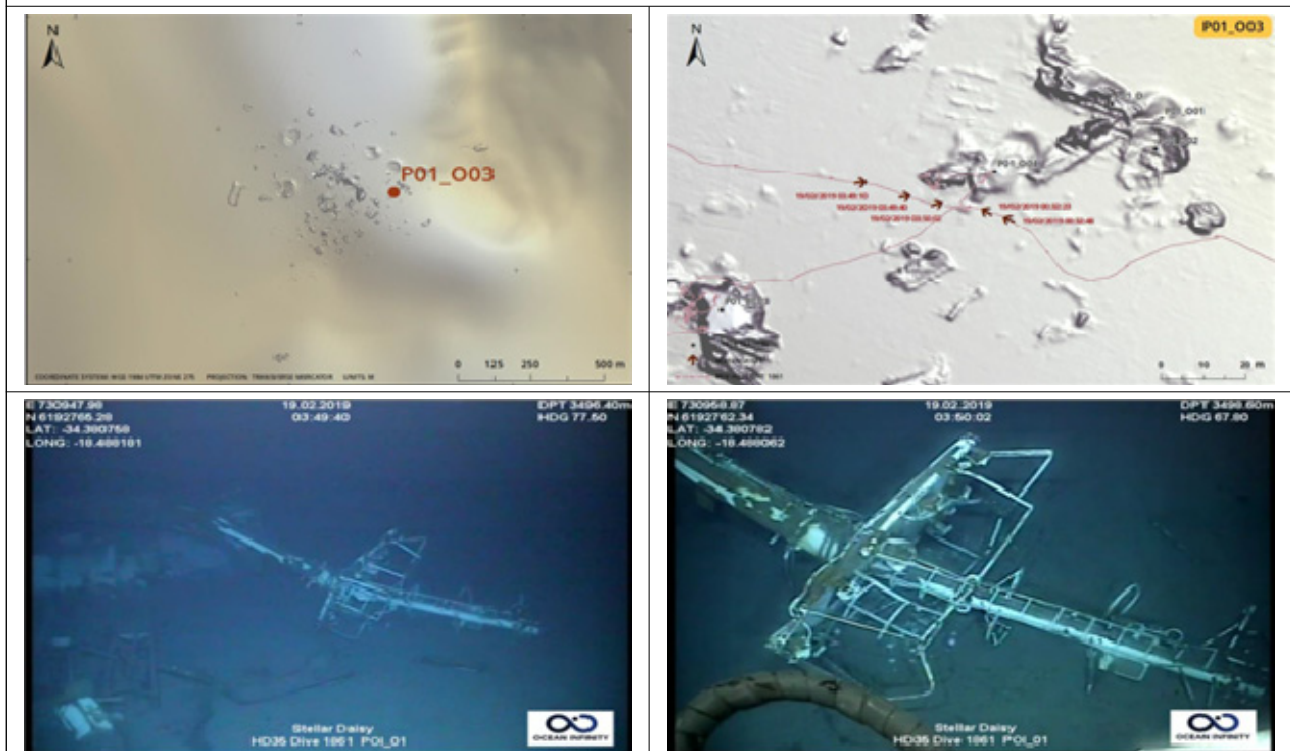
46. P01_003

The objects were identified as part of the mast structures of Stellar Daisy.

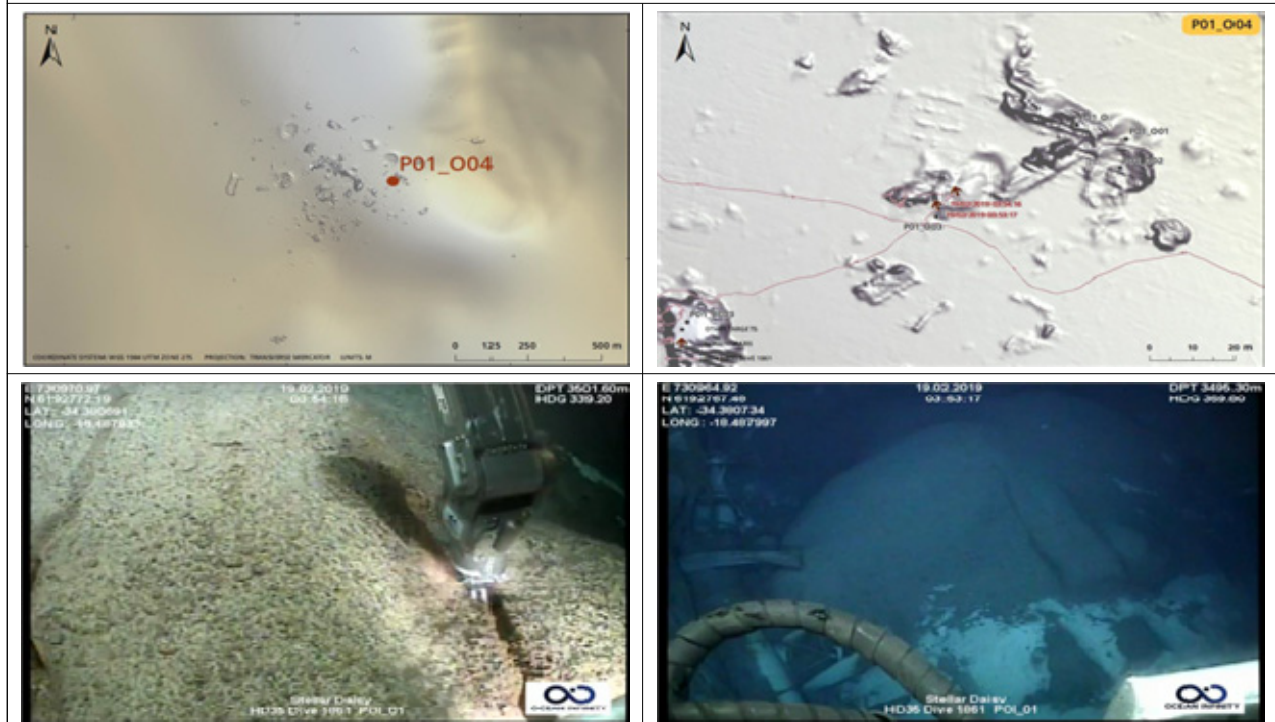
47. P01_004

There are solid objects of iron ore and crumpled stiffened plate structures, presumed to be part of the internal structures of cargo holds.

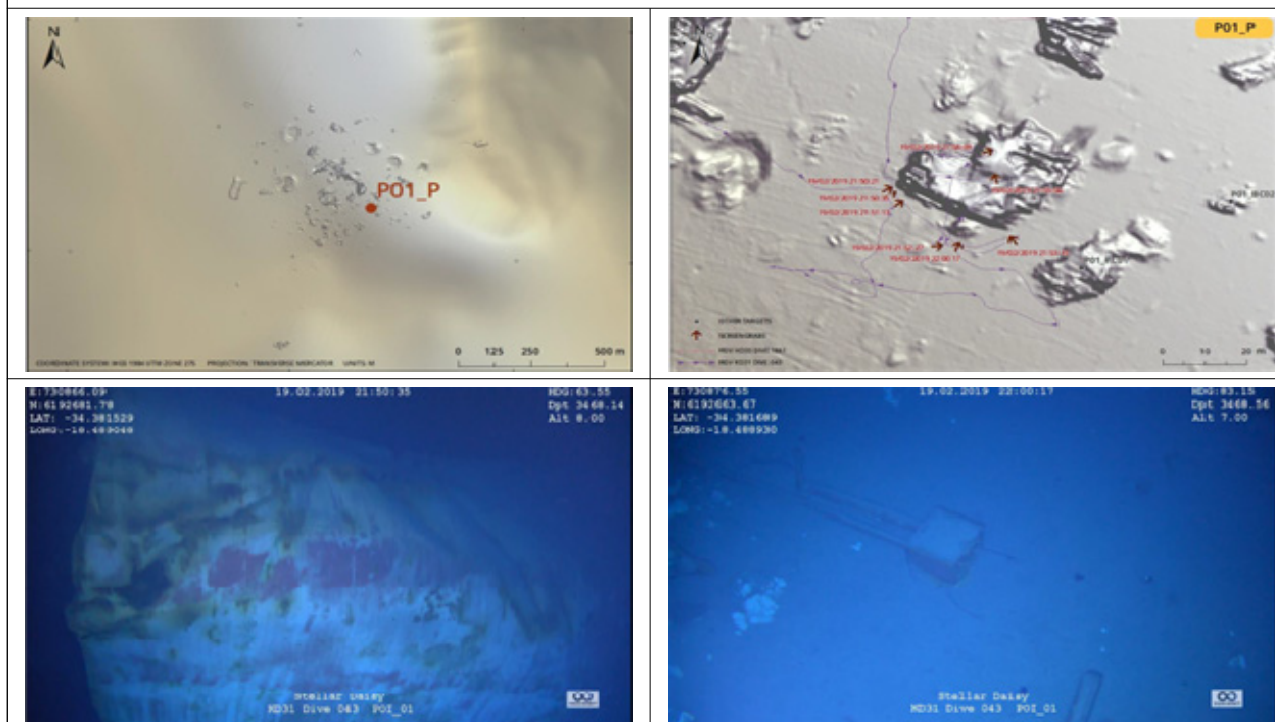
48. P01_P

Numerous small stiffened plate structures are seen torn and crushed, and debris of the bollard and control panel (electric cabinet) are in the way. They are presumed to be structures from near the accommodation area.

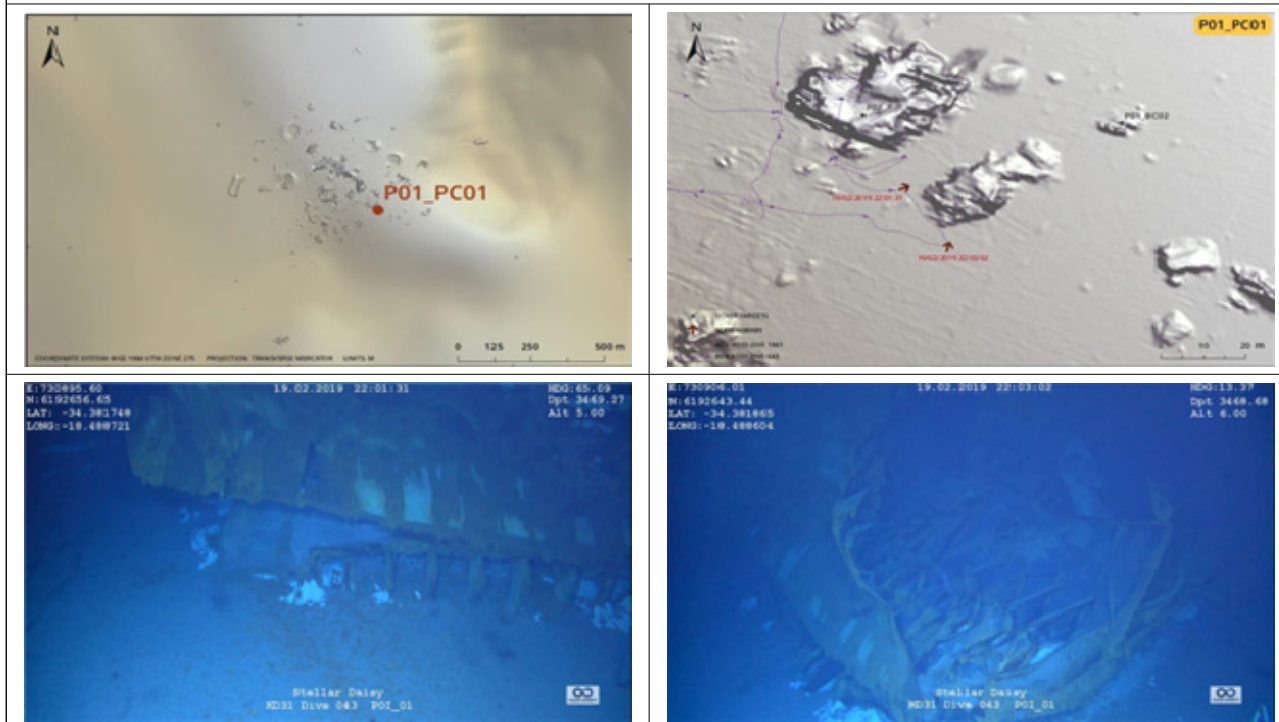
49. P01_PC01

There are torn and dented stiffened plate structures attached with frames where stiffeners passed through. They are presumed to be part of the hull's internal structures.

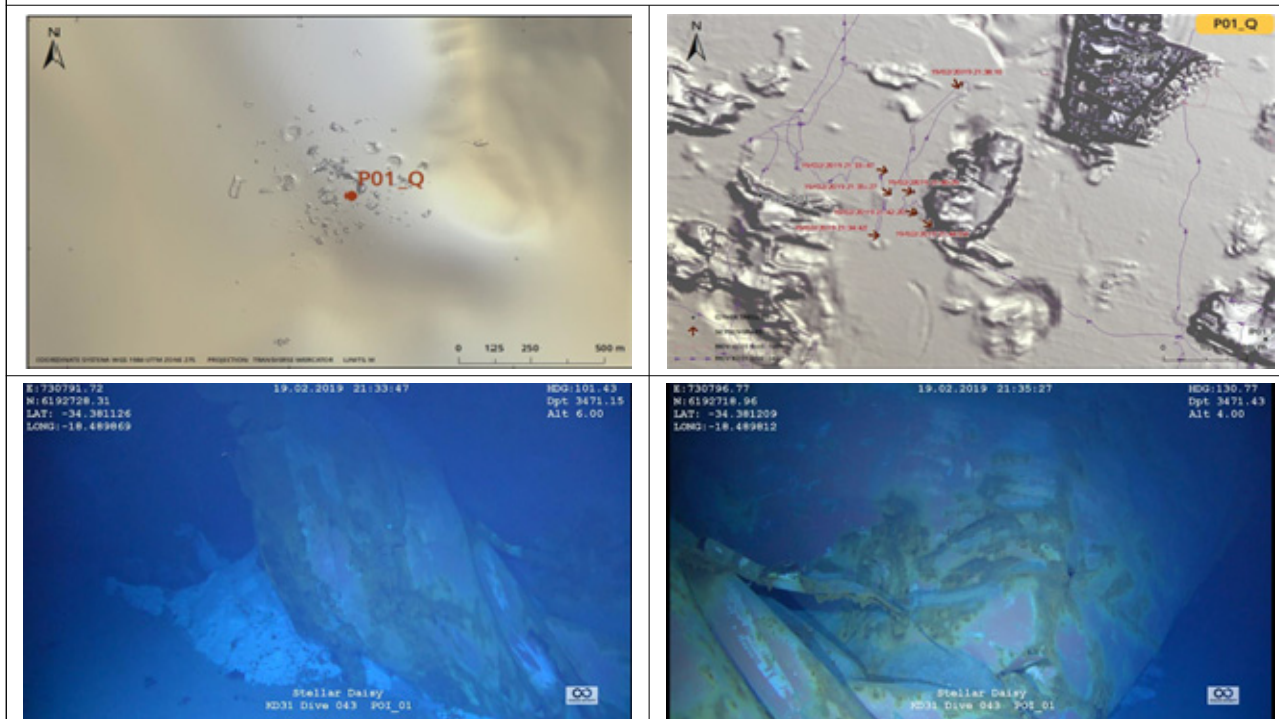
50. P01_Q

There are severely torn structures that could be either the shell plating or deck plating. Also, debris of the adjacent ladder structure was sighted.

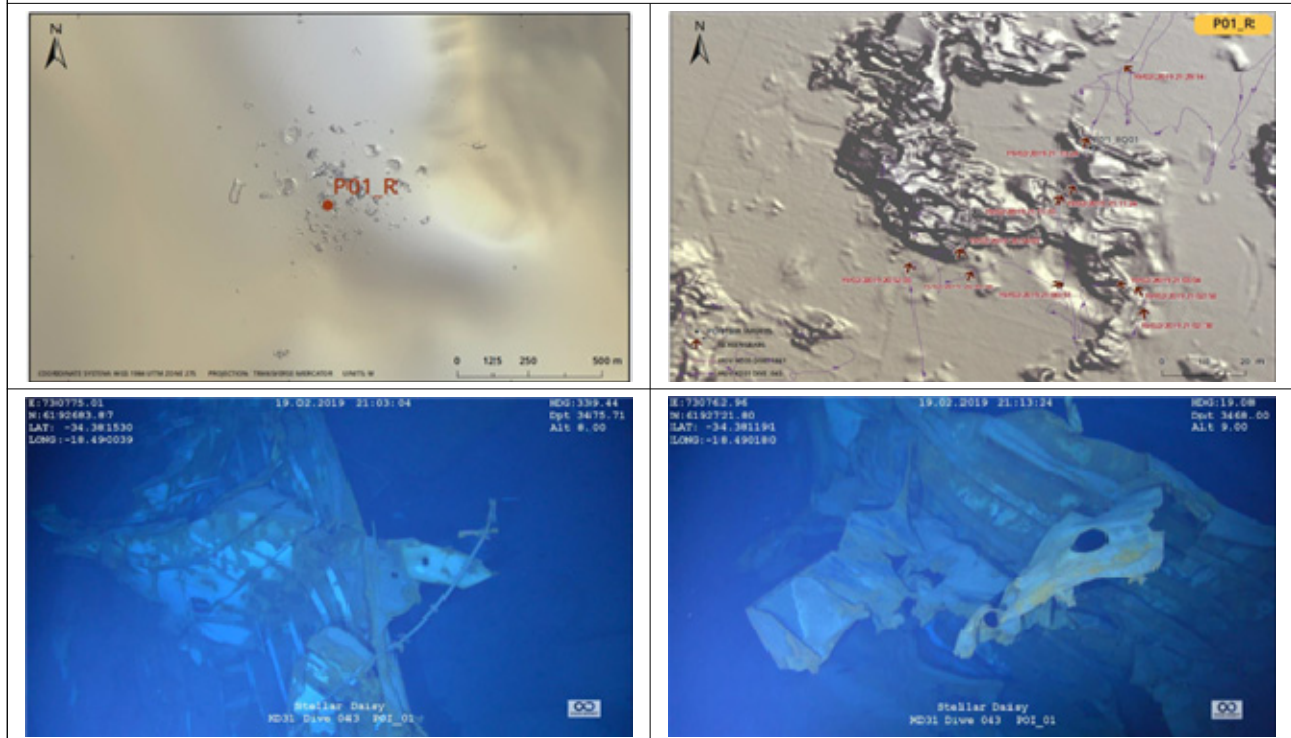
51. P01_R

Seen here are debris of cables and many small stiffened plate structures, which are torn and dented. They are presumed to be part of the hull's internal structures.

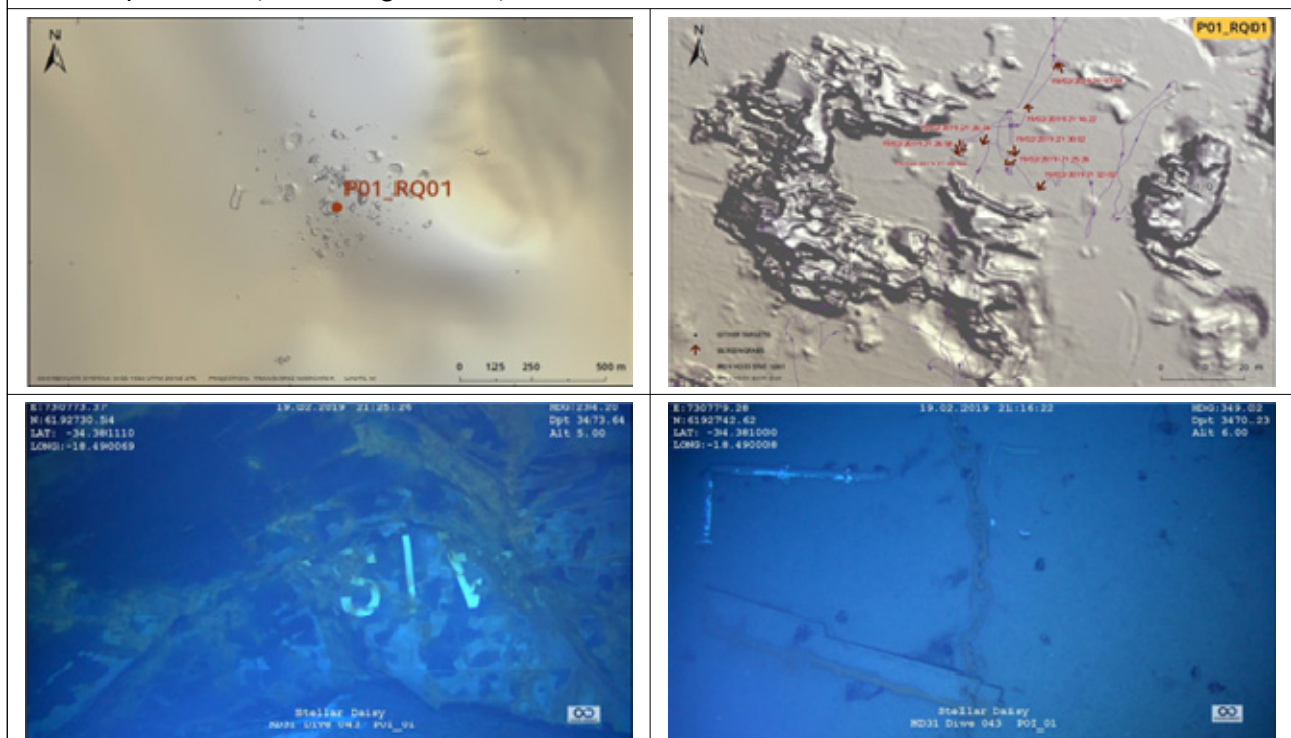
52. P01_RQ01

The point of interest was identified as the bow area based on the indications, such as the ship's name, mooring chains, and the draft mark.
