[MSI Report 2022-001]

Marine Safety Investigation Report

– Sinking of VLOC, Stellar Daisy –

Korea Maritime Safety Tribunal
Marine Safety Investigation Team

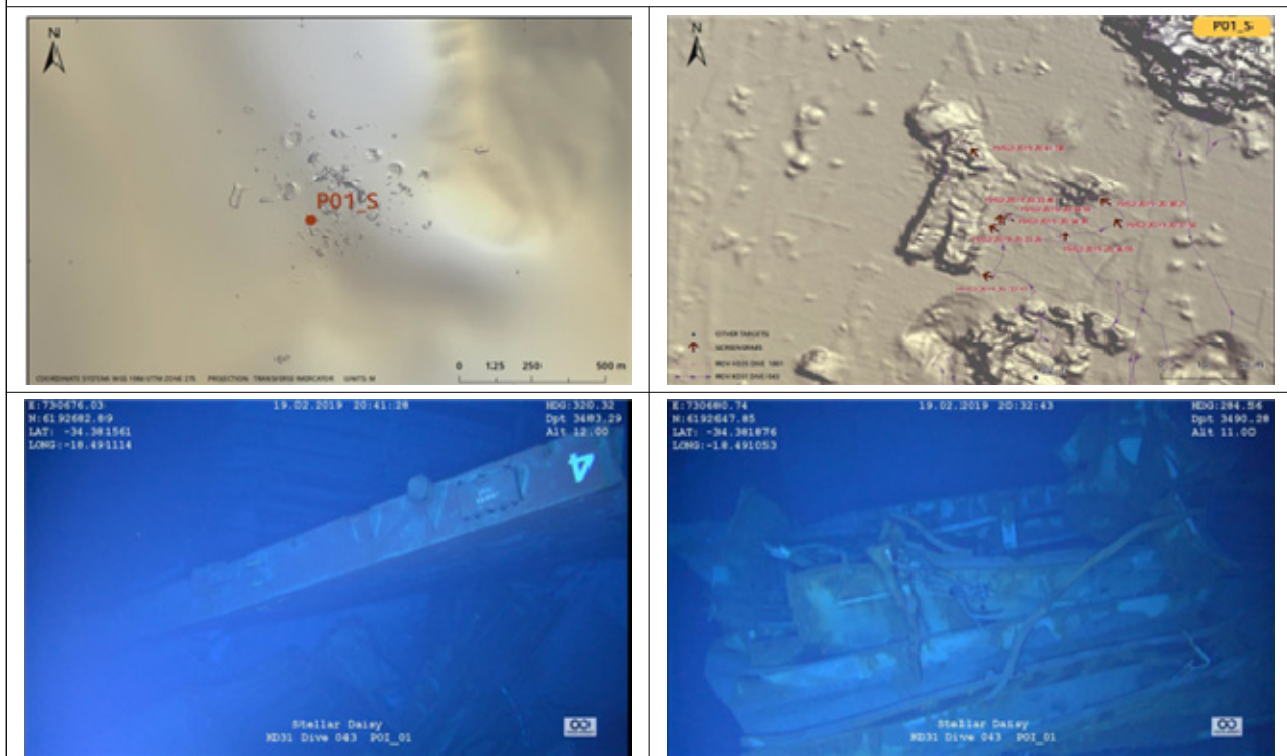
53. P01_S

The objects were identified as cargo hold hatch cover No. 4.

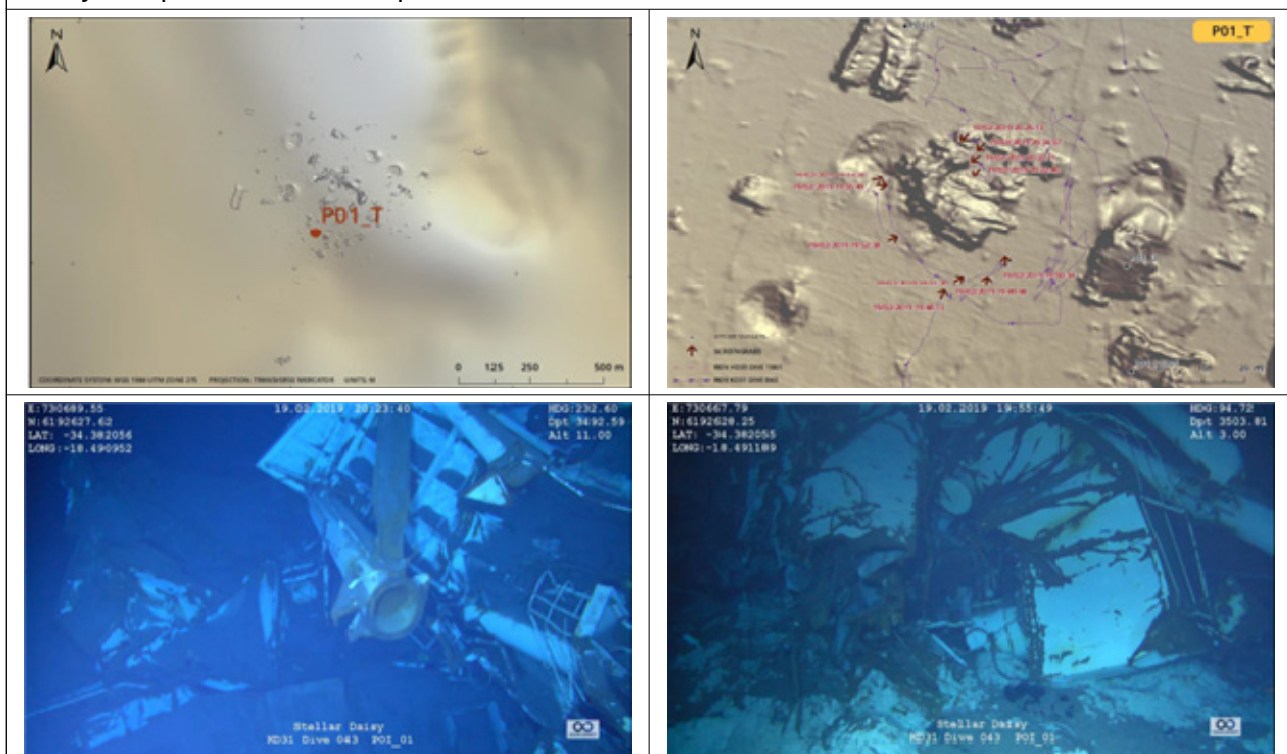
54. P01_T

There are debris mixed up with handrail and pillar structures, mast steps, and cables. They are presumed to be part of structures in the accommodation area.

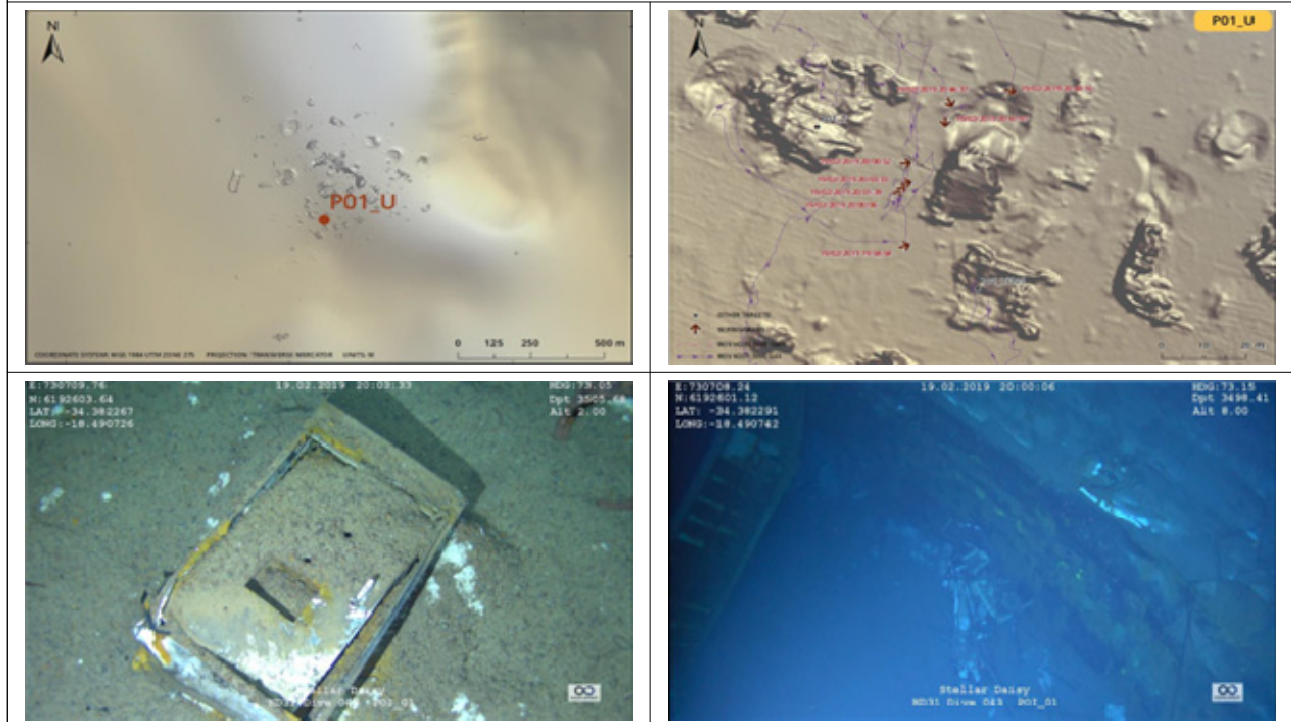
55. P01_U

The objects include debris considered to be an electrical control cabinet, wires, and cables. Also seen are dented stiffened plate structures, indicating that may be debris from inside the hull compartments.

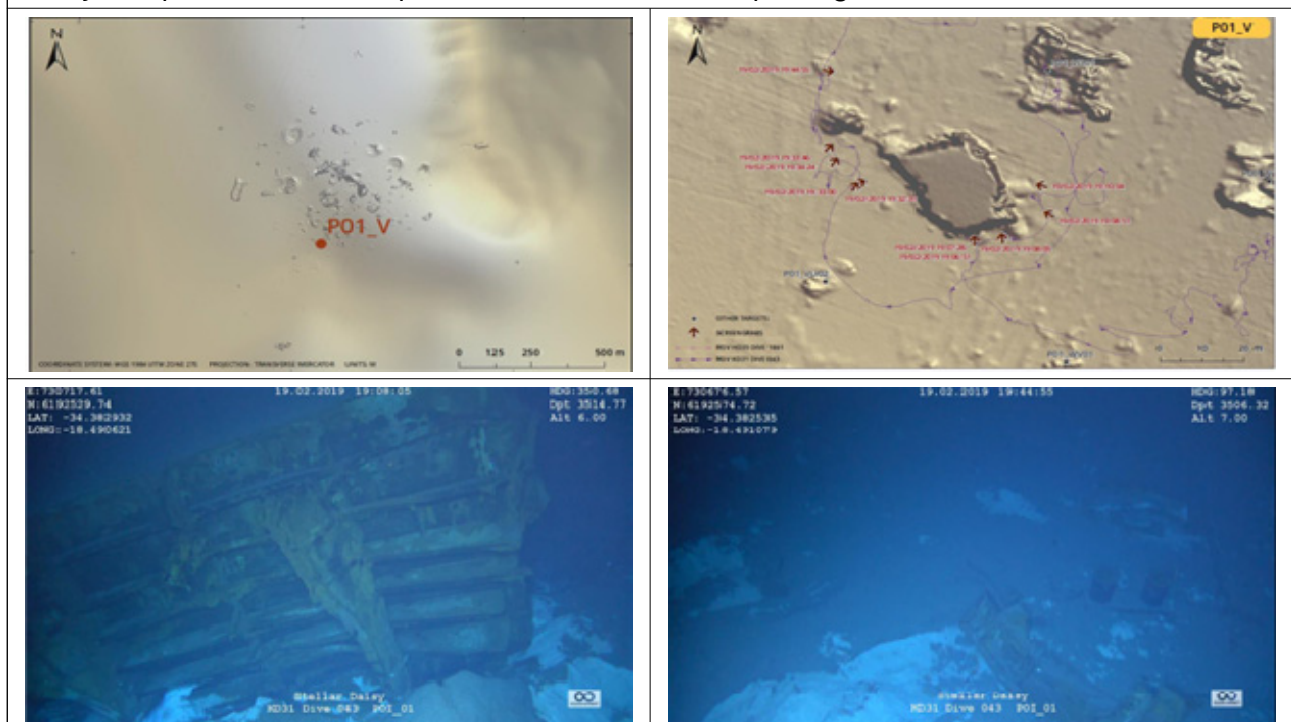
56. P01_V

There are torn and severely dented frames where pipes passed through, and a bollard. They are presumed to be part of the deck or shell plating.

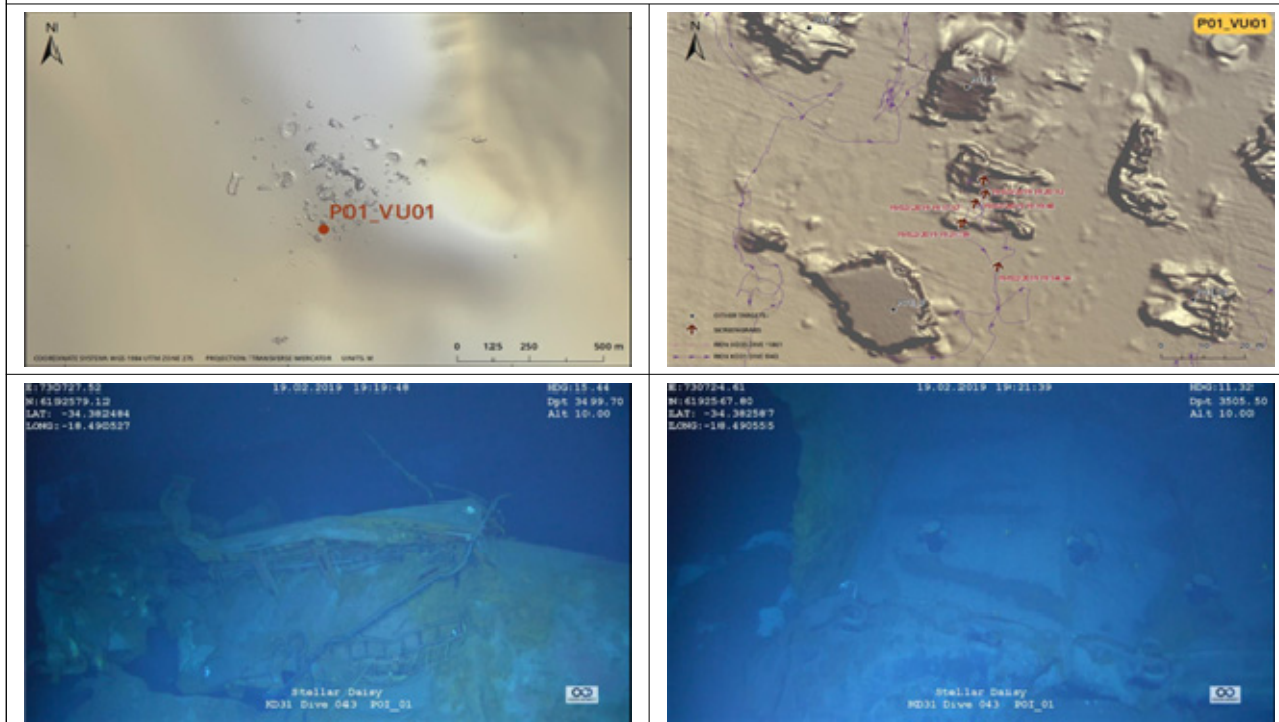
57. P01_VU01

There are metal fragments of ladders or pipes, debris of rope cables, bollards attached to the hull structures, and a stiffened plate structure where pipes passed through. They are presumed to be detached from the deck area.

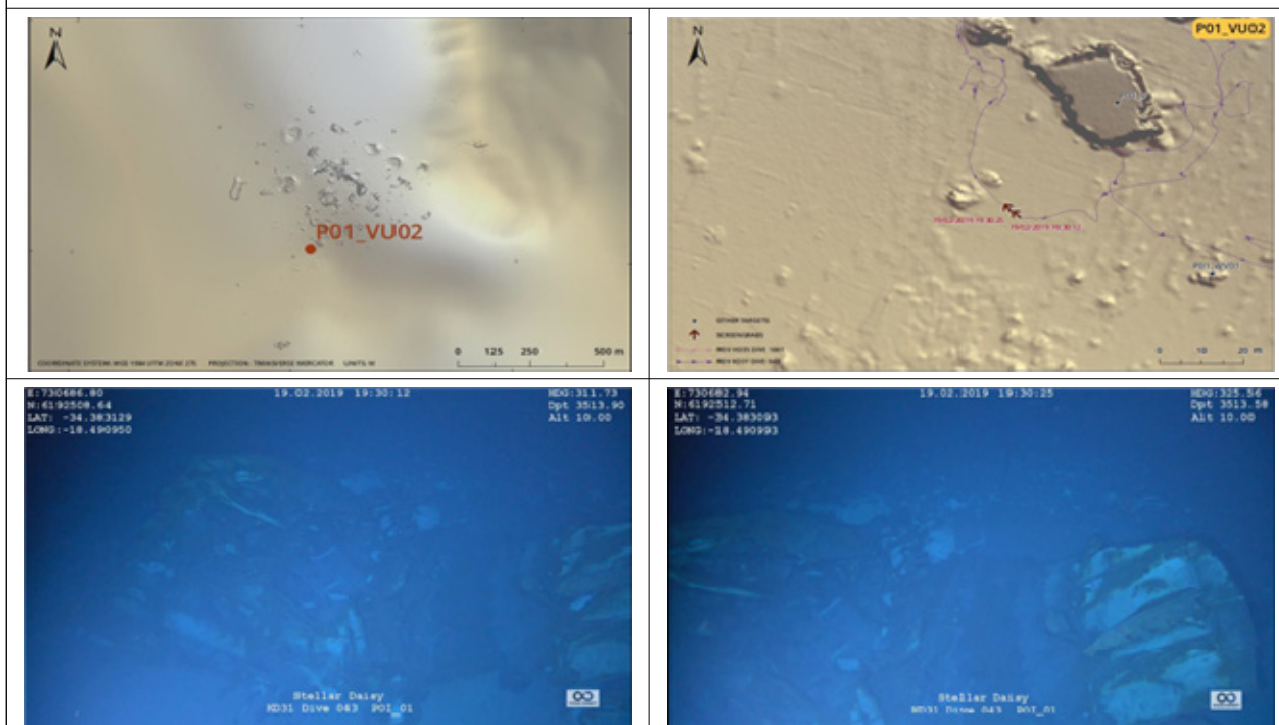
58. P01_VU02

The objects are torn and dented stiffened plate structures presumed to be part of the hull's internal structures.

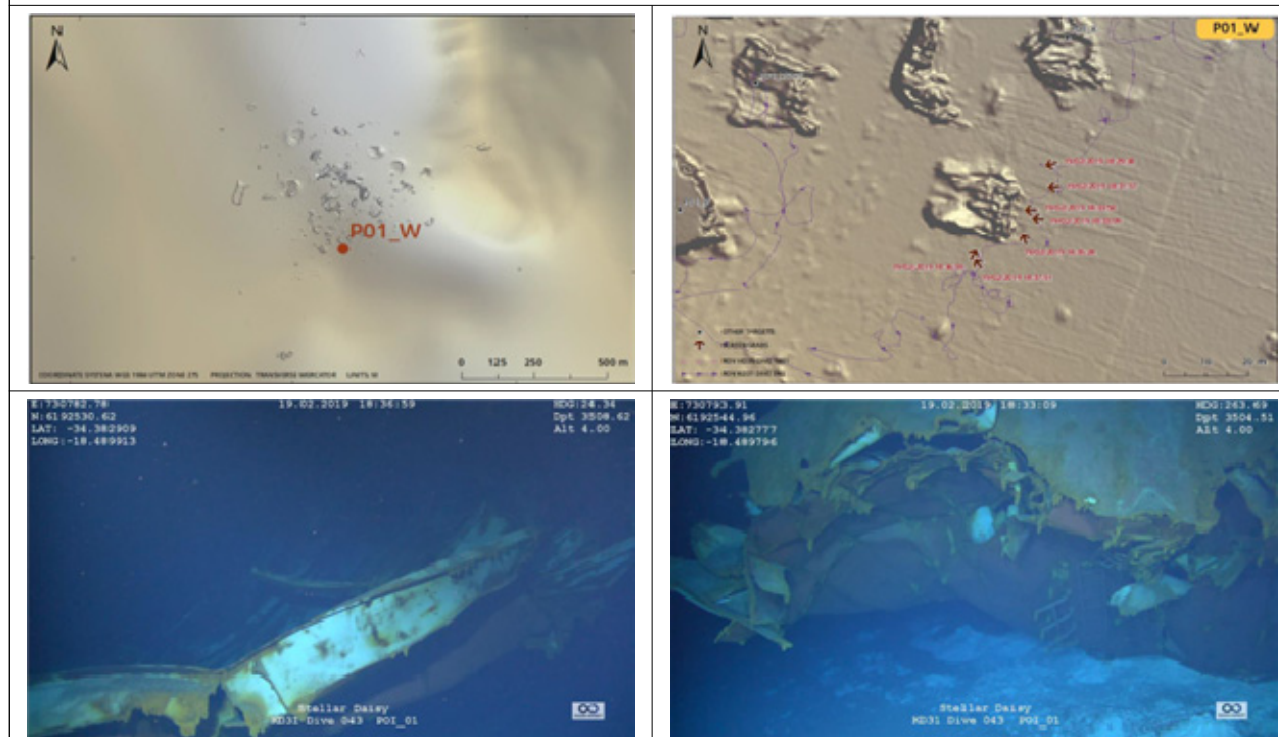
59. P01_W

Torn and crushed stiffened plate structures are piled up. Their identity is very much uncertain, but they are believed to be outfitting structures of the hull.

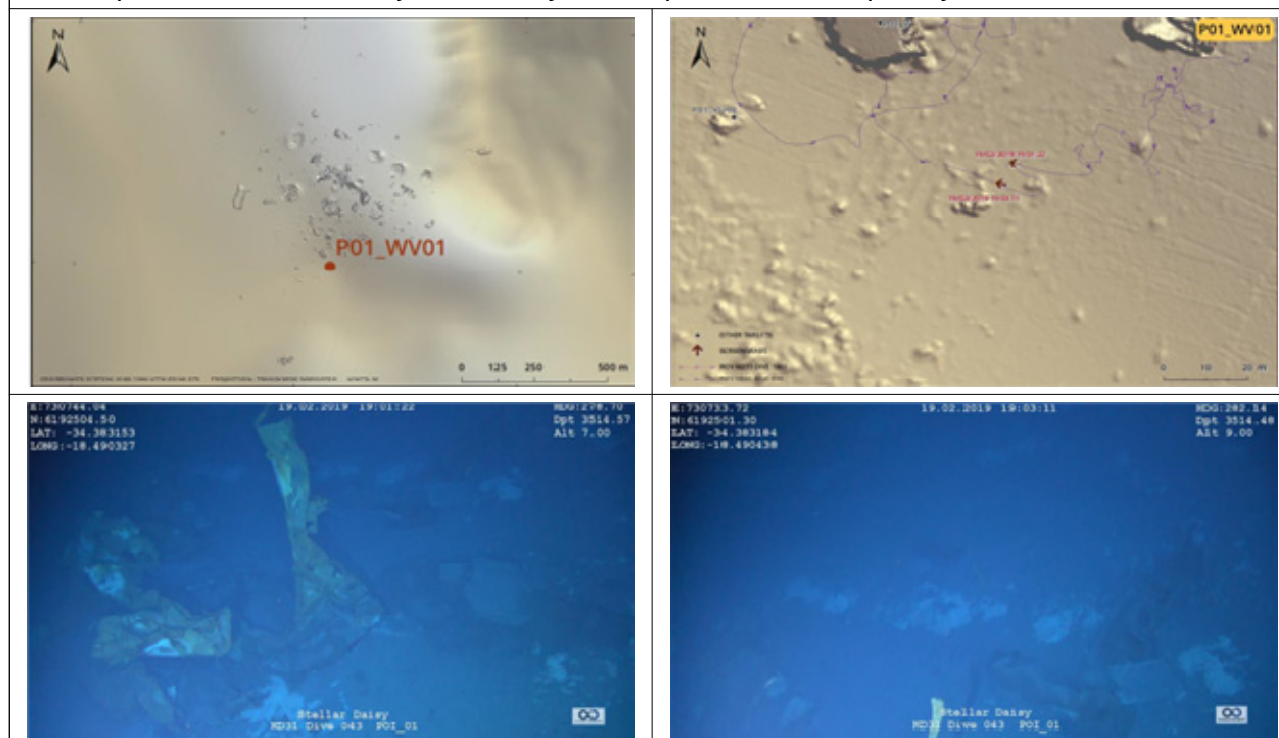
60. P01_WV01

The objects are part of the stiffened plate structures crushed and torn into two to three pieces. It is not easy to identify which part of the ship they came from.

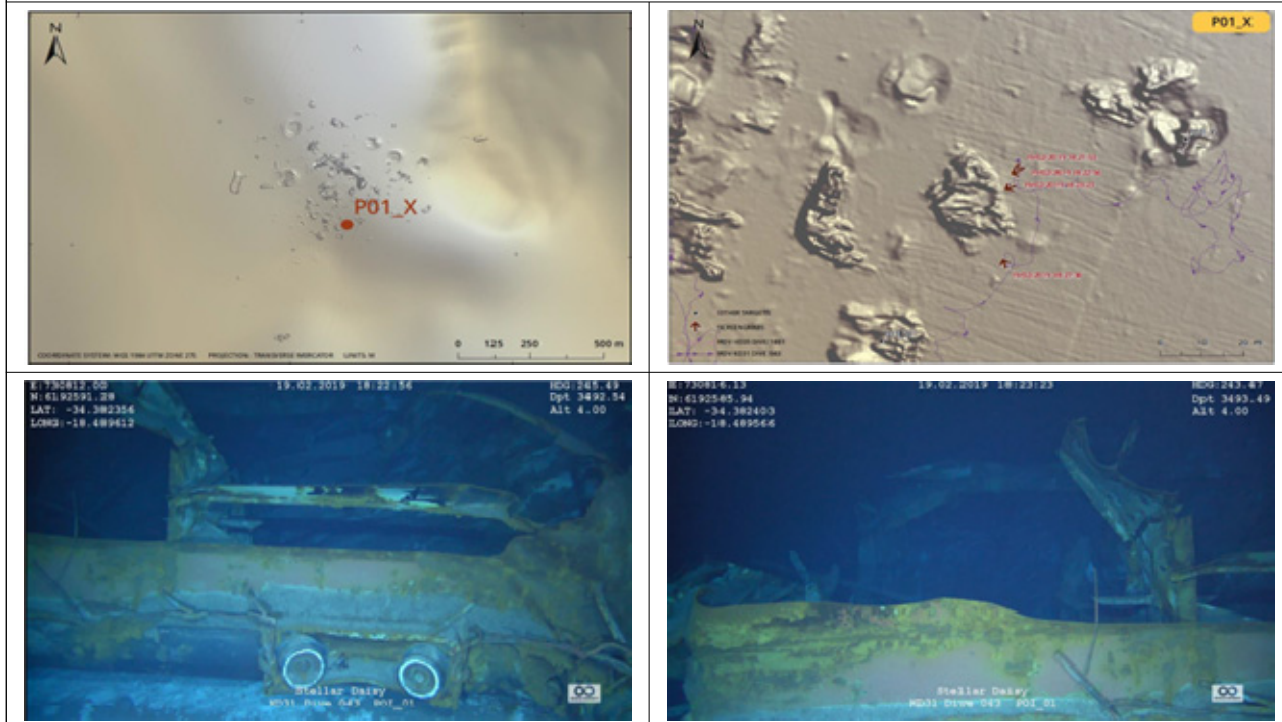
61. P01_X

There are several torn and crushed stiffened plate structures discovered. They are presumed to be debris of the structure where the edge of the deck meets the area above the draft on the shell plating.

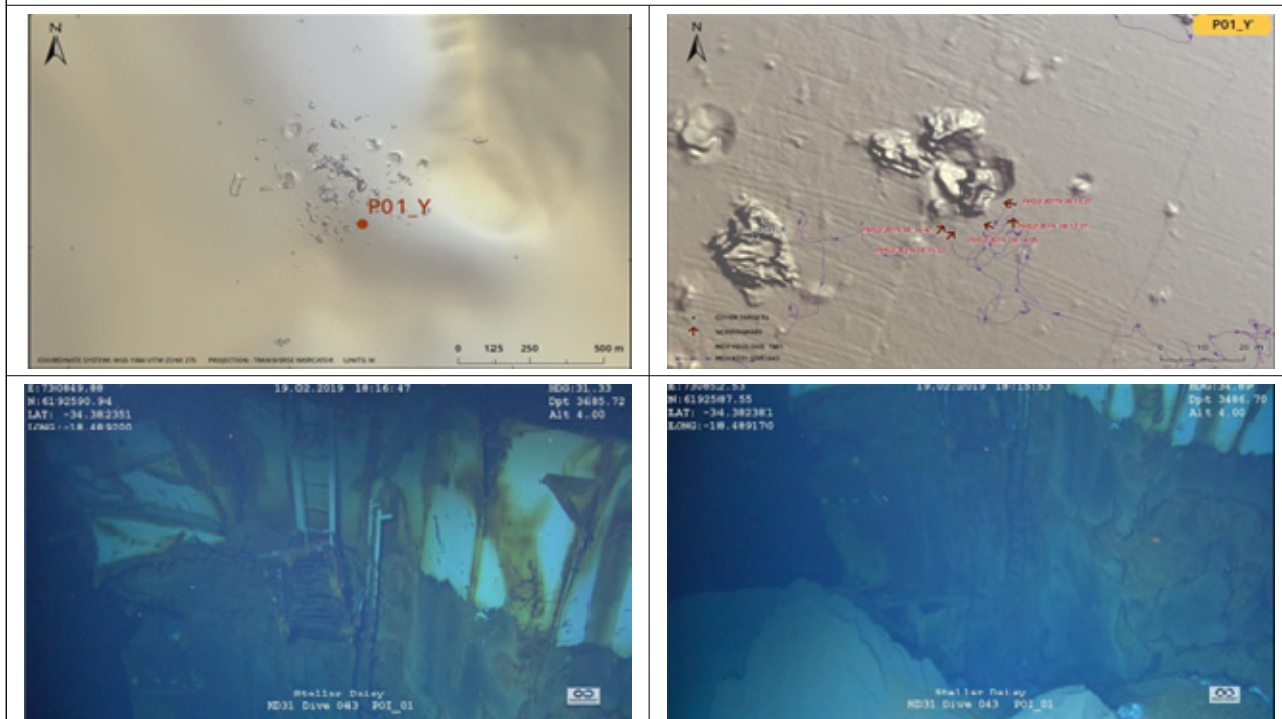
62. P01_Y

The objects are torn and crushed stiffened plate structures. They are presumed to be the bulkhead structures inside cargo holds or the hull.

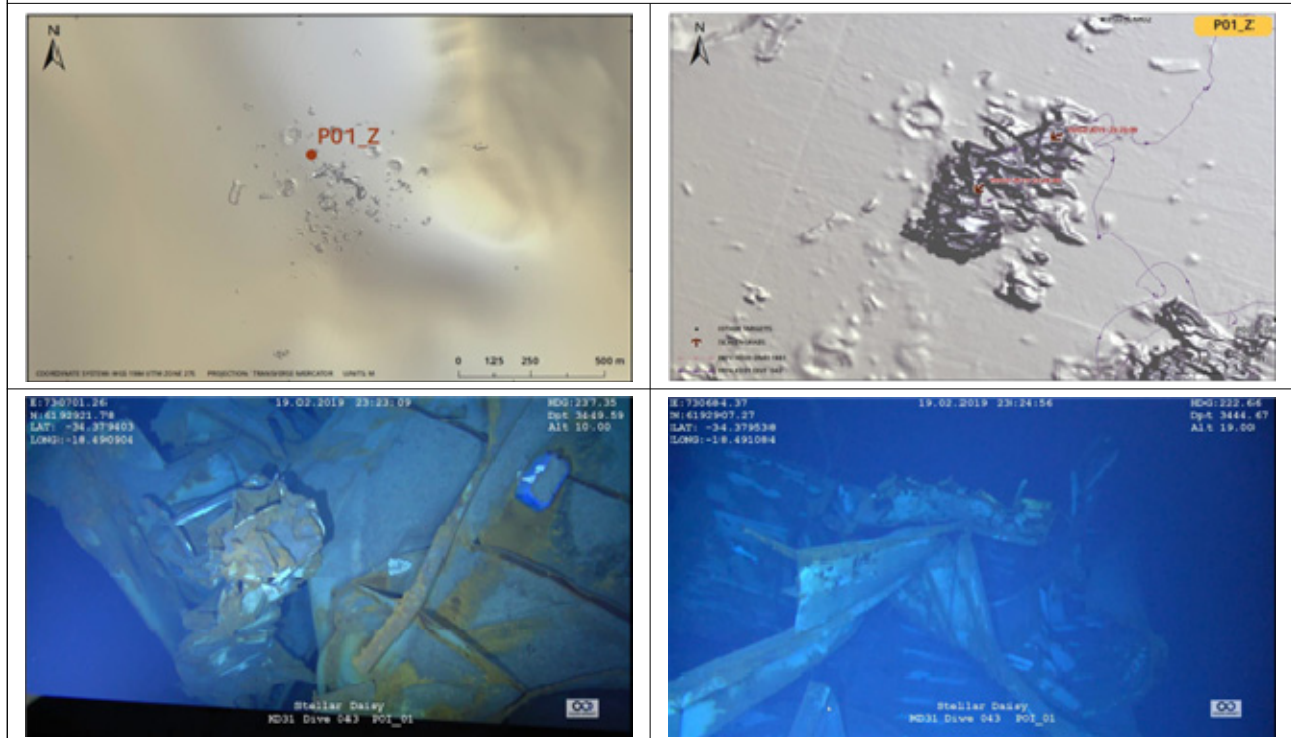
63. P01_Z

The objects are torn and crushed stiffened plate structures. They are unidentifiable but presumed to be the structures from cargo holds or the bulkhead inside the hull.

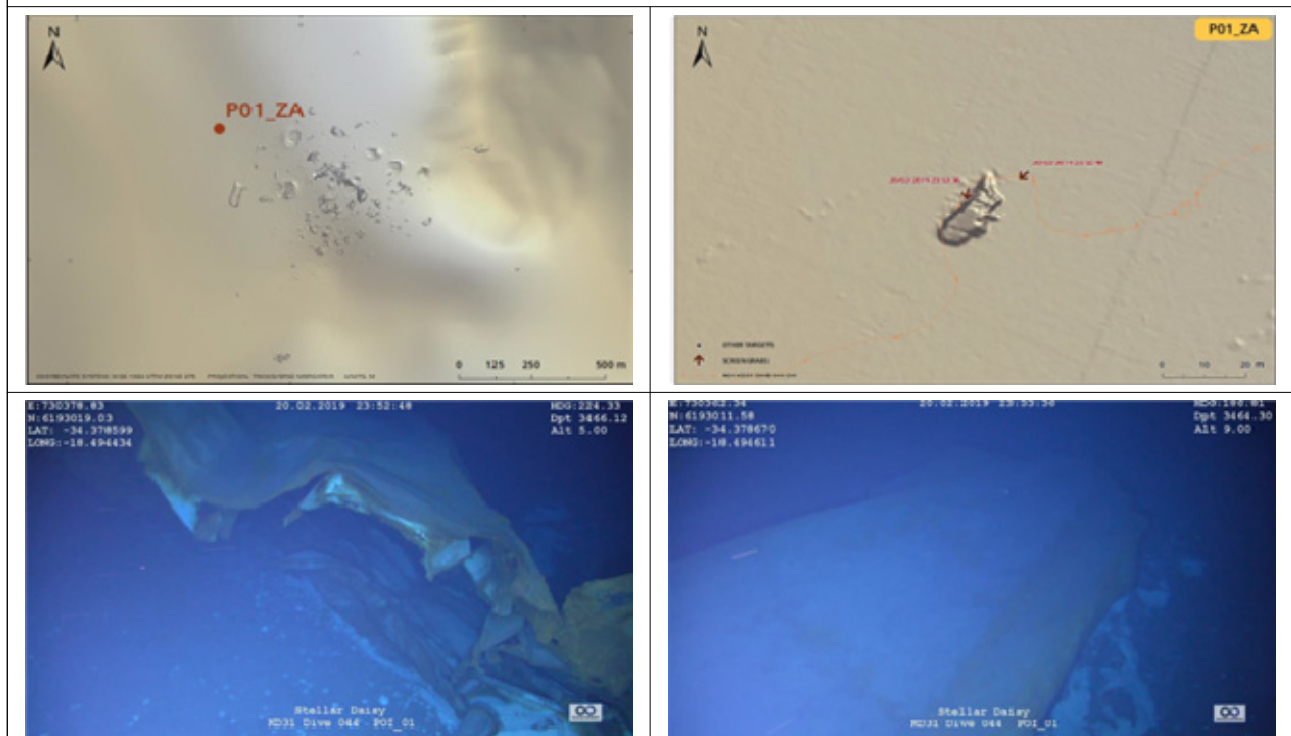
64. P01_ZA

The objects are torn and dented stiffened plate structures. Given that the structures are red, they are presumed to be an area below the deck or the draft.

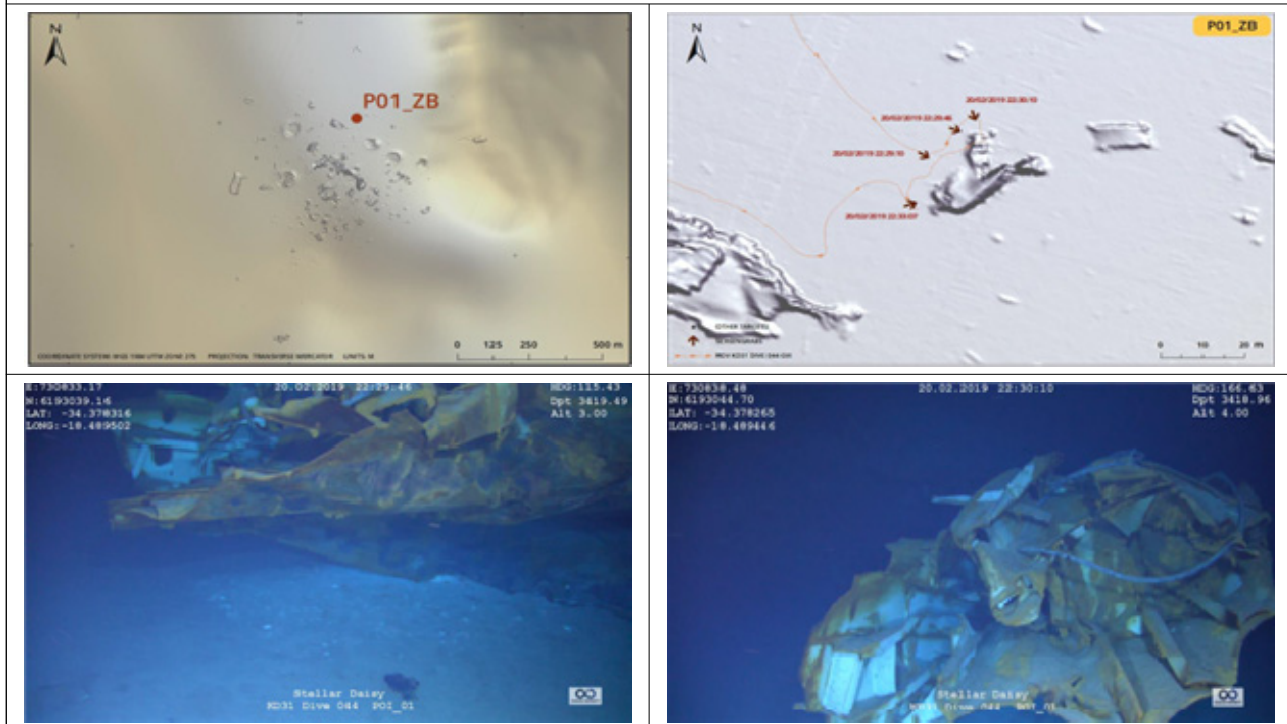
65. P01_ZB

The objects are ripped and dented stiffened plate structures. One of the sides is colored gray while the other side is black. This suggests they are from the area above the draft on the shell plating.

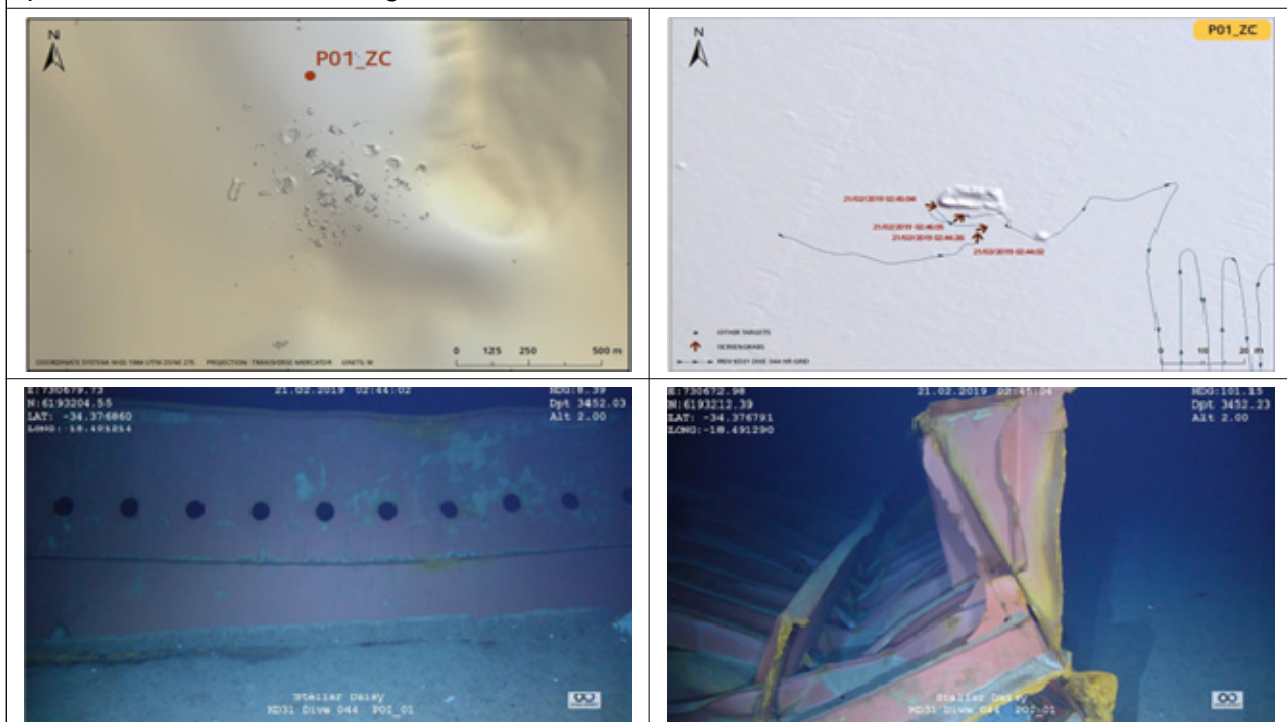
66. P01_ZC

The objects are structures with equally spaced openings. They are presumed to be part of the hatch coaming.
