Marine Safety Investigation Report on Containership Sawasdee Bangkok

– Fatality of a crew member –

Date of Accident: 31 December 2017

**Korea Maritime Safety Tribunal
Marine Safety Investigation Team**

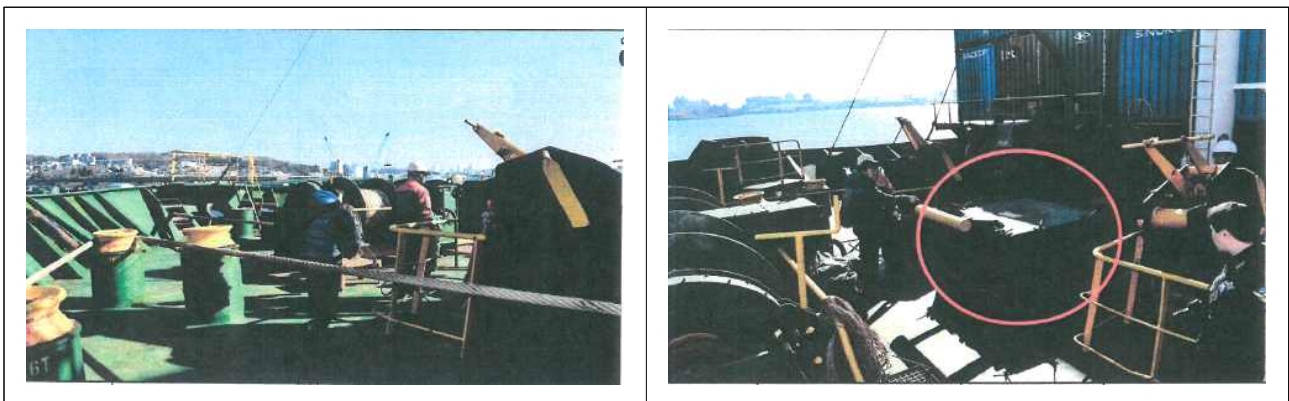
<Figure 4> Photo of the forecastle deck and the bosun store

2.5.2 The forecastle deck of Sawasdee Bangkok is equipped with a windlass, winch, and other machinery. The bosun store is located under the forecastle deck. Crew have to lift the small hatch to open and enter the bosun store.

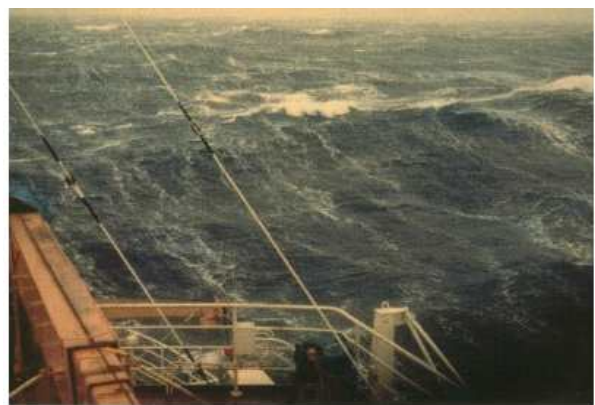
4.2.4 Given those meteorological records and statements, the crewmembers are presumed to have worked on the forecastle deck while withstanding wind speeds of about 30 knots (15.4 m/s) or higher,¹¹⁾ meaning wind strong enough to shake trees and cause a person difficulty in walking against.

BEAUFORT FORCE 8
WIND SPEED: 34-40 KNOTS

SEA: WAVE HEIGHT 5.5-7.5M (18-25FT), MODERATELY HIGH WAVES OF GREATER LENGTH, EDGES OF CREST BEGIN TO BREAK INTO THE SPINDRIFT, FOAM BLOWN IN WELL MARKED STREAKS ALONG WIND DIRECTION,

4.2.6 It seems inappropriate for the crew to have proceeded with the maintenance operations on the forecastle deck under the weather conditions at the time of the accident, including the wind speed and the wave height. If such operations had been urgent and inevitable for the containership to avoid flooding through a crack in the hull, there should have been sufficient assessment and preparations for the impact of the weather on the operations.
