[MSI Report 2022-006]

Marine Safety Investigation Report on General Cargo Ship YUJIN ACE

– Fatality of a crew member –

Korea Maritime Safety Tribunal
Marine Safety Investigation Team

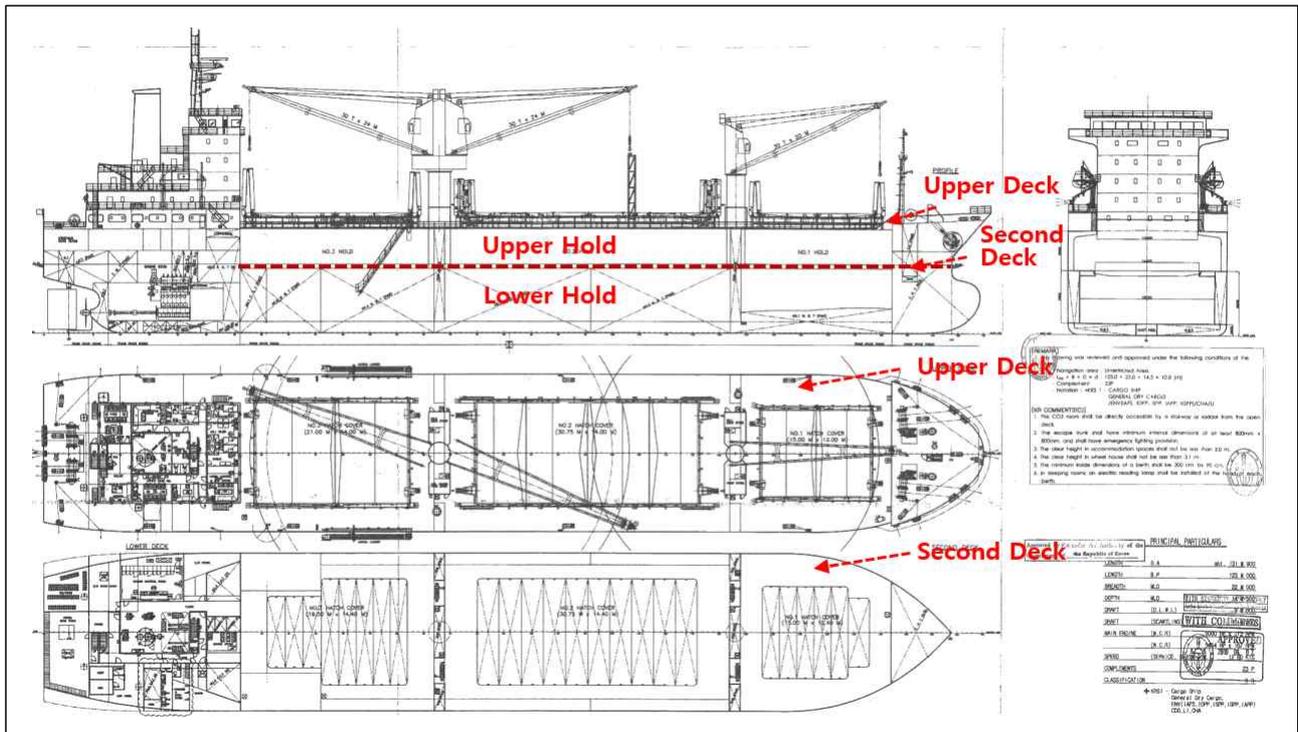
<Figure 2> Arrangement and Structure of holds

2.5.2 The ship has 3 cargo holds and each cargo hold is divided into upper and lower cargo hold in the from of a tween deck. The second deck is installed in the middle of the cargo hold to divide the upper and lower cargo hold. The floor of the cargo hold to the lower deck is about 7.4 meters high.

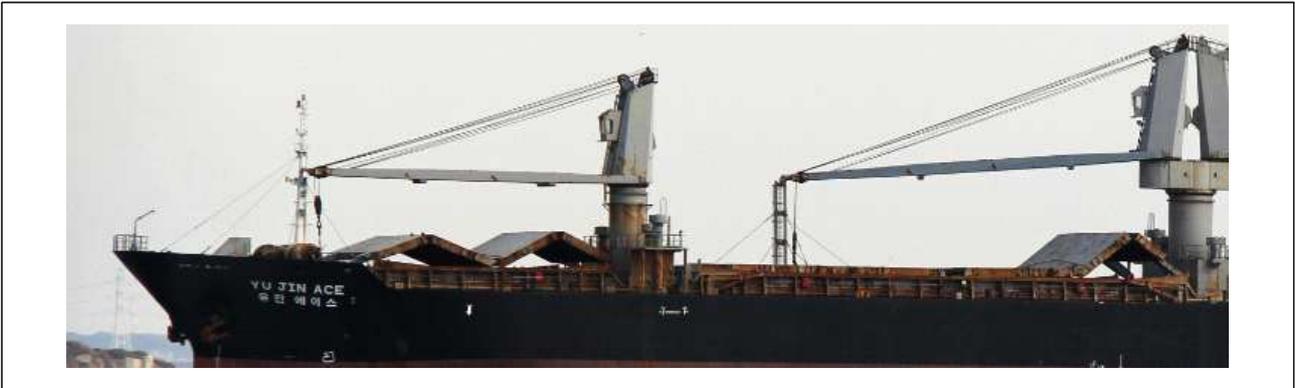
<Figure 3> The Hatch Cover of the Upper deck

2.5.3 The hatch cover of the Upper deck is open and closes by folding type but the Hatch Cover of the Lower deck, which consists of several rectangle Pontoons, is a Pontoon type opening and closing by the ship's crane.

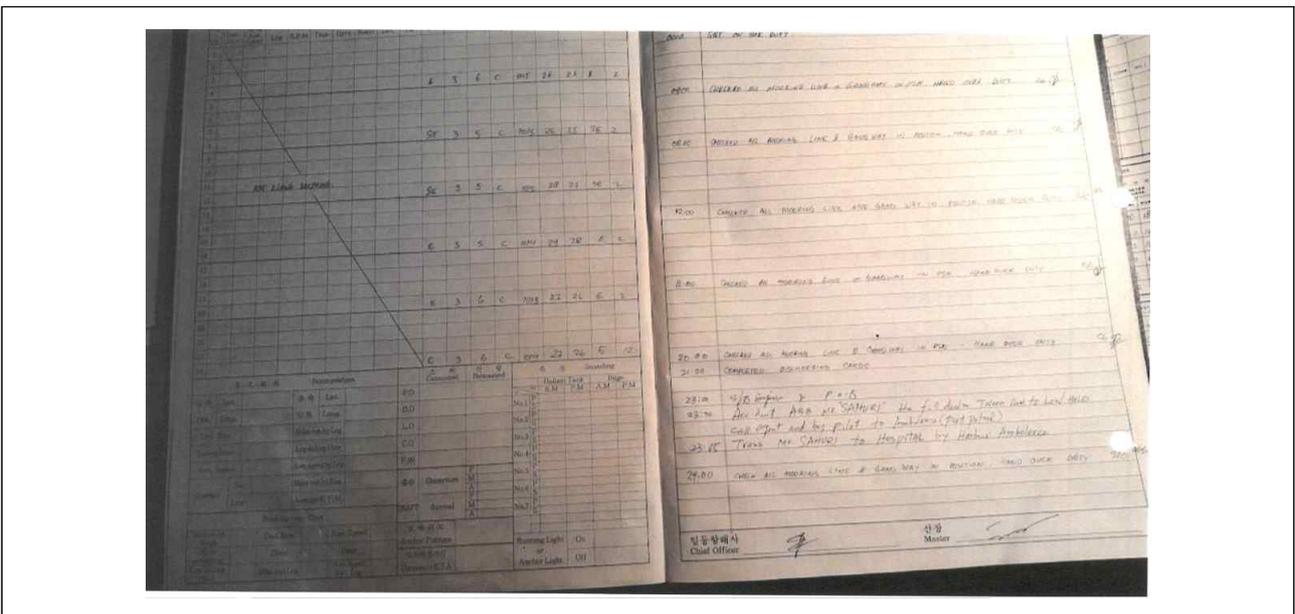
<Figure 6> At the time of the accident, deck log book

2.6.1 Based on the deck log book of the YUJIN ACE at the time of the accident, the east wind was blowing at about 3~5m/s, the weather condition was overcast, and the temperature was about 27 degrees Celsius.
