[MSI Report 2023-001]

Marine Safety Investigation Report

– Fatal Accident on LNG Tanker Hyundai Technopia –

Date of Accident : 16 June 2021

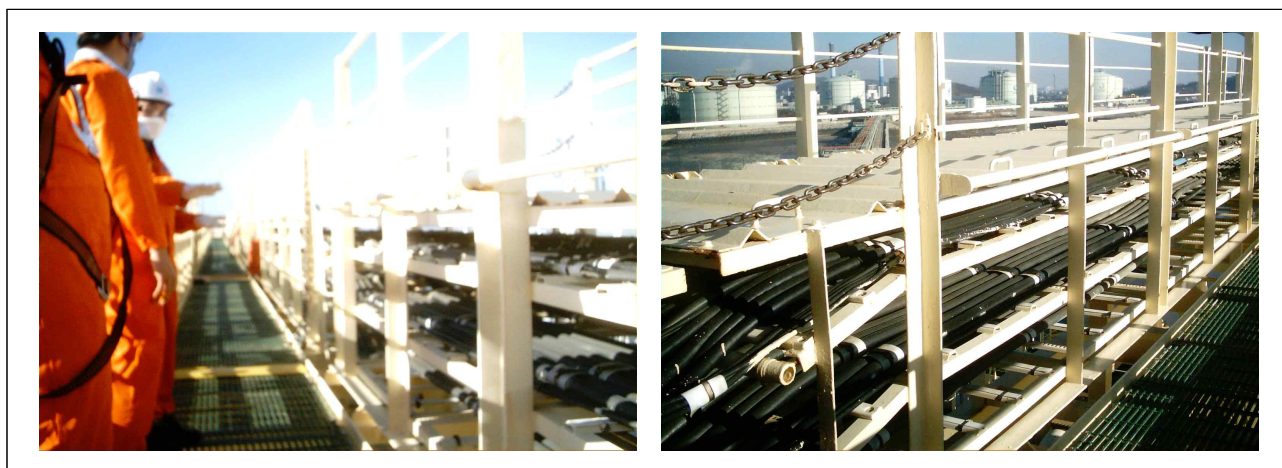
<Figure 5> A catwalk (green) and an electrical cable tray (ivory)

2.6.2 An electrical cable tray is a steel structure which protects electrical lines and cables installed on cargo tanks. It is located right next (on the starboard side) to the catwalk, which is slightly (approx. 96 cm) lower than the tray. It is not originally designed to be used as a regular passageway for crewmembers.⁵⁾

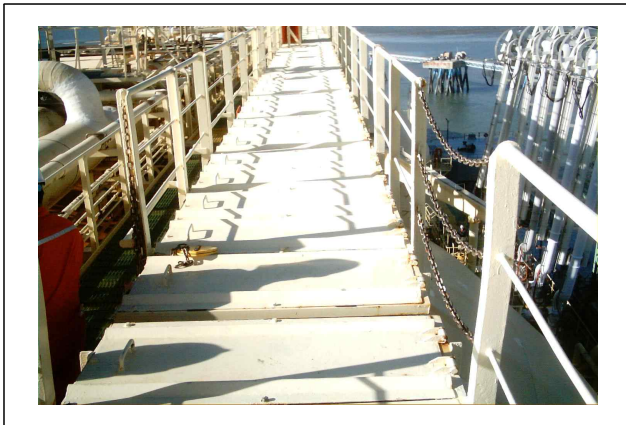
<Figure 12> Electrical cable tray (topside)

4.3.1 Before the accident occurred, three chains had been hung at an interval along of the electrical cable tray.¹⁸⁾ At the time of the accident, the chains hanging in the middle and the lowest one became unhooked, thereby failing to prevent OS B's fall.
