# **Marine Safety Investigation Report**

## **– Fatal Accident aboard Research Vessel Isabu –**

Date of Accident: 5 July 2022

**Korea Maritime Safety Tribunal**  
**Marine Safety Investigation Team**

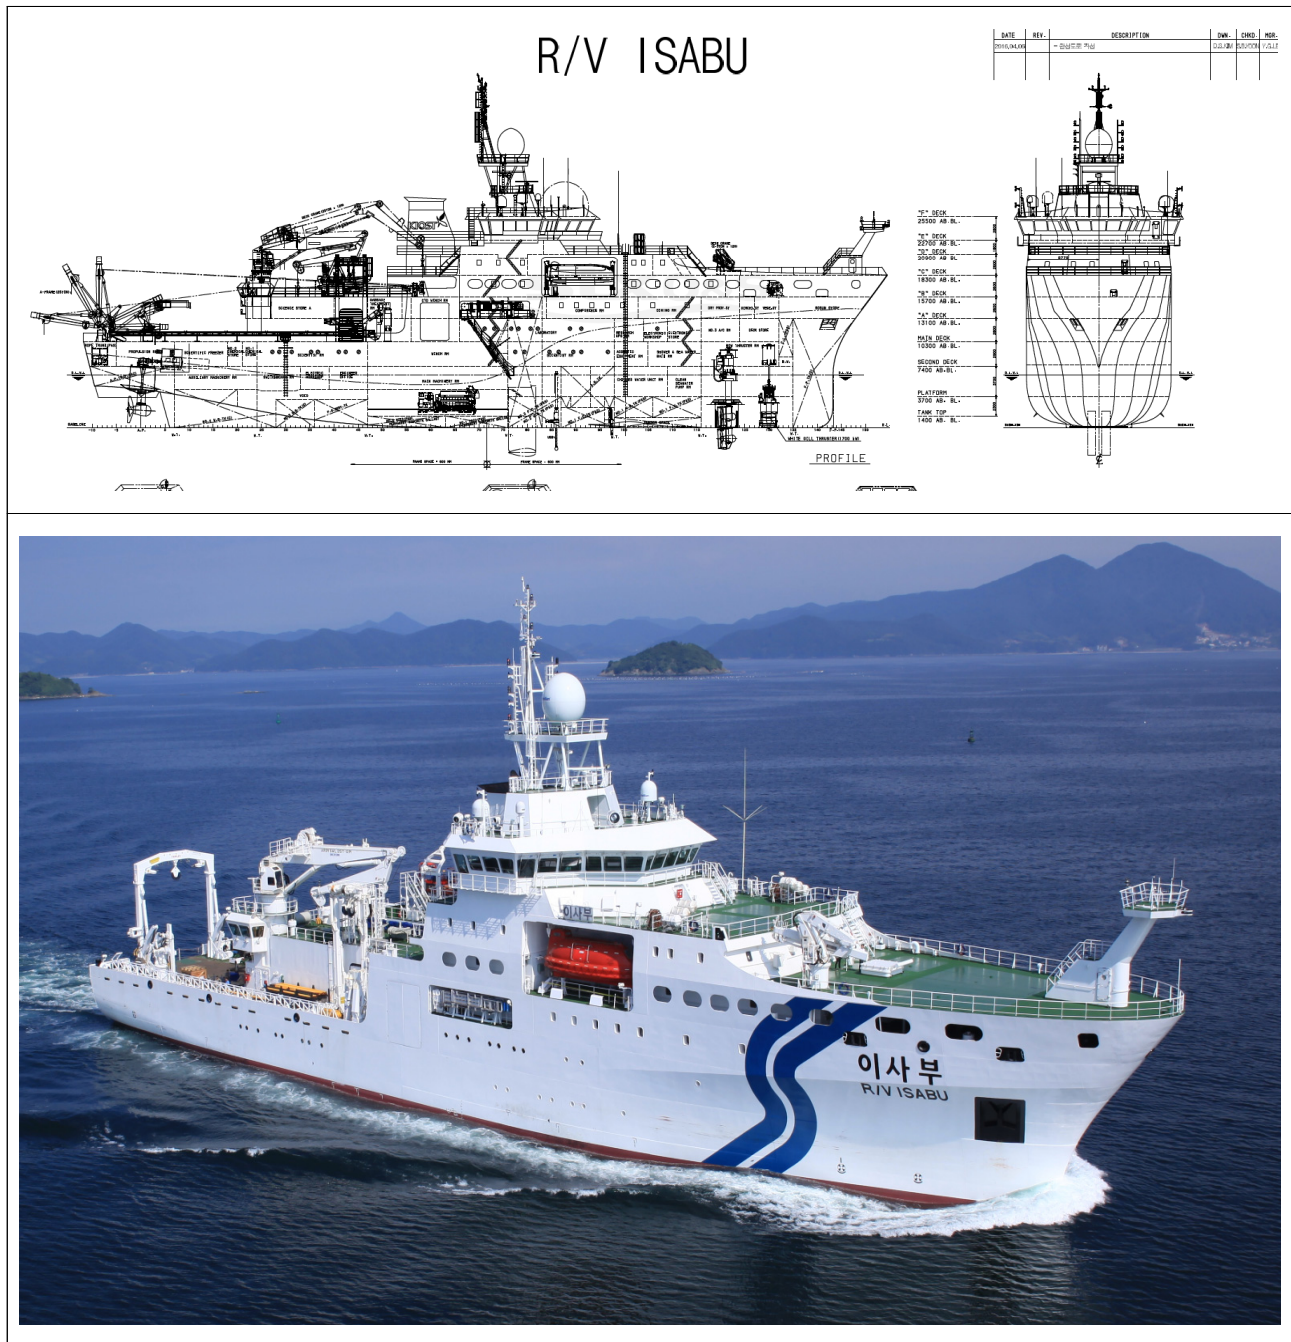
<Figure 1> General arrangement and photo of Isabu

2.1.2 Isabu, launched by STX Offshore & Shipbuilding Co., Ltd. on 15 May 2015, is a research vessel with a gross tonnage of 5,894 tons, a length of 89.33 meters, a beam of 18.00 meters, and a depth of 10.30 meters.

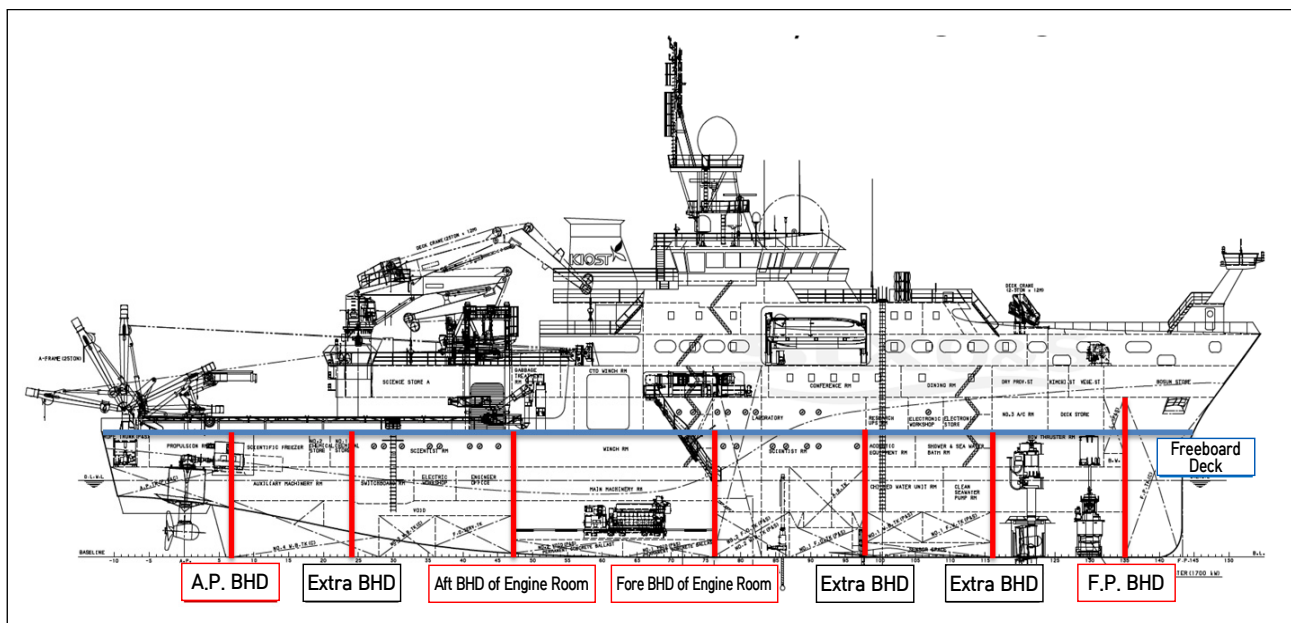
<Figure 2> Location of watertight bulkheads

2.6.1 Isabu is equipped with seven watertight bulkheads in total. Among those, the forepeak and after peak bulkheads, and both fore and aft bulkheads of the engine room are required under the rules and regulations of the Structural Standards of Steel Ships<sup>2)</sup> and the classification society. The other three bulkheads were added during the design and shipbuilding process.

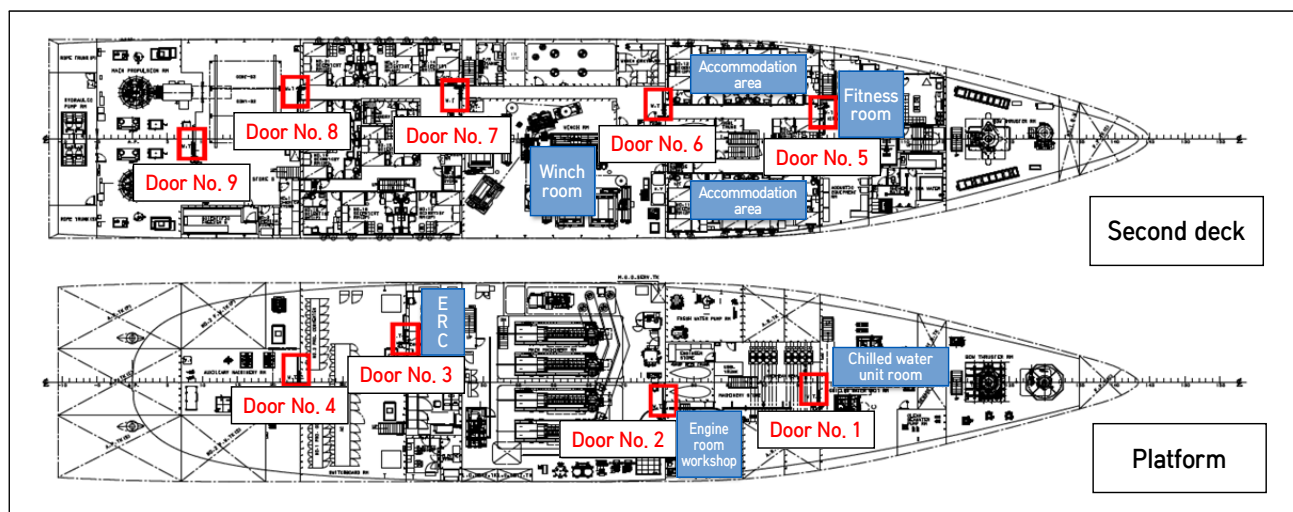
<Figure 3> Location and Nos. of watertight doors

2.6.3 Isabu has a total of nine hydraulic sliding watertight doors: five on the second deck, where the fitness room and researchers' cabins are located; and four on the platform, where the engine facilities are located.

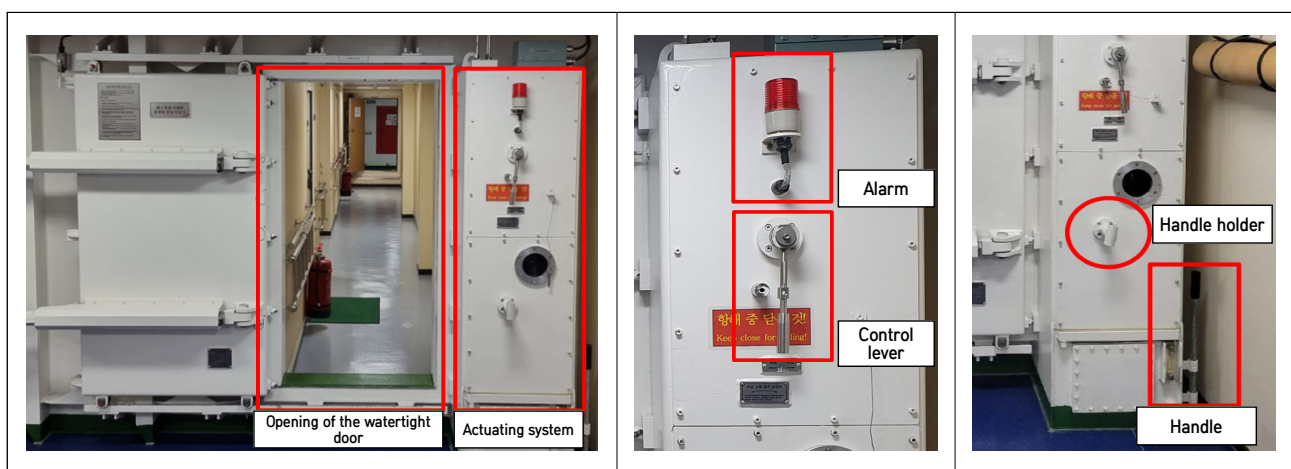
<Figure 4> Opening and actuating system (left); control lever and alarm (middle); and hand pump handle (right)

2.7.2 The vessel's watertight doors are operated by the hydraulic sliding system consisting of oil tanks, a hydraulic pump, an accumulator, control levers, hand pump handles, a pressure gauge, and an alarm. This system runs at a maximum pressure of 180kg/cm<sup>2</sup> with 440 volts, and the accumulator has a capacity of 32 liters. The alarm, connected to a 24-volt emergency power supply, gives off audible/visual signals.

2.7.3 The watertight door specifications say it takes 20 to 40 seconds to close the watertight door under normal conditions, and closing takes up to 90 seconds when the hand pump is used.

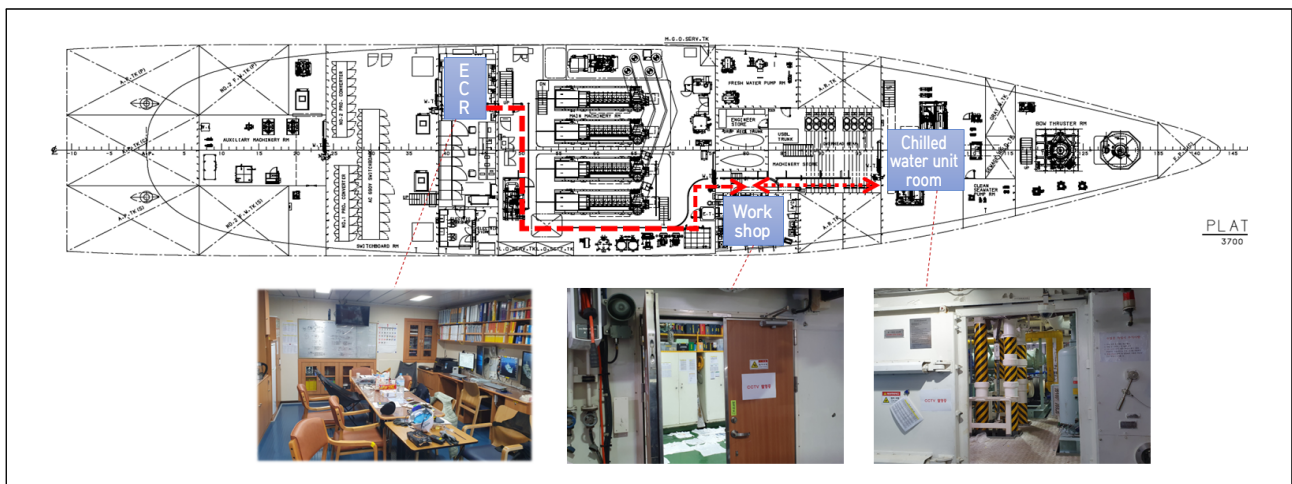
<Figure 5> Route taken by the chief electrician (ECR → Workshop ↔ Chilled water unit room)

3.1.5 From 14:10 to 14:15, she was standing in front of the chilled water unit room on the way to the workshop. Watertight Door No. 1 is the entrance of the room, which was always open.

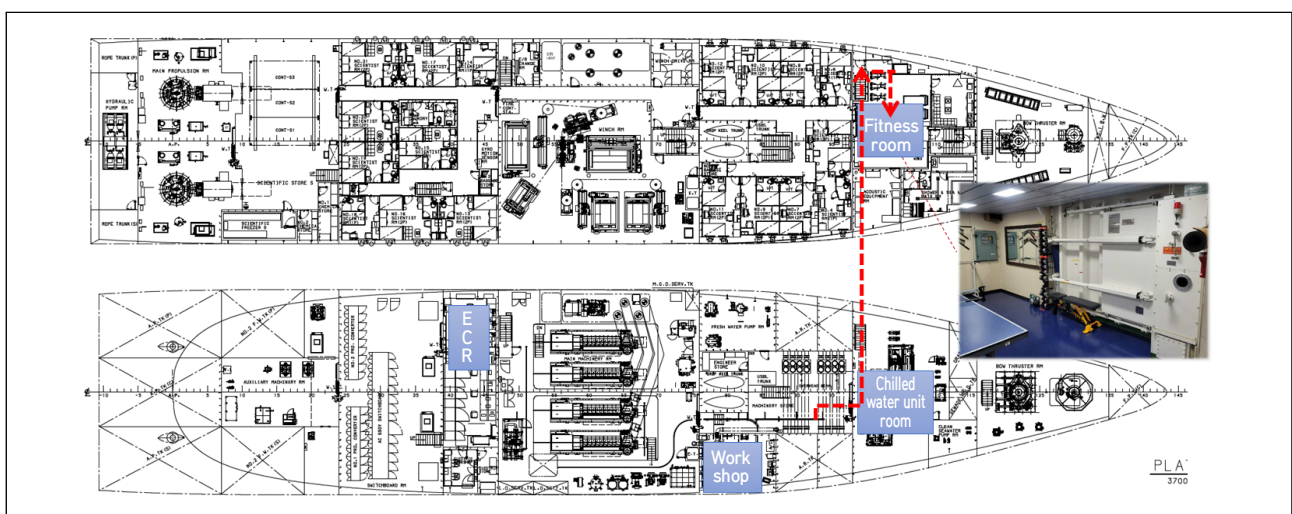
<Figure 6> Route taken by the chief electrician (Chilled water unit room → Fitness room)

3.1.6 At 14:15, the chief electrician walked up the stairs inside the chilled water unit room and went to the fitness room. The fitness room has Watertight Door No. 5 with an actuating system attached on the right side.

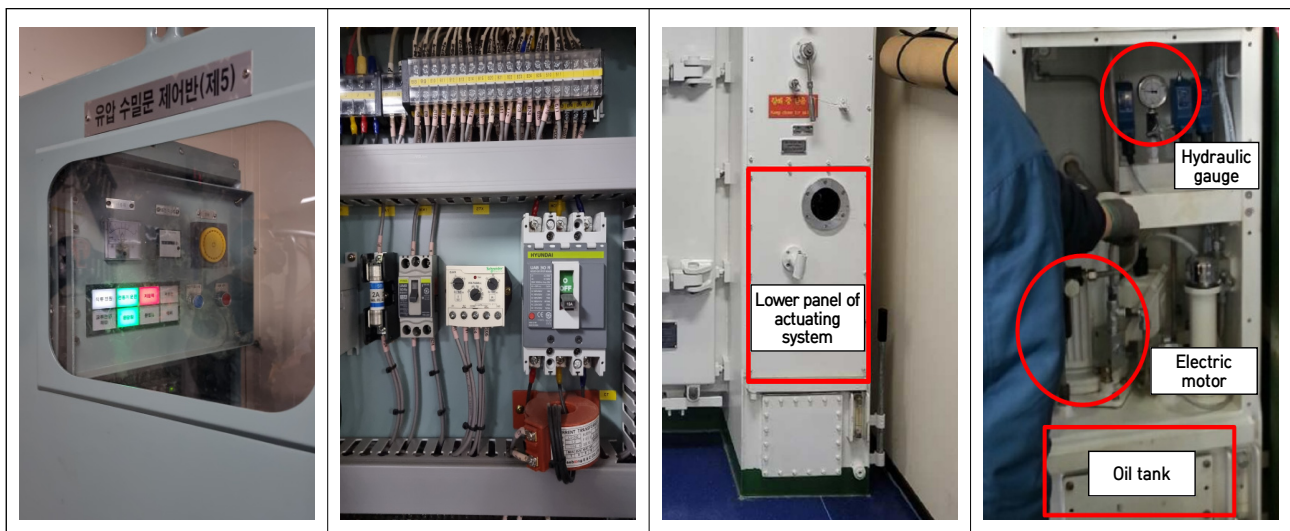
<Figure 7> Power switchboard, switchboard interior, lower panel of the actuating system, and inside the panel (from left)

3.1.7 From 14:15 to 15:05, the chief electrician stayed at the fitness room.<sup>9)</sup> She opened the cover of the power switchboard installed on the wall and checked its condition. The switchboard was closed with the power off. There are two power switches inside: one is a 440-volt power switch that operates the watertight door's hydraulic system; and the other one is a 24-volt emergency power switch for ringing an alarm and displaying a control console.

3.1.8 Then, she opened the lower panel of the actuating system where the watertight door's control lever was installed, checked the hydraulic gauges, electric motors, and other equipment, and cleaned the inside with cleaning cloths. While doing so, the watertight door remained closed.<sup>10)</sup>

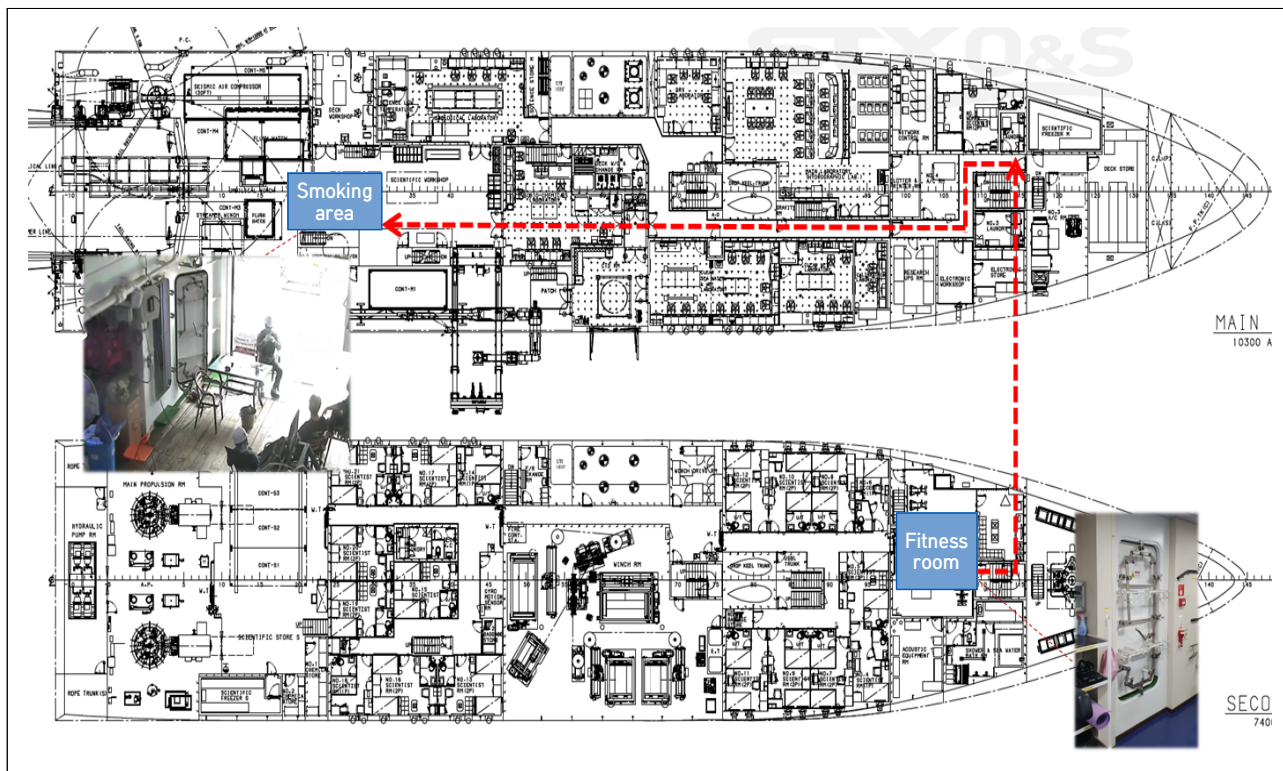
<Figure 8> Route taken by the chief electrician (Fitness room → Smoking area)

3.1.9 At 15:05, the chief electrician stopped cleaning for a while, opened the front door of the fitness room, walked up one flight of stairs, and went to the smoking area in front of the deck workshop at the stern of the main deck. The smoking area was an open space with tables and chairs where she could see A-frame cranes at the stern of the main deck.

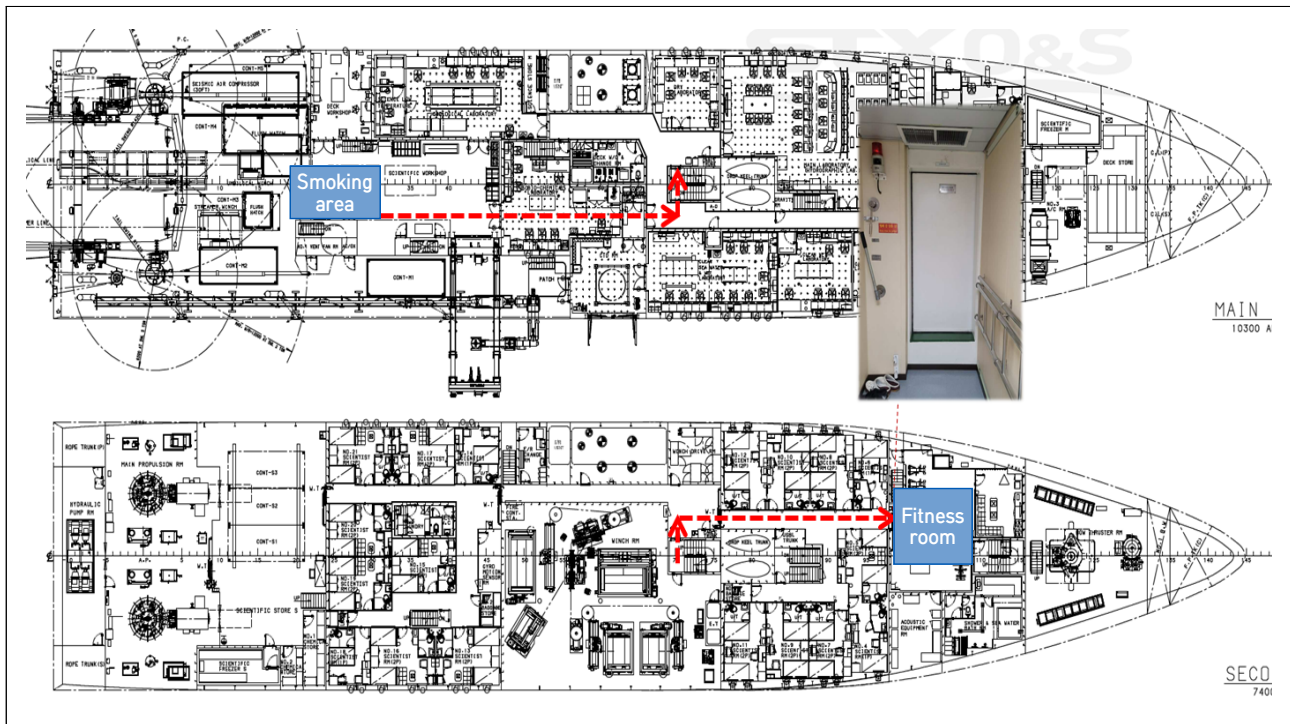
<Figure 9> Route taken by the chief electrician (Smoking area → Fitness room)

3.1.12 At 15:15 when coming down to the second deck, she walked along the corridor where the cabins for researchers and crew are located and arrived at Watertight Door No. 5. At that time, the door was kept closed.

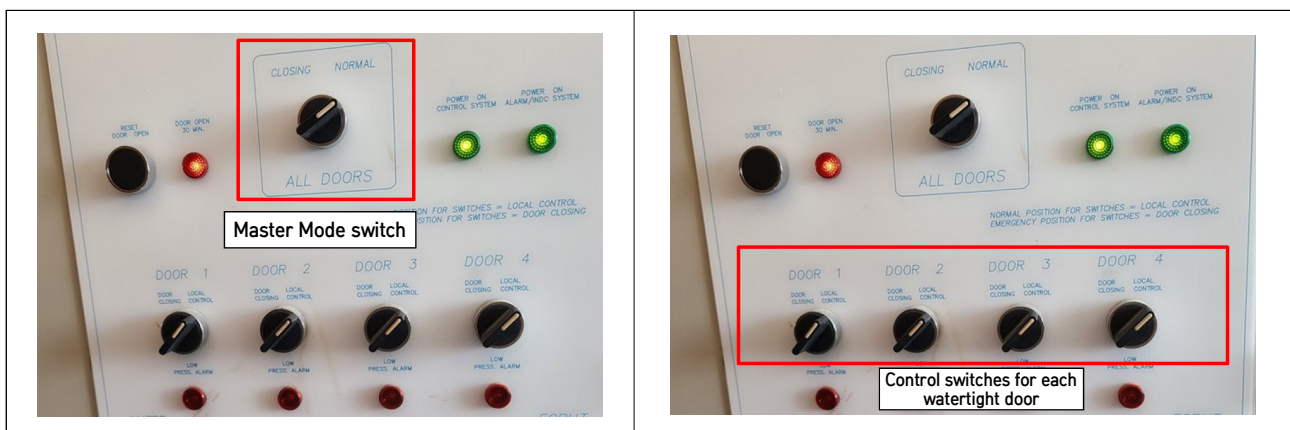
<Figure 18> Control console for watertight doors onboard Onnuri

4.6.4 Another research vessel of the KIOST, "Onnuri," has the Master Mode switch with Control switches for each watertight door below it on the central control console at the bridge, showing that the console has different functions and arrangement from that of Isabu.

4.6.5 It seems that the various functions of the control console on Isabu are likely to confuse the crew when they fail to understand their differences and functions. Therefore, it is considered important to provide sufficient training for the crew and

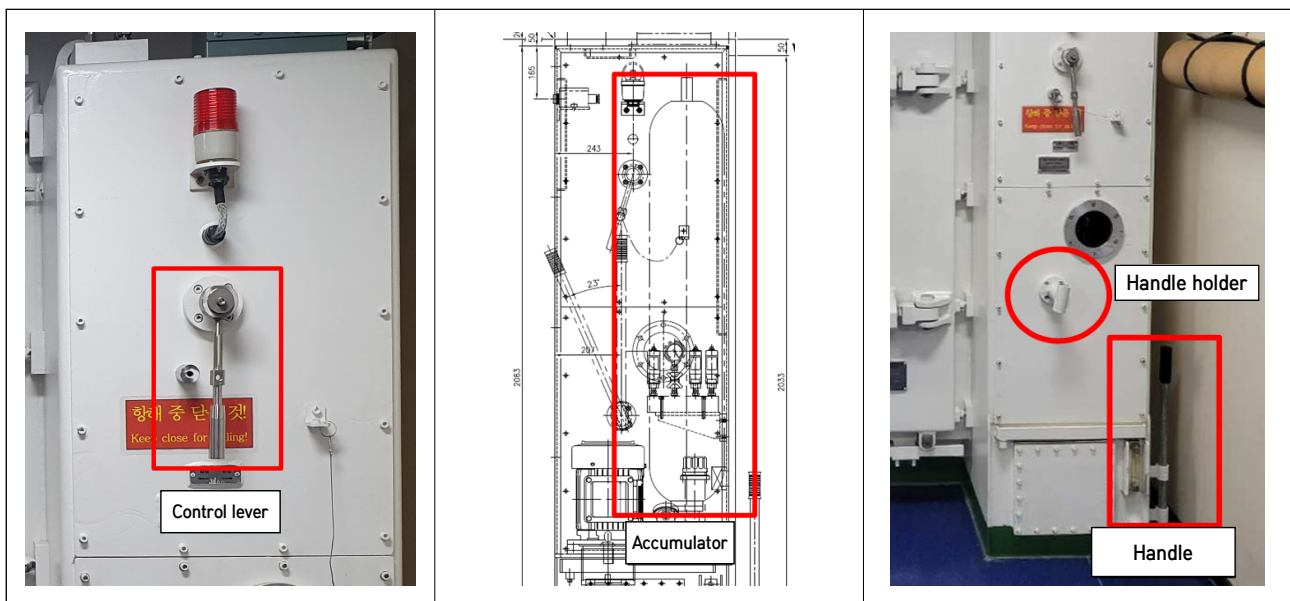
<Figure 19> Control lever (left); accumulator in the diagram (middle); and hand pump handle (right)

4.6.7 Meanwhile, the watertight doors onboard Isabu may be operated locally, at each door itself, in one of three ways: First, a person can use a control lever by running the hydraulic pumps; second, when the power is off, the door can be operated by the residual pressure of the accumulator; and third, if the oil pressure is not sufficient to operate the door, a person can use a handle for emergency operation to manually operate it.
