# **Marine Safety Investigation Report**

## **on Oil/Chemical Tanker *New Bright***

**- Explosion -**

**Date of Accident: 21 December 2023**

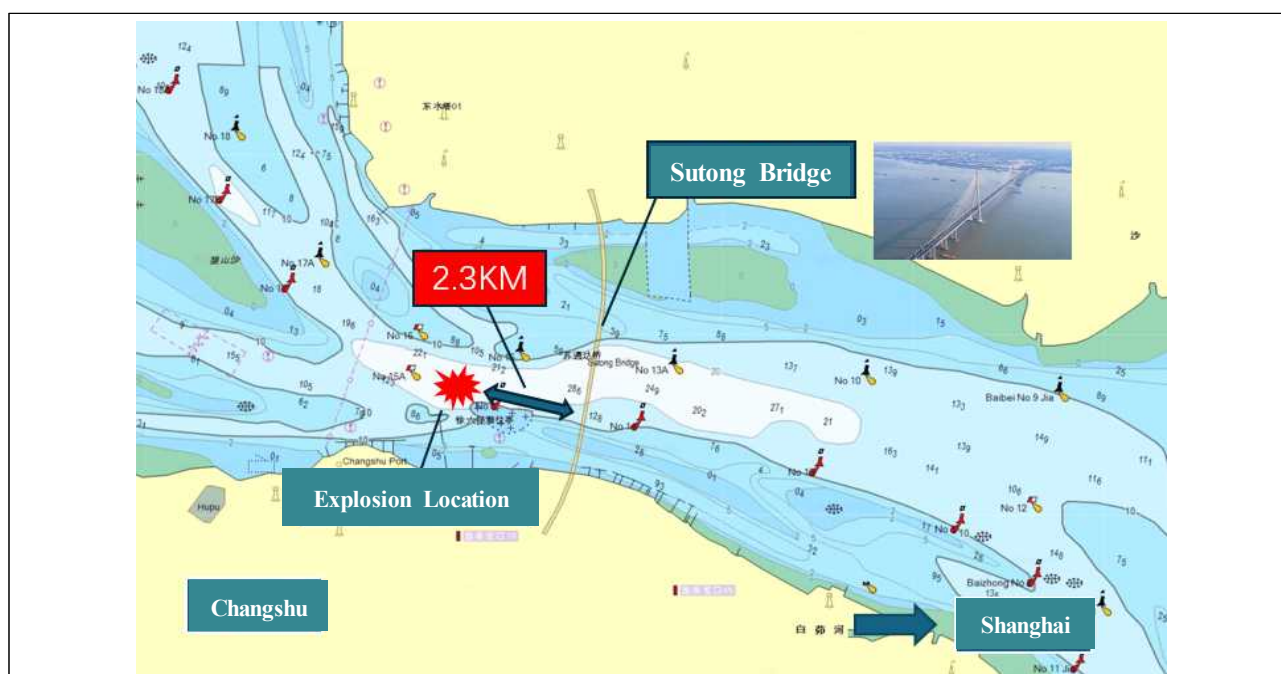
- 1.6 The explosion occurred at 15:06 on 21 December 2023 about 2.3 kilometers west of the Sutong Yangtze River Bridge (31-45-36N, 121-01-35E). The accident location on board is adjacent to CT No. 3, where the flame first ignited; explosions occurred two to three times consecutively; and then, the hull rapidly listed to starboard.
- 1.7 The accident occurred at around 15:06 on 21 December 2023, and the New Bright master who was adjacent to the bridge wing gave the order to abandon ship, pressed the distress button, and directed the crew to lower the life rafts. At around 15:40 on the same day, a total of 22 persons, including 19 crewmembers and three pilots, were safely rescued by a boat from the China Maritime Safety Administration (MSA). The fire was extinguished at around 20:00.

<Figure 1> The explosion location of New Bright (quoted from the Chinese MSA documents)

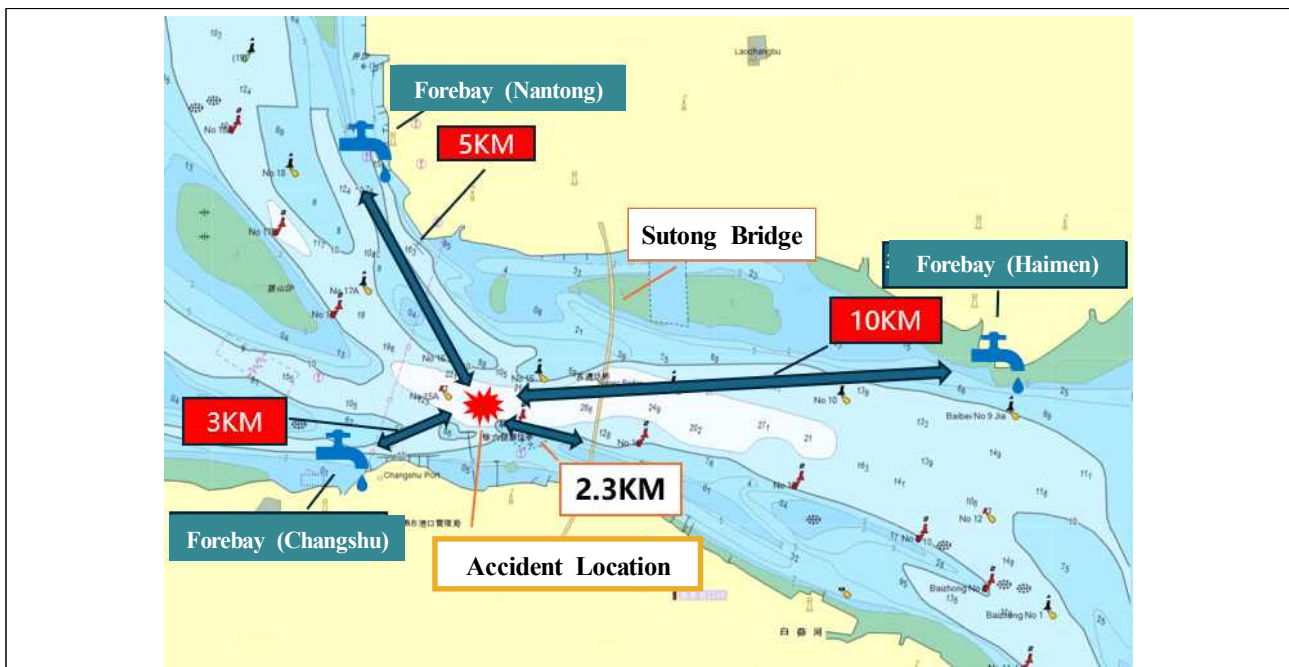
- 3.2.8 The explosion occurred at 15:06 on 21 December 2023 about 2.3 kilometers west of the Sutong Yangtze River Bridge (31-45-36N, 121-01-35E). The accident location on board is adjacent to CT No. 3 where the flame first ignited; explosions occurred two to three times consecutively; and then, the hull rapidly listed to starboard.
- 3.2.9 At the time of the accident, it was overcast with a wind blowing from the northwest at 8 to 10 meters per second; the waves were about 0.3 meters high; and visibility was about 7 nautical miles. The temperature was about 4 degrees below zero.

**<Figure 11> Explosion location and the adjacent forebays (quoted from the Chinese MSA's documents)**

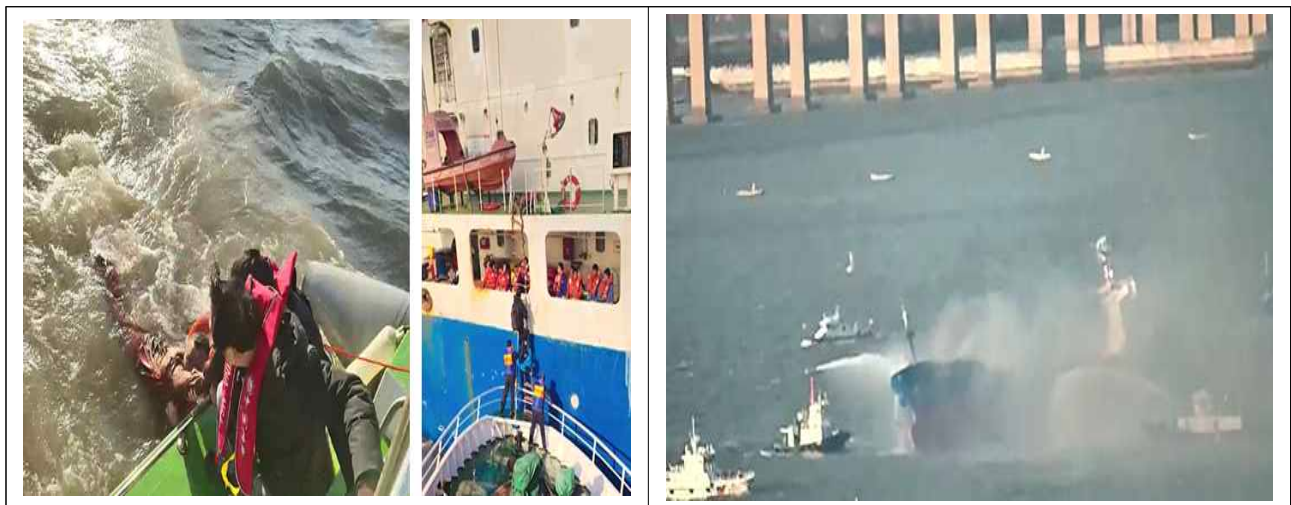
3.3.2 OS "A" and "B," who were on standby at the forward muster station, jumped into the river and one pilot evacuated to the life raft and abandoned the ship. At around 15:40 on the same day, a total of 22 crewmembers, including 19 crewmembers and three pilots, were safely rescued by the boat of the Chinese MSA. The fire was completely extinguished by around 20:00.

**<Figure 12> Rescue operation and evacuation of the New Bright crew (left) and fire extinguishment (right; quoted from the Chinese MSA's documents)**
