LESSONS LEARNED FROM MARINE SAFETY INVESTIGATION REPORTS

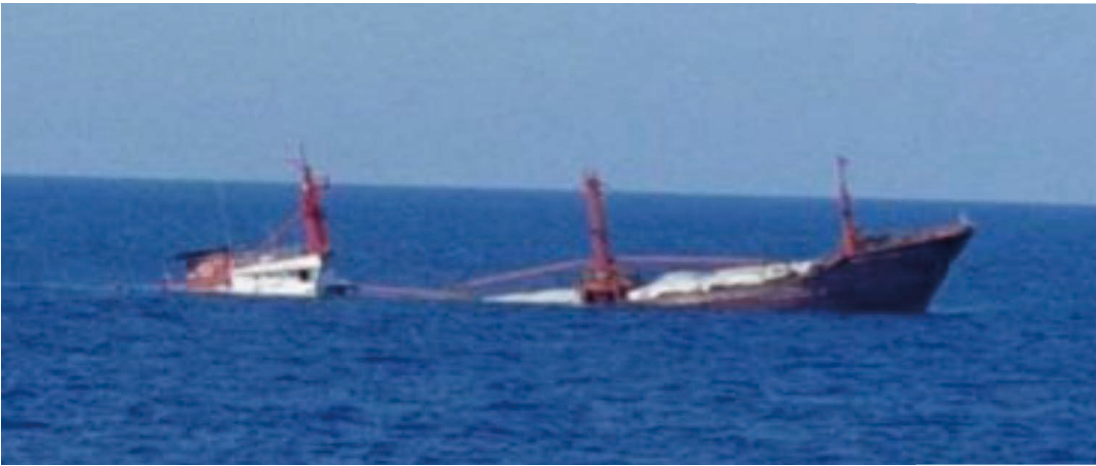
A 1,200 GT general cargo ship, which was carrying iron slag on a cabotage voyage in good weather conditions, raised a Mayday call through VHF Channel 16, stating that its engine-room was flooding and that the ship gradually sinking. The Master then ordered his crew to launch the rescue boat to abandon the sinking ship. A containership navigating in the vicinity responded to the Mayday call and successfully rescued all 10 crew members from the rescue boat. The 10 crew members were later transferred to a Coast Guard boat. As a result of the flooding, the general cargo ship sank and was declared a total loss. There was no oil pollution, crew injury or death arising from the incident.

- The 1984-built general cargo ship had carried out periodic maintenance and repair of the sea water pipelines (pipe, valve, seal, gasket) in the engine-room during dry-docking.

- However, considering the age of the vessel, it was postulated that corrosion, decay and failure in the sea water pipelines may have been contributory to the flooding.

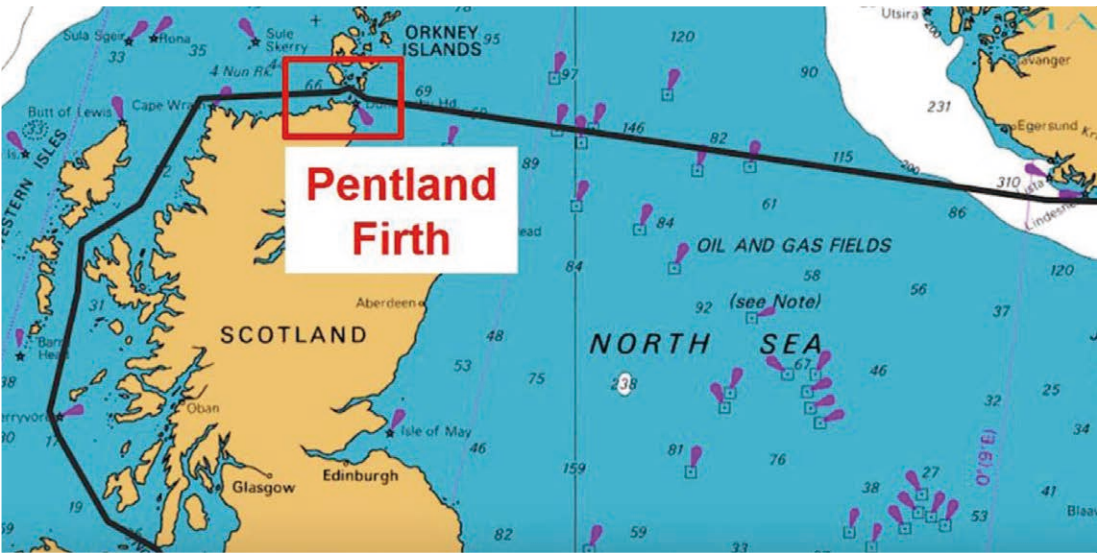
- The cement carrier was put to sea with significant shipboard safety deficiencies relating to its rescue boat launching arrangements and bilge pumping system in the void spaces beneath the cement cargo holds.

- The rapid nature of the capsizing denied the crew the opportunity to broadcast a distress message or the chance of a controlled abandonment. The emergency position indicating radio beacon (EPIRB) was probably released from its housing but then became trapped in the upturned hull and therefore did not float free to the surface or transmit.

- ✓ Six hours on/six hours off watchkeeping routine in short coastal trading cargo vessels can generate high levels of fatigue. Additional problems will almost certainly increase the hours of work and disrupt normal working routines. Deteriorating sea conditions will adversely affect the quality of sleep. Thus, there was a significant risk of crew suffering the effects of fatigue, affecting the outcome of decisions.
