# 2017년도 주요 해외 해양사고 교훈사례집

해양수산부  
중앙해양안전심판원

## 2017년도 주요 해외 해양사고 교훈사례

IMO 협약이행 전문위원회  
4차, 2017년

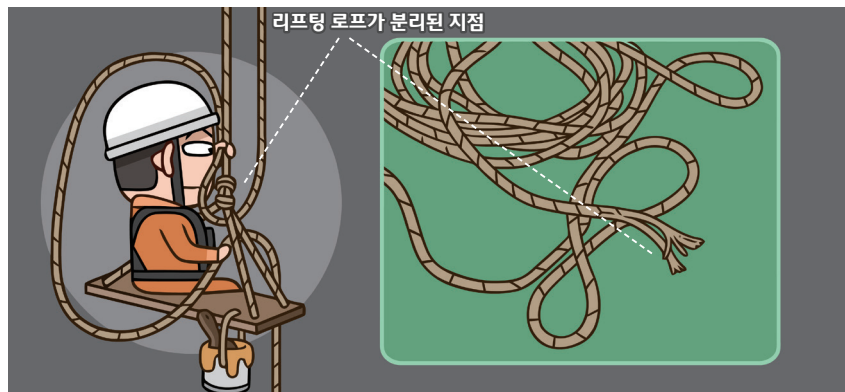
- 의자를 고정하고 있던 로프의 상태가 양호하지 않았다는 점이 사고의 가장 큰 원인이다. 또한 선원들이 의자에 앉아 있던 선원을 갑판으로 올리기 위해 rope ladder와 같은 안전한 방법을 사용하지 않고, 로프를 잡아당기는 방법을 사용했다.
- 선박 외판작업에 대한 허가가 이루어졌지만, 부유보조설비 및 추락방지장비 사용, 철저한 감독 등 기본적인 예방조치가 이루어지지 않았다. 갑판에서 작업을 감독하던 선원은 구멍조끼를 착용한 상태에서 작업하는 것이 불편하다는 이유로 실종 선원이 준비된 구멍조끼를 입지 않는 데 동의했다. 구멍줄은 선박에 제대로 고정되지 않았고, 끊어진 로프 등 다른 장비도 용도에 맞는지 확인하기 위한 점검이 제대로 이루어지지 않았다.

Figure 2.1 리프팅 로프

- The rope holding the Bosun's chair was in poor condition - the main reason for its failure. Further, the crew were heaving the rope to recover the man sitting on the Bosun's chair instead of using a safer method, such as a rope ladder for the man to climb up to the deck.
- Although a permit to work over the side had been issued, basic precautions were not in place. These include using a personal flotation aid, effective fall prevention equipment and proper supervision.

The person supervising on deck had agreed to dispense with the available lifejacket as it was inconvenient to work while wearing it. The lifeline was not properly secured to the ship, and other equipment, such as the rope that parted, had not been properly inspected to ensure it was fit for purpose.

Figure 2.1 Damaged part of the lifting rope

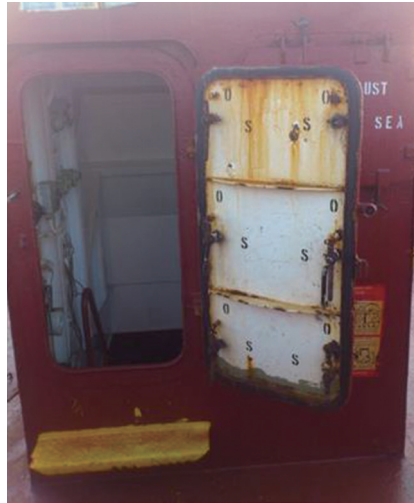
- 기상 상태가 악화되기 전 풍우밀문을 제대로 잠그거나 확인하지 않아 악천후 상황에서 문이 열렸다.
- 선원은 선박이 악천후 속에서 항해하는 도중 선수루 갑판에서 사망하였다. 당직항해사는 선장에게 자신의 의도를 의논하거나 알리지 않았고, 아무런 예방조치 없이 악천후 상황에서 선수 쪽으로 보내는 것에 대한 위험성을 충분히 고려하지 않았다.
- 사망한 선원 역시 위험한 상황에서 선수 쪽으로 이동할 때의 위험에 대해 충분히 고려하거나 당직항해사의 지시에 의문을 제기하지 않았다.

Figure 4.2 The weather-tight door on the fore-castle deck 출처 Investigation report(HKSAR)

- The weathertight door opened in heavy weather because it had not been properly secured for sea or checked before the onset of bad weather.
- The crew member who died was on the fore deck with the ship heading into heavy weather. The officer of the watch did not consult or advise the master of his intentions and did not take sufficient account of the risk of sending a man forward in heavy weather without taking any precautions.
- The crew member also did not take sufficient account of the risk of going forward in the prevailing conditions or challenge the instructions of the officer of the watch.

Figure 4.2 The weather-tight door on the fore-castle deck SOURCE Investigation report(HKSAR)

- 악천후 상황에서 갑판에 나가는 것은 위험하다. 선박안전을 위해 꼭 필요하다면 선장이 해당 조치의 위험을 평가하고 위험요소를 최소화하기 위한 모든 예방조치를 취해야 한다.
- 악천후로부터 횡동요운동(rolling), 종요운동(pitching) 및 항해 중의 위험 등을 줄이기 위해 선박을 피항하는 것은 누구든 갑판에 나가기 전에 취해야 할 중요한 예방조치이다.
- 선박을 파도로부터 안전하게 지키는 위해 풍우밀문, 수밀문 및 갑판의 다른 개구부 등을 닫는 것은 매우 중요하다.
- 해상 기상예보를 모니터링하여 악천후를 만나기 전 풍우밀문과 수밀문이 제대로 닫혀있는지 확인하는 등의 필요한 예방조치를 취하는 것이 중요하다.

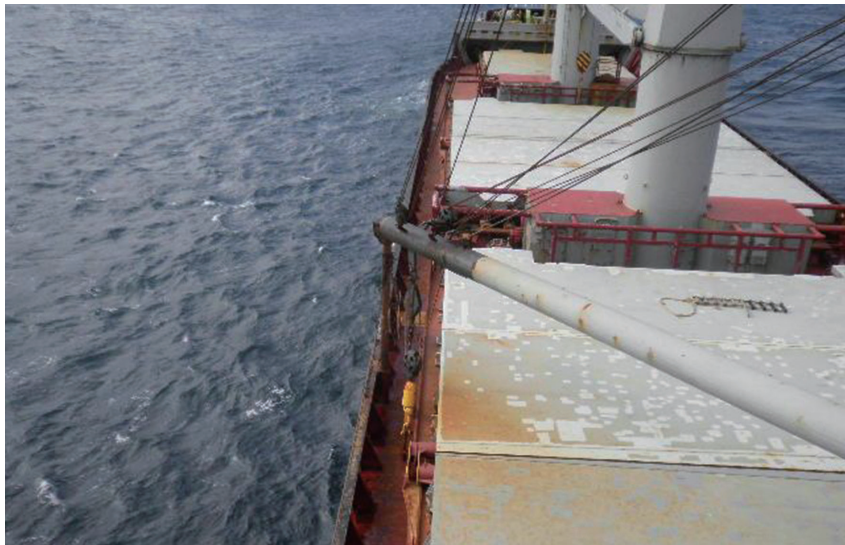
Figure 5.3 View from bridge 출처 Investigation report(Panama Maritime Authority)

Figure 5.3 View from bridge SOURCE Investigation report(Panama Maritime Authority)

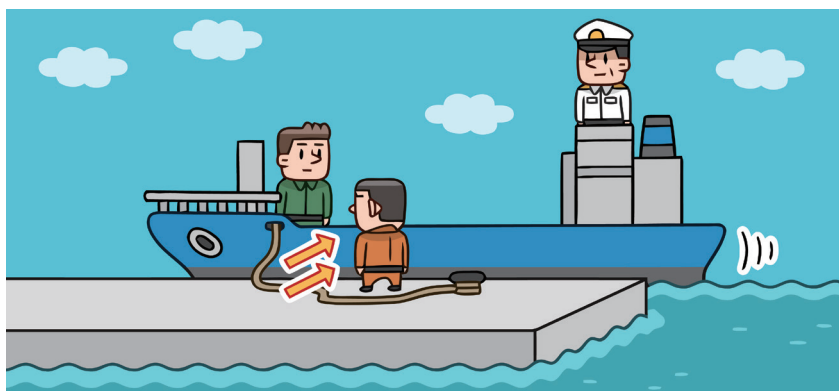
- 사고를 당한 항만노동자는 계류작업이 진행 중인 위험 지역으로 들어갔다. 선박 갑판에 있던 선원들은 그들이 있는 위치에서 이 노동자나 계선줄을 보지 못했고, 마찬가지로 선교에 있던 어느 누구도 이 노동자를 보지 못했다.
- 육상의 계선줄 담당자들은 계류작업이 진행 중인 위험지역으로 사고를 당한 항만 노동자가 들어가는 것을 막지 않았다. 계류작업을 진행한 회사의 안전관리 시스템에는 출입금지 지역에 허가 없이 진입하는 것을 막기 위한 충분한 절차가 마련되어 있지 않았다. 그러한 지역에 대한 경고표시도, 진입을 막기 위한 어떠한 다른 물리적인 조치도 마련되어 있지 않았다. 계류작업 회사에 대한 감독과 관련하여 부두관리 회사의 안전관리 역시 미흡했다.

Figure 6.1 The Scene of the casualty 출처 Investigation report(China MSA)

- The stevedore moved into a hazardous area, where mooring operations were still underway. The ship's crew on deck could not see him or the mooring line on the wharf from their positions, and no one on the bridge noticed him.
- The shore mooring linesmen did not prevent the stevedore from entering the hazardous area where they were still conducting mooring operations. The mooring gang company's safety management system did not have adequate procedures to prevent unauthorized entry to prohibited areas. There were neither warning signs for such areas nor other physical measures to prevent entry to them. The safety oversight of the company managing the wharf (with respect to supervision of the mooring gang company) was also inadequate.

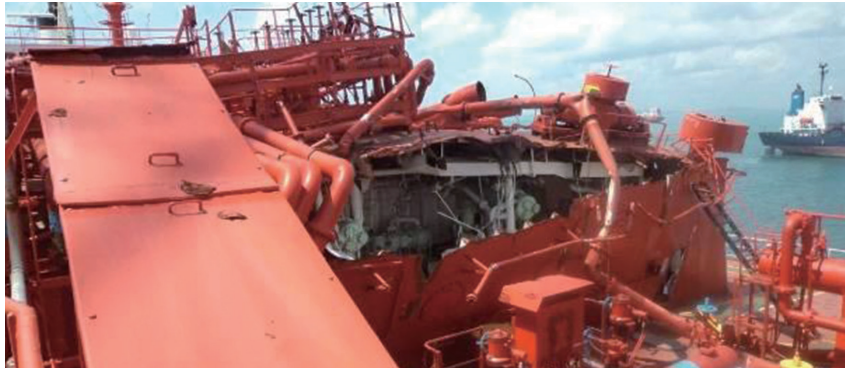
LNG 운반선이 부탄과 프로판을 운반하고 있었다. 선원 2명이 적재용 매니폴드로 이어지는 발판사다리를 떼어 내 고치려고 하는 중이었다. 이 작업은 항만국 통제 시 발견된 몇 가지 미흡한 점을 개선하기 위한 작업의 일환이었다. 절단기에 들어가는 가스는 부탄으로, 가스압축기 입구 파이프에서 공급되었다. 절단토치 역시 선박 갑판의 압축공기라인에 연결되어 있었던 것으로 보고되었다. 선원들이 절단노즐을 켜자 화물 압축기 입구 파이프의 토치와 연결된 호스를 따라 역화가 일어나면서 압축기실에서 폭발과 화재가 발생했다. 절단작업을 진행하고 있던 선원 2명이 사망했고, 갑판에서 유지보수 작업 중이던 다른 선원 2명이 중상을 입었다. 압축기실과 재액화설비 및 기타 장비가 심하게 훼손되었다.

Figure 9.1 Fwd cargo compressor Room 출처 Investigation report(Panama Maritime Authority)

Figure 9.1 Photo of the accident(Fwd cargo compressor Room) SOURCE Investigation report(Panama Maritime Authority)

- 가능하다면 인화성 화물을 운반하는 선박의 화물구역 내에서의 열 작업은 가스 프리절차가 모두 진행되어 해당 구역이 안전하다는 확인이 이루어진 후 수리조선소에서 진행해야 한다.
- 항해 중 열 작업이 반드시 필요한 경우에는 상세한 위험평가를 통해 사용하는 도구의 적절성에 대한 평가를 포함해 해당 작업에서 발생할 수 있는 모든 중대한 위험요소를 파악한 후에만 진행해야 하며, 적절한 위험 완화조치를 취해야 한다. 여기에는 어떠한 종류든 열 작업과 관련된 수리나 유지보수를 위한 절차가 포함되어야 하며, 특히 심각한 사고를 일으켜 생명과 재산을 위협하는 탄화수소에 노출된 구역에서의 작업은 이러한 절차가 매우 중요하다. 또한 작업허가, 안전관리시스템에 따른 합의된 절차, 개인보호장구 사용, 안전한 도구사용 및 “작업중단방침” 등 위험을 통제하기 위한 예방조치가 있는 경우 이 역시 위험평가에서 고려해야 한다.

- 어떠한 상황에서도 선원들은 수리작업을 진행하기 위해 화물가스를 배출하려고 해서는 안 된다. 화물 라인을 변경할 경우에는 언제든지 관련 행정기관과 선급협회의 승인을 받아야 한다.
- 이번 인명사고를 초래한 관행은 어떠한 상황에서도 용인되어서는 안되며, 산소아세틸렌 등의 재래식 방법의 불꽃절단 방식은 보편적이지만 항상 능숙한 작업자가 진행하고 “작업허가”를 받아야 한다. 그렇게 해도 역화의 위험은 항상 존재한다. 영국 보건 안전청(Health and Safety Executive)은 발행물 INDG297(개정 1판)에서 다음과 같이 조언하고 있다. “역화는 보통 산소가 연료가스 호스로(또는 연료가 산소호스로) 거꾸로 흘러 들어가 호스 내부에 폭발성 혼합물이 생성되어 발생한다. 그러면 불꽃이 토치를 통해 호스 안으로 연소되어 들어가고, 심지어 조절기와 실린더에까지 이를 수 있다. 역화로 장비가 손상되거나 부서질 수 있고, 심지어 실린더가 폭발할 수도 있다.
- 올바른 점화절차를 사용한다. 혹시라도 있을 수 있는 폭발성 가스혼합물을 제거하기 위해 토치에 점화하기 전에 호스를 퍼지(purge) 시킨다.
- 분출관(blowpipe)은 스프링이 달린 역류방지 밸브가 있는 것을 사용한다.
- 작업에 맞는 가스압력과 노즐 크기를 사용한다.
- 이러한 조치를 통해 역화의 위험을 줄일 수는 있지만 완전히 제거할 수는 없다. 역화가 일단 발생하면 역류방지 밸브로 중단시킬 수 없다.

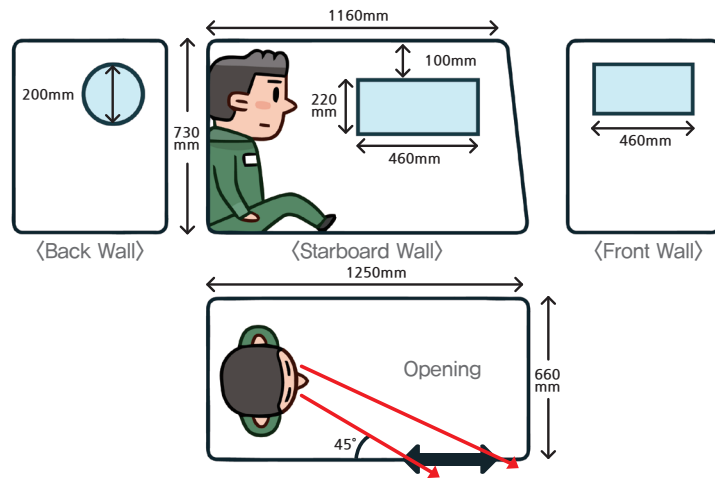
- 폭우로 시계가 제한되었고 자동차운반선의 레이더 화면에도 악영향을 주어 당직 항해사가 어선을 발견하지 못했다.
- 자동차운반선의 당직항해사는 다른 모든 선박에도 AIS가 작동하고 있다고 생각하여 AIS가 없는 어선을 발견하지 못했다.
- 어선의 갑판원은 당직실의 앞은 자리에서 자동차운반선이 접근하는 것을 모니터링할 수 없었다.
- 어떤 선박도 무중신호를 울리지 않았다.
- 자동차운반선의 당직항해사와 어선의 갑판원 둘 다 시계가 제한된 상황이었다는 것을 알았지만 어느 누구도 충돌 전에 지원을 요청하지 않았다.

Figure 10.3 Watch room Dimensions Diagram 출처 Investigation report(JTSB)

Figure 10.3 Watch room Dimensions Diagram SOURCE Investigation report(JTSB)

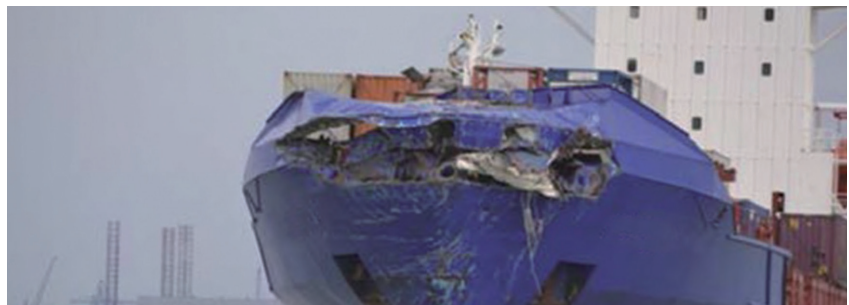
선박 통행량이 많은 지역에서 근접상황이 발생했다. 선박 두 척이 횡단하는 상황에서 유지선인 25,000톤급 자동차운반선이 피항선인 6,000톤급 컨테이너선에게 연락하여 좌현으로 방향을 선회해 컨테이너선의 선미를 지나가겠다고 제안했다. 이 부분에 대해 합의가 이루어졌으나, 상황이 전개되면서 컨테이너선이 우현으로 선회했고 결국 자동차운반선의 우현과 충돌했다. 자동차운반선은 컨테이너선의 구상선수와 충돌하여 크게 손상되었다. 자동차운반선은 결국 15분 내에 침몰했고, 선원 11명이 사망했다.

Figure 11.3 Crash ship picture(After) 출처 Investigation report(Bahamas Maritime Authority)

Figure 11.3 Photo of the ship in the collision(After) SOURCE Investigation report(Bahamas Maritime Authority)

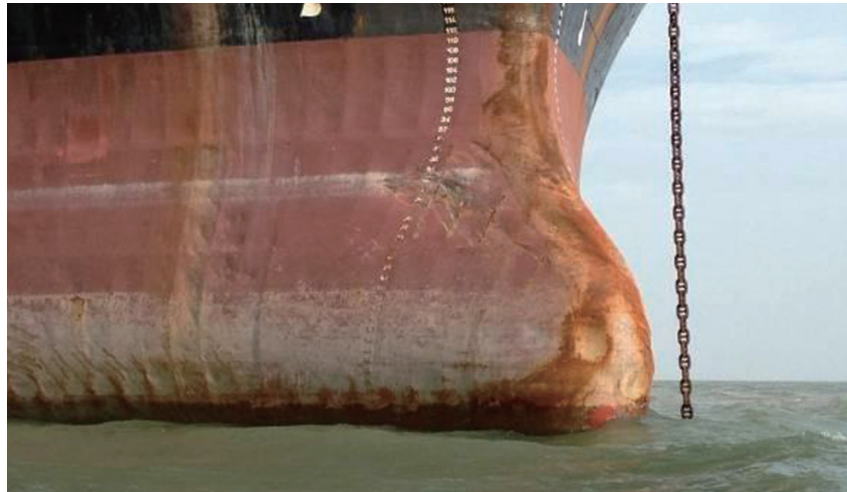
25,000톤급 벌크선이 도선사가 승선한 상태로 부두로 가고 있었다. 선박은 방향을 선회하고 부두로 접안하기 위해 앵커와 예선을 사용했다. 그 과정에서 선수 부분이 부두에 계류되어 있던 바지선의 좌현 측과 충돌하여 바지선의 선체를 심하게 손상시켰다. 바지선은 침몰을 막기 위해 부두에서 천수 구역으로 이동했다. 이 사고로 인해 오염이나 부상자는 발생하지 않았다. 벌크선의 피해는 미미했다.

Figure 12.1 Bulk Carrier 출처 Investigation report Investigation report(Panama Maritime Authority)

Figure 12.1 Photo of the ship after collision(Bulk Carrier) SOURCE Investigation reportInvestigation report (Panama Maritime Authority)

- 부두에 접근하는 동안 선속은 선박 조종에 필요한 최소수준으로 줄여야 한다.
- 선박의 항해계획은 선박의 조종성과 현지상황을 고려해 부두에서 부두까지 상세하게 수립되어야 한다.
- 선장과 도선사는 항해계획에 대해 충분히 의논하고 서로의 의도에 대해 이해를 같이 해야 한다.
- 선교팀과 도선사 간의 조율과 정보교환이 용이하도록 선교자원관리(BRM, Bridge Resource Management)가 효과적으로 이루어져야 한다. 선원 및 도선사는 선교자원 관리에 대해 충분한 교육을 받아야 한다.

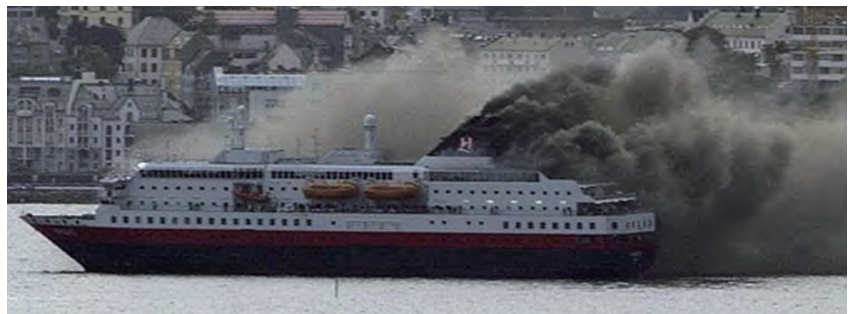
Figure 14.1 At the time of ship fire 출처 Thomas Molnes, Investigation report(AIBN, Accident Investigation Board Norway)

로로여객선의 기관실에서 화재가 발생했다. 그로 인해, 기관장과 실습기관사가 사망하고 선원 2명이 중상을 입었다. 발화지점은 우현 측 주기관 5번 연료분사펌프 근처인 것으로 결론지어졌다. 화재 발생 당시, 1등기관사, 실습기관사, 기관부원이 우현 측 주기관 실린더 헤드 위치의 바깥쪽에 위치한 공작실에 있었다. 이들은 우현 주기관의 앞쪽에서 짙은 검은 연기와 불길의 솟아오르는 것을 보았다. 이들은 가장 앞쪽에 있는 문 두 개를 통해 공작실에서 빠져나갔지만 기관실을 통해 대피하기 위해 화재 지점 근처를 지나가야 했다. 1등기관사와 기관부원은 전방격벽의 좌현 측에 있는 수밀문을 통해 기관실을 빠져나갔다. 이들은 기관실에서 대피할 때 실습기관사를 보았는지 기억하지 못했다. 1등기관사와 기관부원은 복도를 지나 계단을 올라가 3번 갑판(Deck 3)의 승객 안내구역으로 대피했다. 실습기관사 역시 동일한 경로를 따라 이동한 것으로 보이나, 그의 시신이 4번 갑판(Deck 4)의 계단으로 이어지는 문 바로 안에서 발견된 것으로 보아 3번 갑판에서 멈추지 않고 4번 갑판까지 이동한 것으로 결론지어졌다. 세 사람 모두 중증화상을 입었다. 기관장과 다른 기관부원은 좌현 측 주기관 실린더헤드 위치의 바깥쪽에 위치한 청정기실에 있었다. 기관장은 바로 인접한 소각기실에서 막 나와 기관부원과 1분 정도 이야기하던 중 소각기실이 짙은 검은 연기로 가득 찼다는 것을 깨달았다. 기관장은 조사를 위해 소각실로 되돌아갔다. 기관부원은 처음에는 청정기실의 뒷문에서 기관실을 들여다본 후 기관장을 찾으러 되돌아갔다. 기관장이 보이지 않자, 청정기실의 뒷문을 통해 대피하여 기관실 Floor plate로 내려가 기관실 좌현 선미 쪽의 수밀문을 통해 발전기실로 이동했다. 그곳에서 기관제어실로 간 뒤 선교로 연락할 수 있었다. 나중에 청정기실에서 기관장의 시신이 발견되었다. 주기관과 보조기관이 모두 작동을 멈추면서 비상발전기가 가동되었으나 과열되어 곧바로 멈추었다. 그로 인해 선박의 소화펌프와 기타 전기장비들이 제대로 작동하지 않았다. 다행히 선박이 해안에 가까이 위치해 있어 부두로 예인되었고 그곳에서 소방관들이 진화작업을 진행했다. 한편, 승객 207명과 선원 55명은 전원 좌현 측 구명보트 두 척으로 대피했다.

- 연료분사펌프용 체결볼트 4개가 전부 헐거워서 펌프하우징이 움직일 수 있었던 것으로 나타났다. 파손된 표면에 대해 이후 진행된 조사 결과, 펌프 몸체가 움직이면서 주기적으로 발생한 수직하중 때문에 노후로 인한 파손이 발생하여 연료유 리턴파이프가 손상되었을 가능성이 가장 높았다. 펌프몸체가 움직인 것은 12일 전 펌프를 교체한 후 체결볼트가 제대로 고정되지 않았기 때문이었다. 화재는 중요한 제어장비로 번졌다. 원래 엔진제조업체가 각 연료펌프 앞에 비산방지장치(spray shields)를 설치했었으나 화재 당시에는 설치되어 있지 않았다. 비산방지장치가 설치되어 있었다면 연료와 불꽃이 제어장비에 영향을 미치는 것을 방지했을 수도 있다.

- 구체적인 직무 내용이 회사의 안전관리시스템에 명시되어 있는 경우, 임무를 안전하게 완수하기 위해 제조사에서 제시한 중요한 정보(체결볼트 조임 시 토크 값 등)가 포함되어야 한다. 기본지식이 있었다면 선박의 기관사들이 이러한 정보가 없다는 점에 대해 문의를 했겠지만, 문서화된 작업지침에 의존해야 할 경우 모든 필요한 절차와 데이터가 해당 문서에 반드시 포함되어 있어야 한다는 것을 이번 인명피해를 통해 알 수 있다.

- 관련 행정기관과 선급협회는 기준을 준수하지 않는 방열 부분을 파악하기 위해 연차검사 등에 열화상 이미지 도입을 고려해야 한다.

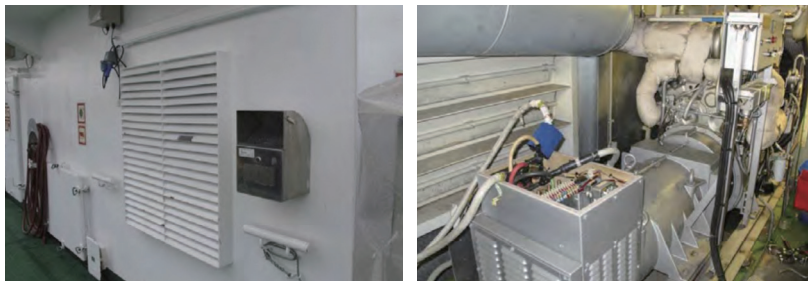
Figure 15.1 Damper of the emergency generator 출처 Investigation report (AIBN)

- 댐퍼가 열린 후 다시 빨리 닫혔거나 아예 열리지 않았고, 공기가 충분히 냉각되지 않아 비상발전기실의 온도가 상승했다. 이로 인해 냉각수 온도가 급격히 상승하여 냉각수 라인이 고온에 노출되었고, 냉각수 온도가 끓는점까지 올라가면서 압력이 상당히 상승한 것으로 보인다. 압력을 견디지 못한 호스가 파열되고 기관에 대한 마지막 남은 냉각효과가 사라지면서 기관이 정지한 것으로 보인다.
- 댐퍼는 보통 닫힌 상태로 있고 스프링으로 그 상태를 유지하도록 되어 있으며, 발전기가 작동하면 축압기에서 압축된 공기를 공급받아 자동으로 열린다. 압축 공기는 공기압축기(발전기실에 설치, 주배전반으로부터 급전)를 통해 만들어진다. 2년 전 동종선의 사고(좌초)로 이 시스템의 취약점이 발견된 후, 비상 발전기실의 공기 공급라인에 체크밸브를 설치하여 전원공급이 중단될 경우 공기의 압력이 떨어지는 것을 방지하도록 했다. 선내정비시스템에 따라 자동으로 작동하는 댐퍼를 주기적으로 점검하도록 되어 있었고, 화재 발생 약 2개월 전 이 점검이 시행되었을 당시 다음과 같은 메모가 기록되었다. “체크밸브가 원래 기능대로 작동하지 않아 댐퍼가 열마 후 닫힌다. 새로운 에어실린더가 반대로 작동한다. 그때까지 블랙아웃 시 댐퍼가 닫히지 않고 열린 상태로 될 수 있게 고정시켜 두어야 한다.”[원문 인용] 이 정보가 육상의 안전관리팀이나 동종선들과 공유되지 않았고, 비상상황 시 반드시 공기공급이 이루어지도록 하기 위한 효과적인 임시조치도 취해지지 않았다.

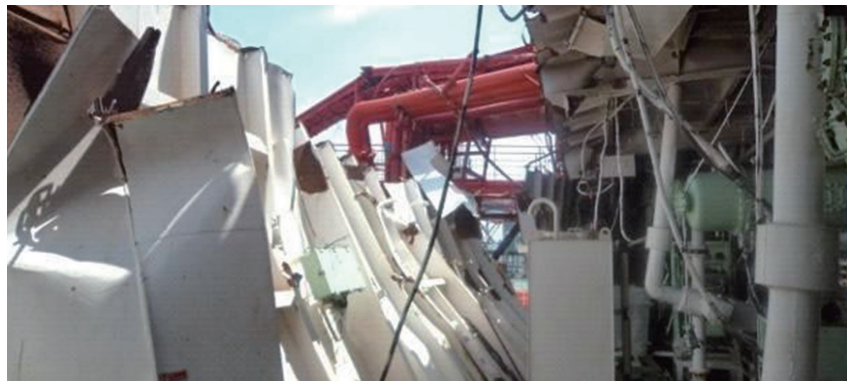
Figure 9.2 Photo of the accident(Out Side cargo compressor Room) SOURCE Investigation report(Panama Maritime Authority)

An LPG carrier was carrying a cargo of butane and propane. Two crew members were attempting to crop out and renew step ladders leading to the loading manifold. The activity was part of work addressing several deficiencies identified during a Port State Control(PSC) inspection. The gas feeding the cutting tool was butane, tapped off the gas compressor inlet pipe. It is reported that the cutting torch was also connected to the vessel's compressed air deck line. When the crew members lit up the cutting nozzle, there was a flashback along the hose connecting the torch to the cargo compressor inlet pipe resulting in an explosion and fire in the compressor room. The two crew members carrying out the cutting operation were killed, and two other crew members, who were also carrying out maintenance work on deck, were seriously injured. The compressor room, the re-liquefaction plant and other equipment were heavily damaged.

- Make sure the blowpipe is fitted with spring-loaded non-return valves.
- Use the correct gas pressures and nozzle size for the job.
- Maintain the equipment in good condition.

These measures will reduce the risk of a flashback but will not completely eliminate it. Non-return valves will not stop a flashback once it has occurred."

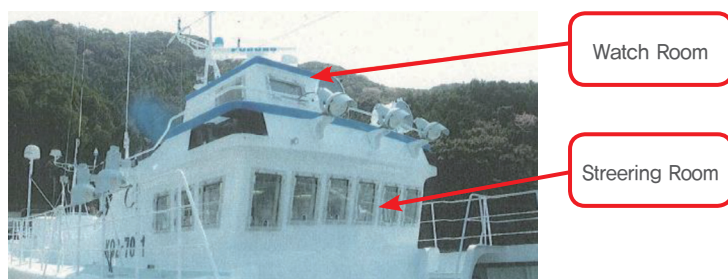
External View of Steering Room and Watch Room

The deckhand on the fishing vessel was not allowed to operate the radar, but merely checked the radar display and observed the car carrier 6 miles away on the fishing vessel's starboard quarter. He then went back to the watch room, which was just a tiny compartment above the steering room. From where he was sitting, there was a blind sector on starboard quarter. The ship subsequently collided with the fishing vessel, causing it to sink. One man was lost out of a crew of eight. The officer on the car carrier did not notice any collision.

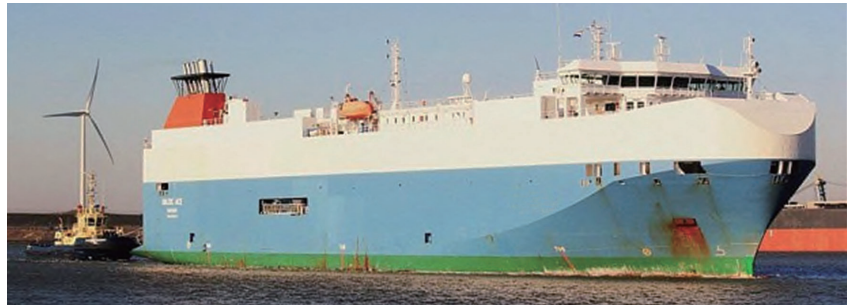
A close-quarters situation developed in an area with heavy traffic. A 25,000 GT car carrier, which was the stand-on vessel in a crossing situation, called a 6,000 GT containership, which was the give-way vessel, to suggest that the car carrier turn to port and pass astern of the containership. This was agreed, but as the situation developed further, the container ship turned to starboard and finally ran into the starboard side of the car carrier. The bulbous bow caused sufficient damage to cause the car carrier to sink within 15 minutes. 11 seafarers were lost.

Figure 11.1 Photo of the ship in the collision SOURCE Investigation report(Bahamas Maritime Authority)

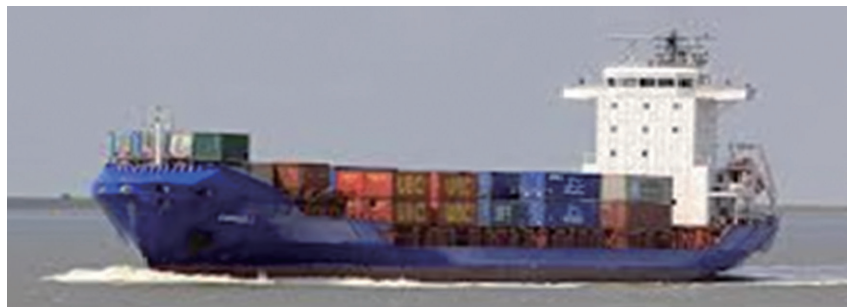
Figure 11.2 Photo of the ship in the collision(Before) SOURCE Investigation report(Bahamas Maritime Authority)
